**COLORADO DIVISION OF RECLAMATION, MINING AND SAFETY
COAL PROGRAM INSPECTION REPORT**

Permit Number: C-1981-017 Mine Name: Coal Basin Mines Operator: Mid-Continent Resources Operator Address:	County: Pitkin Operation Type: Underground Permit Status: Revoked Ownership: Federal
	Operator Representative Present: None
Operator Representative Signature: (Field Issuance Only)

Inspection Start Date: June 22, 2013 Inspection Start Time: 11:30 Inspection End Date: June 22, 2013 Inspection End Time: 11:35		Inspection Type: Aerial Inspection Inspection Reason: Normal I&E Program Weather: Clear	
Joint Inspection Agency: None		Joint Inspection Contacts:	
Post Inspection Agency: None		Post Inspection Contacts:	
Inspector(s): Brock F. Bowles Harry B. Ranney	Inspector's Signature:

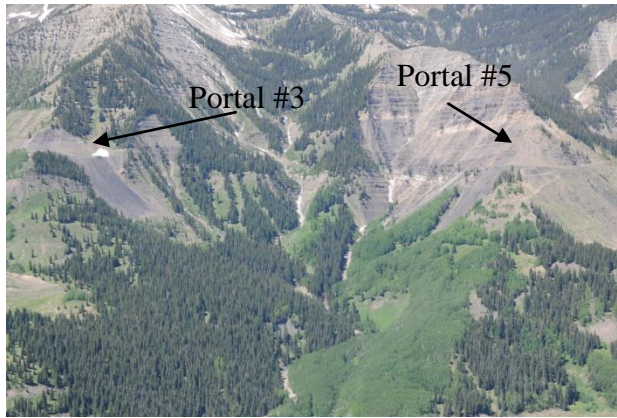
Photo 1 – Portals #3 and #5

The backfill of portals #3 and #5 appear to be stable (photo 1). There are no signs of slumping. Portal #4 appears to be stable (photo 2). Portals #1 and #2 also appear to be stable.

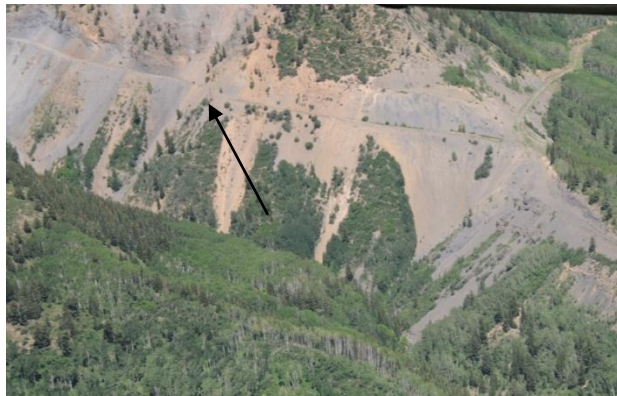
Most of the snow has melted from the site and the roads appear to snow free. It looks like the access road to the #3 portal is still blocked by the collapsed hillside above the road. Most of the roads appear to be passable for ATV's.

Photo 3 – Portal #3 Road Blocked
