**COLORADO DIVISION OF RECLAMATION, MINING AND SAFETY
COAL PROGRAM INSPECTION REPORT**

Permit Number: C-1981-025 Mine Name: North Thompson Creek Mine Operator: MINREC, Inc. Operator Address: Mr. James E Stover 2352 N 7th St, Ste B Grand Junction, CO 81501	County: Garfield Operation Type: Underground Permit Status: Inactive Ownership: Federal
	Operator Representative Present: None
Operator Representative Signature: (Field Issuance Only)

Inspection Start Date: June 22, 2013 Inspection Start Time: 11:30 Inspection End Date: June 22, 2013 Inspection End Time: 11:31	Inspection Type: Aerial Inspection Inspection Reason: Normal I&E Program Weather: Clear
Joint Inspection Agency: None	Joint Inspection Contacts:
Post Inspection Agency: None	Post Inspection Contacts:
Inspector(s): Brock F. Bowles Harry B. Ranney	Inspector's Signature:

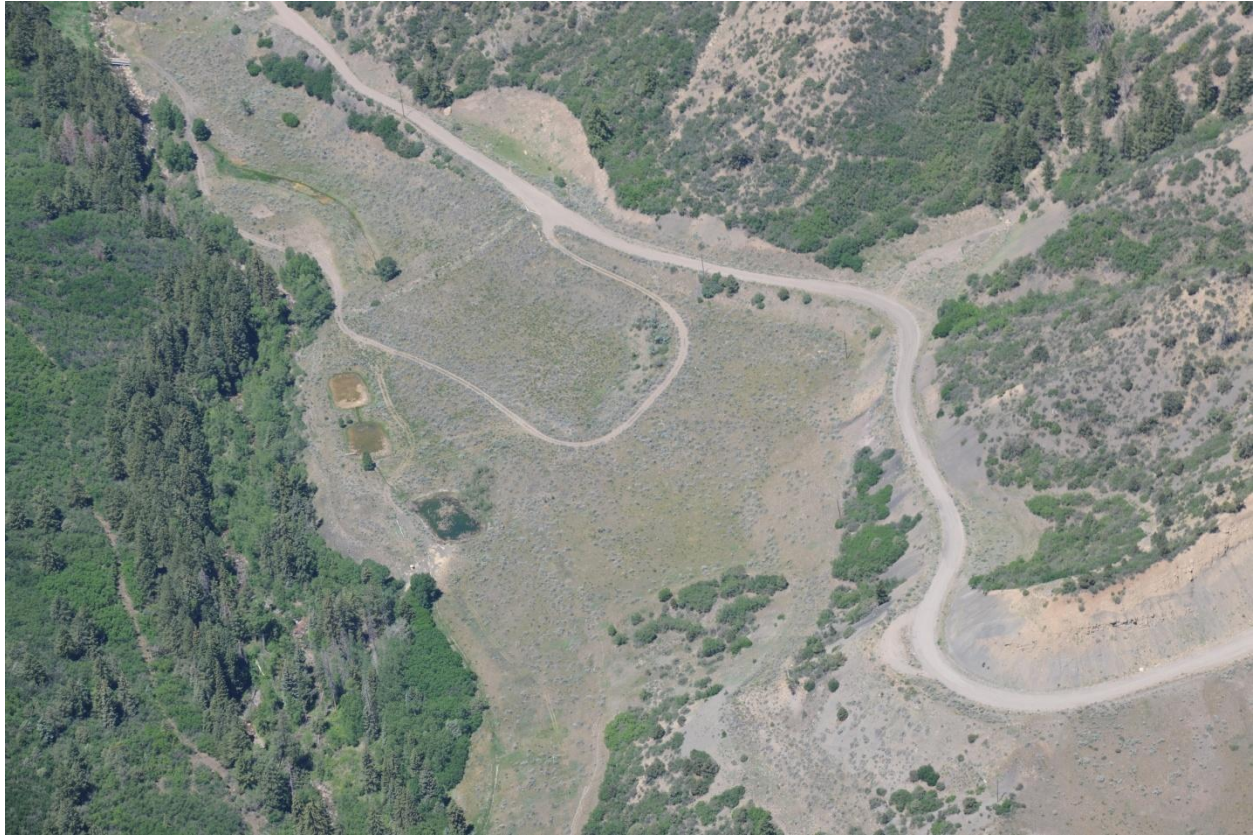
The west end of the long pond has green vegetation. The middle of the long pond has yellow/orange coloring. The east end of the long pond is brown or grey which looks like last year’s dead vegetation. Ponds T1 and T2 contained water. Pond P9 contains water but the vegetation in the pond in grey. There-directed emergency spillway from P9 is clearly seen and the area still has straw mulch on it. The pipes noted in the ditch between Pond T2 and Outfall 001 in the 6/18/2013 inspection report are still in the ditch (photo 1).

Photo 1 – North Thompson Creek Mine Long Pond, T1, T2 and P9
