## COLORADO DIVISION OF RECLAMATION, MINING AND SAFETY COAL PROGRAM INSPECTION REPORT

<b>Permit Number:</b> C-1981-046 <b>Mine Name:</b> Sunlight Mine <b>Operator:</b> Garfield Energy Corporation <b>Operator Address:</b>	<b>County:</b> Garfield <b>Operation Type:</b> Underground <b>Permit Status:</b> Revoked <b>Ownership:</b> Private
	<b>Operator Representative Present:</b>  None
<b>Operator Representative Signature:</b> (Field Issuance Only)

<b>Inspection Start Date:</b> June 22, 2013 <b>Inspection Start Time:</b> 11:25 <b>Inspection End Date:</b> June 22, 2013 <b>Inspection End Time:</b> 11:30	<b>Inspection Type:</b> Aerial Inspection <b>Inspection Reason:</b> Normal I&E Program <b>Weather:</b> Clear
<b>Joint Inspection Agency:</b>  None	<b>Joint Inspection Contacts:</b>
<b>Post Inspection Agency:</b>  None	<b>Post Inspection Contacts:</b>
<b>Inspector(s):</b>  Brock F. Bowles  Harry B. Ranney	<b>Inspector's Signature:</b>

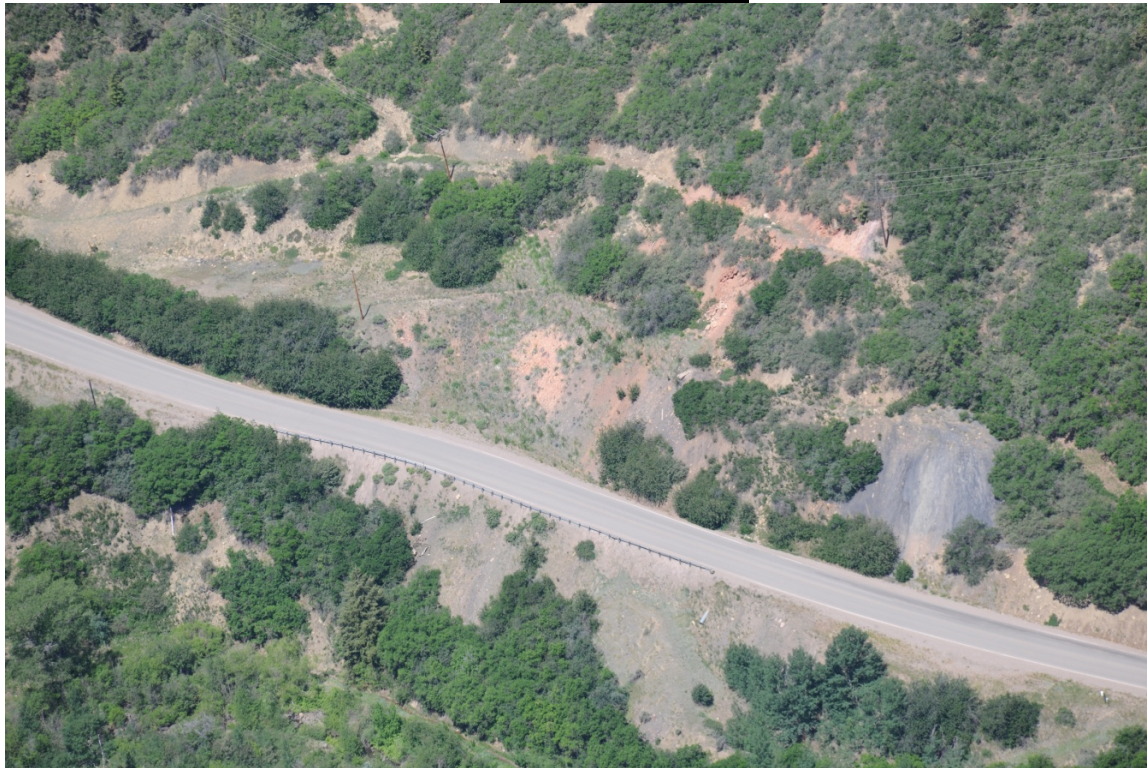
Photo 1 – Area of Mine Above The Road

The portal backfill above the road appears to be stable (photo 1).

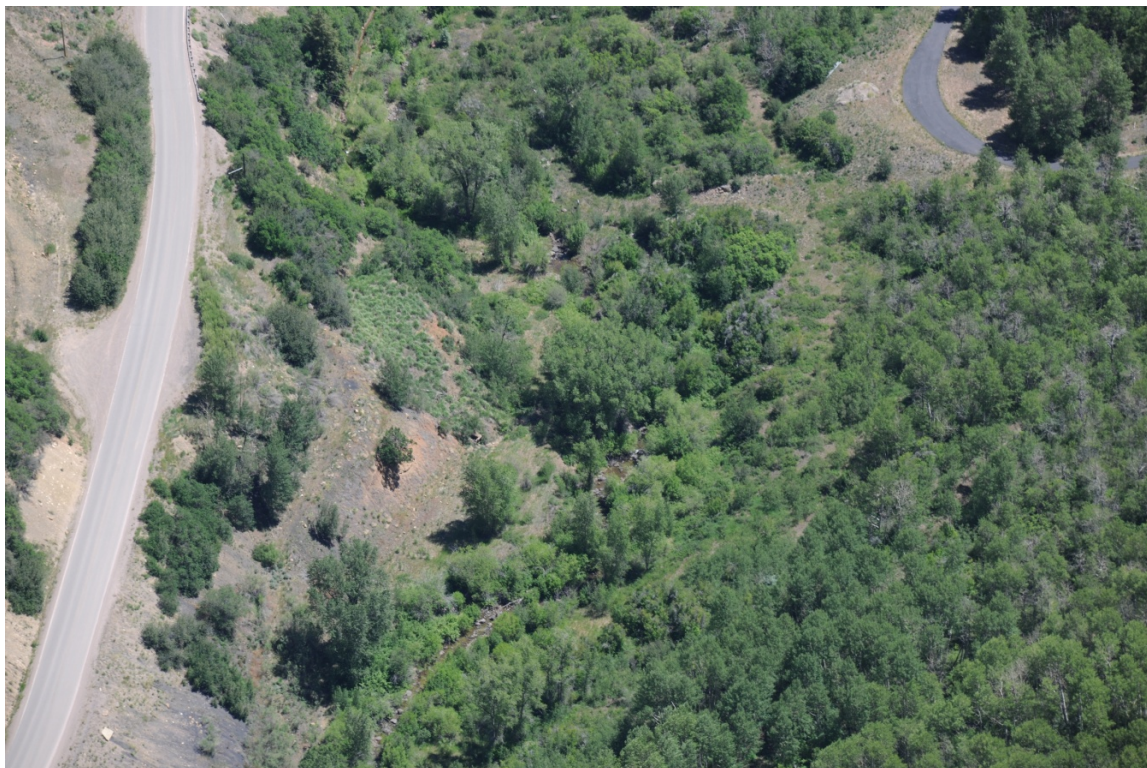
Photo 2 – Area of Mine Below the Road

The large bunch grass above the lower fan portal covers the ground surface well. This coverage makes it difficult to see any additional subsidence that may have occurred in this area (photo 2). One sink hole has been noted 12 feet north of the portal during ground inspections (6/18/2013).
