COLORADO DIVISION OF RECLAMATION, MINING AND SAFETY
MINERALS PROGRAM INSPECTION REPORT
PHONE: (303) 866-3567

MINE NAME: Highway 50 Borrow Area No. 2	MINE/PROSPECTING ID#: M-1999-076	MINERAL: Borrow material for	COUNTY: Mesa
INSPECTION TYPE: Monitoring	INSPECTOR(S): Travis H. Marshall	INSP. DATE: June 12, 2013	INSP. TIME: 10:45
OPERATOR: Elam Construction, Inc.	OPERATOR REPRESENTATIVE: Gayle Lyman	TYPE OF OPERATION: 111 - Construction by Government Agency

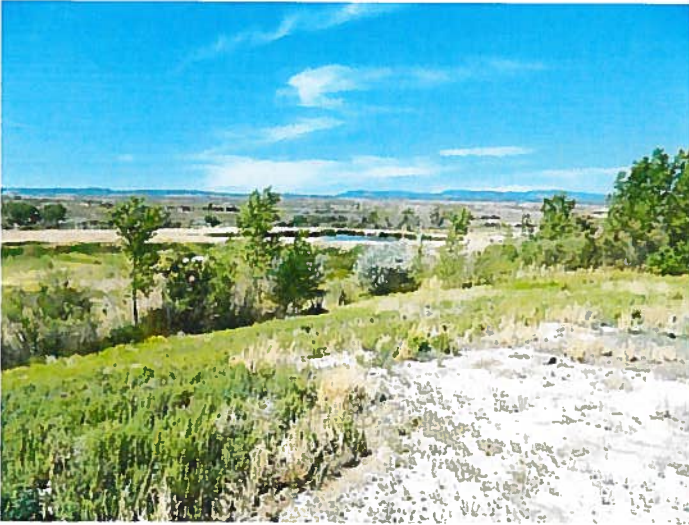
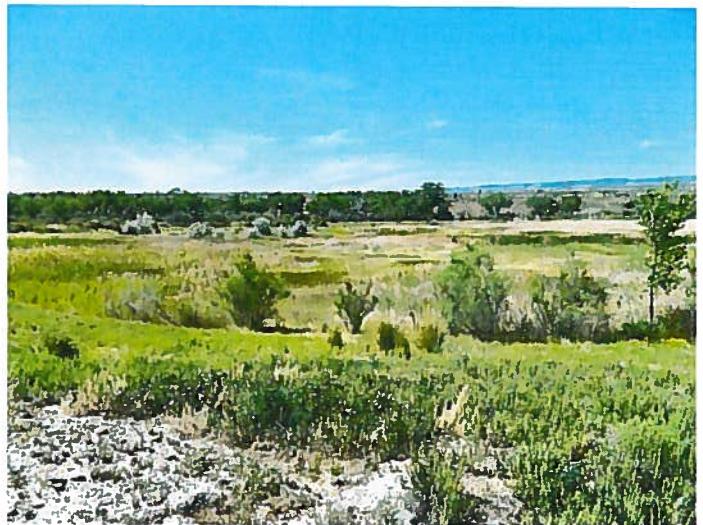
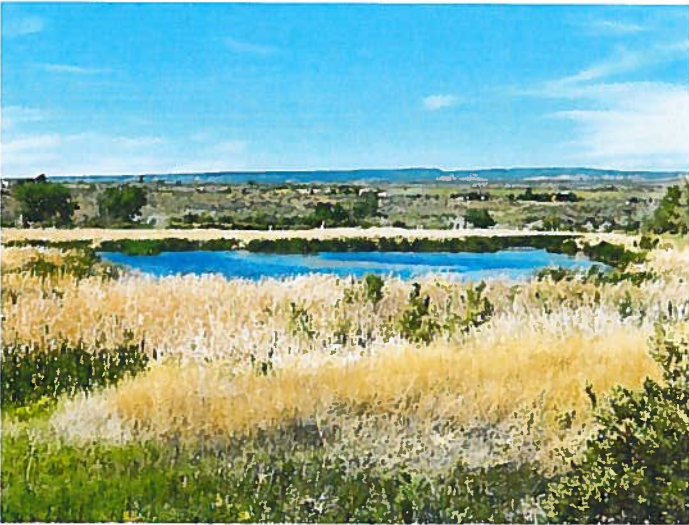
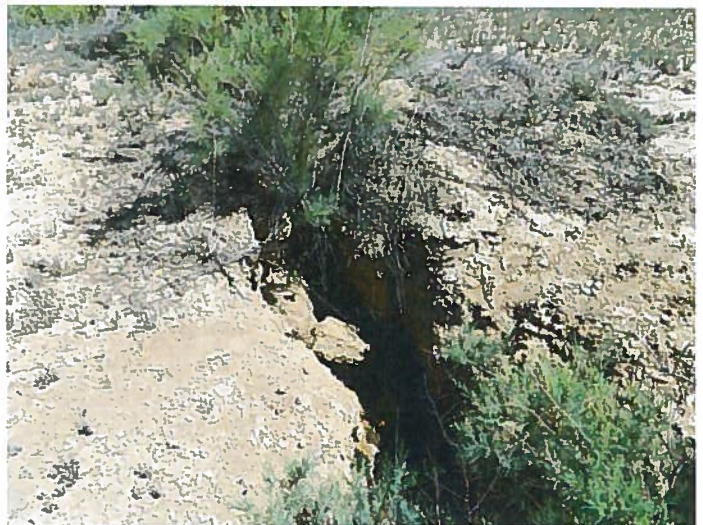
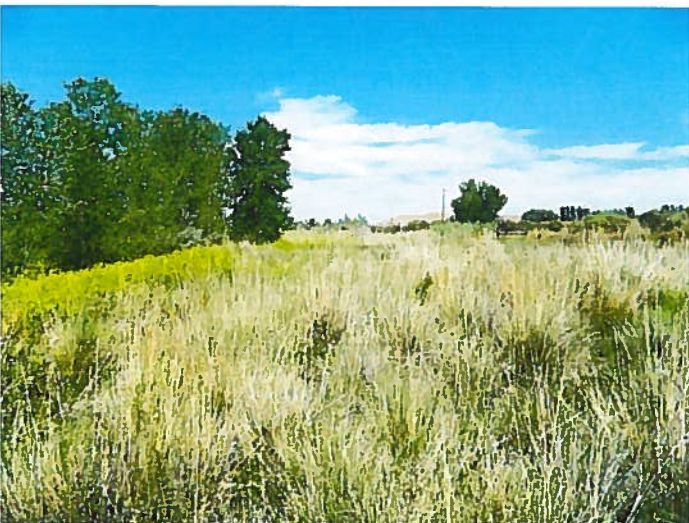
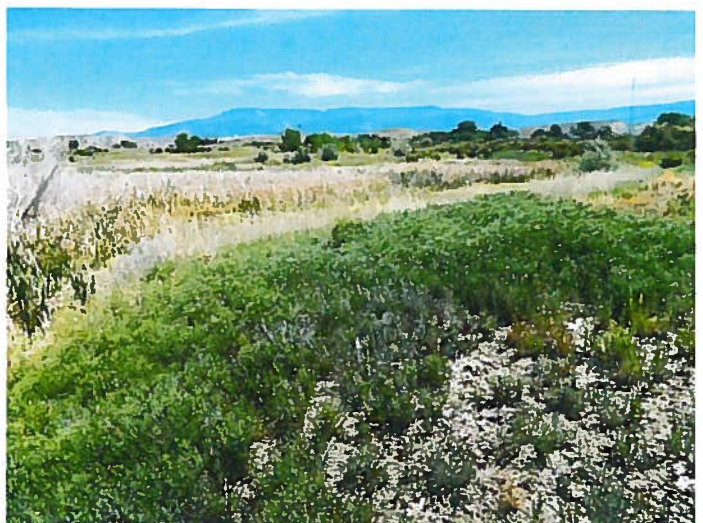
As noted in the March 3, 2005 inspection report the pit is impounding water. This is considered a problem and a well permit to account for the evaporative loss associated with the pond is required by the Colorado Division of Water Resources. Enforcement action will be initiated if an evaporative loss well permit or another form of compliance is not received by the Division on or before July 31, 2013.

The amount vegetation is adequate at the site. However, tamarisk, Russian olive, and Russian knapweed were all observed within the permit boundary. The site was in final reclamation prior to January 19, 2005, specifically prior to October 16, 2000. Therefore, it is considered a "grandfathered" pit that is not required to include Tamarisk and Russian olive in the weed management plan. The presence of Russian knapweed is noted as a problem. A more vigorous implementation of the weed control plan for the Russian knapweed observed at various locations along the western, southern and eastern perimeter of the pond shall be conducted. If demonstration of control of the Russian knapweed in the form of photo-documentation is not provided July 31, 2013 enforcement action will be initiated.

CORRECTIVE ACTIONS: Submit documentation from the State Engineer's Office demonstrating that the impoundment of water in this pit is authorized by that office.

CORRECTIVE ACTIONS: Implement approved weed control plan and provide proof to the Division that this has been done. If a weed control plan is not already in place, the operator shall develop a weed control and management plan in accordance with Section 3.1.10 (6) of the Rule. This plan should be developed in consultation with the county extension agency, or weed control district office and should include specific control measures to be applied, a schedule for when control measures will be applied and a post-treatment
