COLORADO DIVISION OF RECLAMATION, MINING AND SAFETY COAL PROGRAM INSPECTION REPORT

Permit Number: C-1981-037 Mine Name: GEC Strip Mine Operator: GEC Minerals Operator Address: (landowner) Dr W Corley 2605 Constellation Drive Colorado Springs, CO 80906	County: Fremont Operation Type: Surface Permit Status: Revoked Ownership: Private Operator Representative Present: NA
Operator Representative Signature: (Field Issuance Only)

Inspection Start Date: July 1, 2013 Inspection Start Time: 11:45 Inspection End Date: July 1, 2013 Inspection End Time: 14:45		Inspection Type: Coal Partial Inspection Inspection Reason: Citizen Complaint Weather: Cloudy	
Joint Inspection Agency: None		Joint Inspection Contacts:	
Post Inspection Agency: None		Post Inspection Contacts:	
Inspector(s): Janet H. Binns	Inspector's Signature:

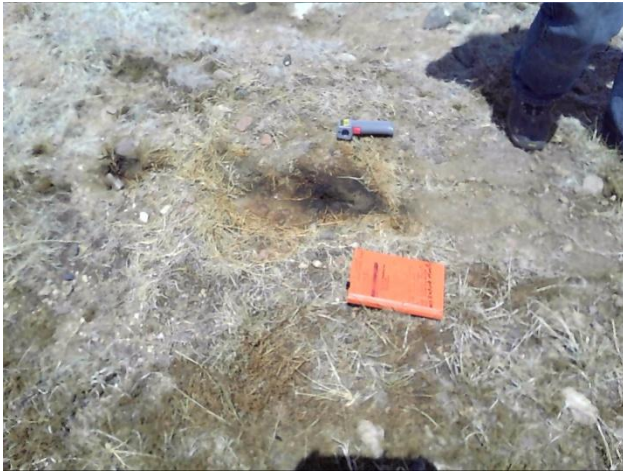
Gary and Janet collected GPS coordinates of the slope and the hot areas. Gary had a thermal camera and was able to collect ground surface temperatures. Temperatures varied throughout the area of concern based on vegetation cover, color of ground surface, and potential coal fire vents. The air temperature was in the upper 80's to low 90's. The weather was partly cloudy with a light breeze. Gary measured ground temperatures from 89 to 120 degrees F. No smoke was visible from the "hot spots" at the time of the inspection. A vent was identified on the eastern side of the area of concern that the landowner had not recently covered with spoil material. There was brown tarry staining around the vent hole and the associated surface crack. Gary measured the surface temperature of the vent

closest to the edge of the slope at 135 degrees F. There was some apparent charring of dried grasses near the vent. This charring was of very limited extent and extended to the immediate several inches around the surface expression of the vent. The vegetation in the vicinity of the vents is composed primarily of low native grasses, annual forbs and Cholla cactus.

Photo 1: surface vent on northern feature (feature 3)

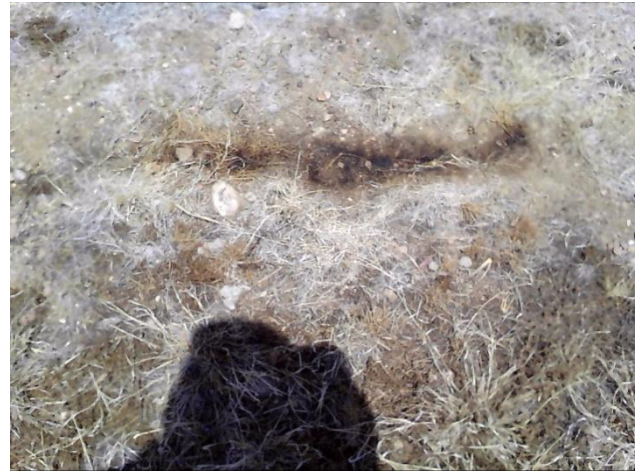
Photo 2: Surface staining and cracking at Feature 3.

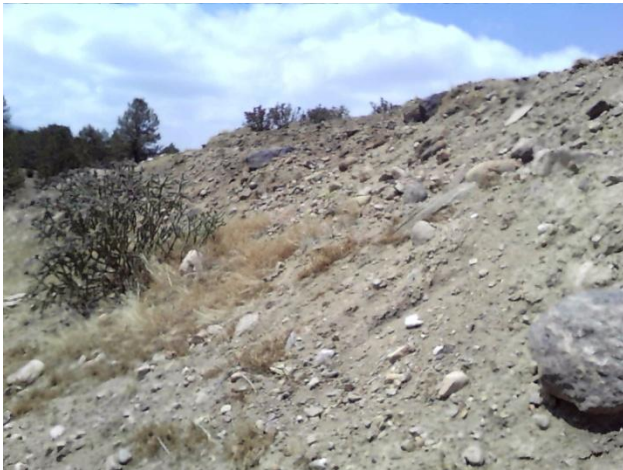
The top of the mesa (slope) appears to have been covered with cobbly "spoil" material. DRMS considers these fire features at the top edge of the slope to be associated with historic mining and not a result of the GEC operation. As such, the Inactive Mine Reclamation Program will follow up on this concern.

Photo 3: Top of slope looking westward. Hot spots appear limited to the top of the slope in the cobbly material.

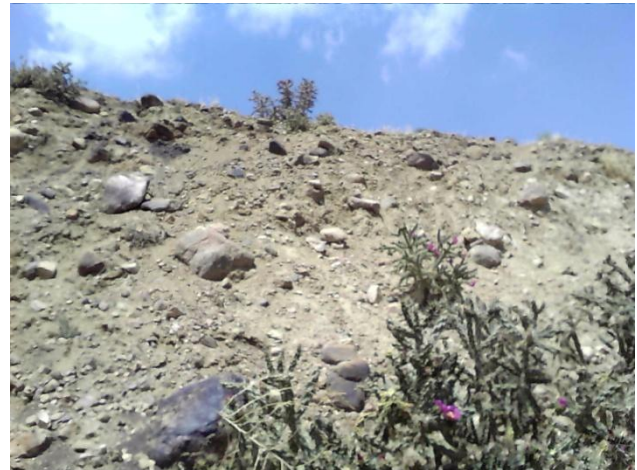
Photo 4: Cobbly top of slope.

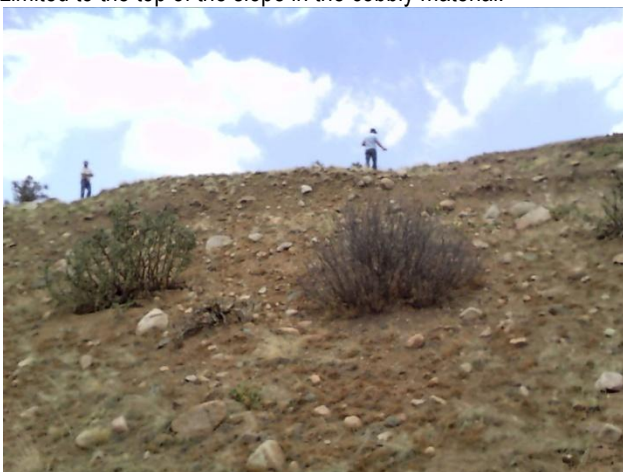
Photo 5: Dr. Corley and Gary Curtiss on top of slope

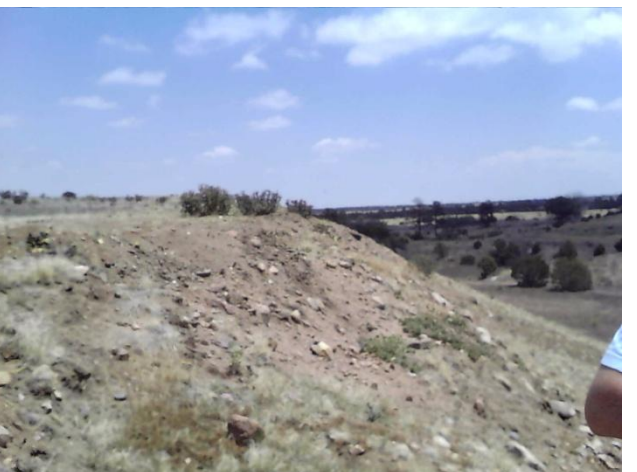
Photo 6: Top of slope looking northward.

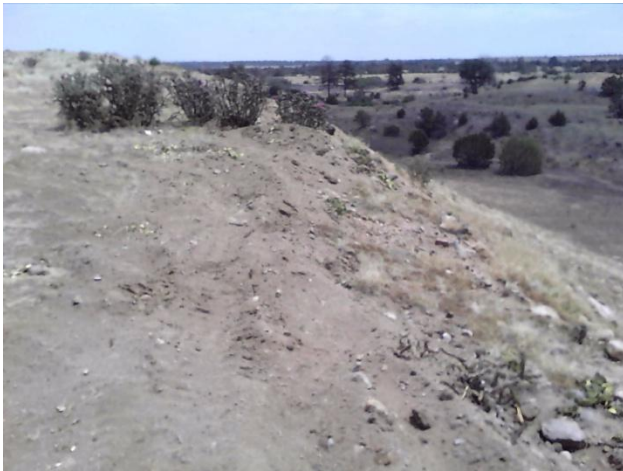
Photo 7: Top of slope; looking to eastward at area had been recently covered with spoil material

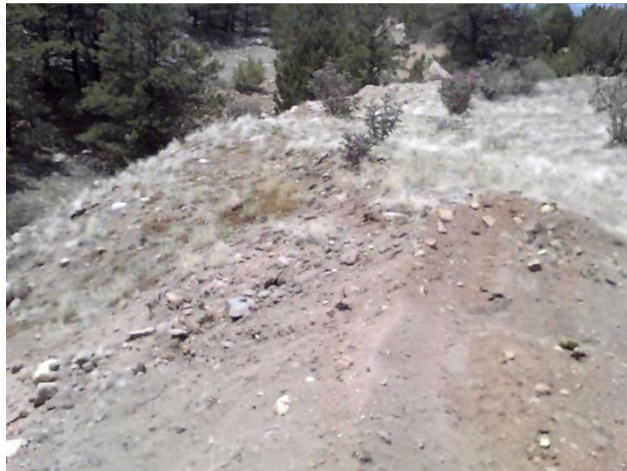
Photo 8: Top of slope: looking to western extent of area of concern and recent spoil material placement

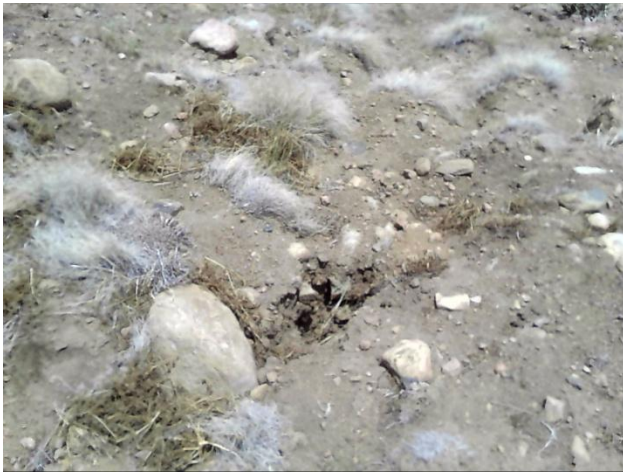
Photo 9: Surficial cracking on western features not recently Covered by Dr. Corley.

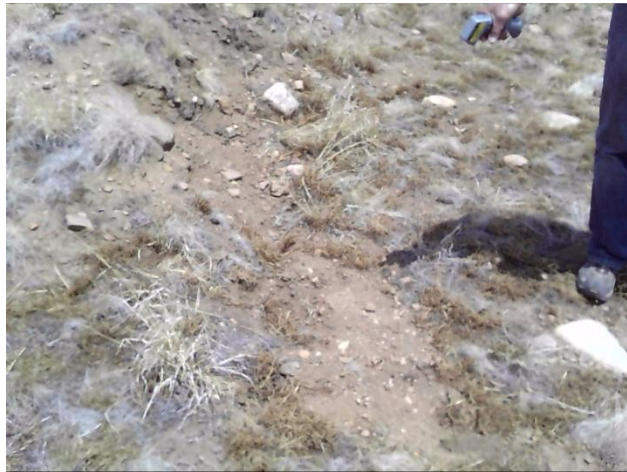
Photo 10: Gary taking thermal temperature of surficial cracks along the top of the slope.
