## COLORADO DIVISION OF RECLAMATION, MINING AND SAFETY COAL PROGRAM INSPECTION REPORT

<b>Permit Number:</b> C-1981-033 <b>Mine Name:</b> Bear Mine <b>Operator:</b> Bear Coal Company, Inc. <b>Operator Address:</b> Mr. Daniel Bear 1326 War Emblem Lane Rock Springs, WY 82901	<b>County:</b> Gunnison <b>Operation Type:</b> Underground <b>Permit Status:</b> Revoked <b>Ownership:</b> Federal
<b>Operator Representative Present:</b>  None – Revoked Permit	
<b>Operator Representative Signature: (Field Issuance Only)</b>

<b>Inspection Start Date:</b> July 10, 2013 <b>Inspection Start Time:</b> 15:15 <b>Inspection End Date:</b> July 10, 2013 <b>Inspection End Time:</b> 15:45	<b>Inspection Type:</b> Coal Partial Inspection <b>Inspection Reason:</b> Normal I&E Program <b>Weather:</b> Clear
<b>Joint Inspection Agency:</b>  None	<b>Joint Inspection Contacts:</b>
<b>Post Inspection Agency:</b>  None	<b>Post Inspection Contacts:</b>
<b>Inspector(s):</b>  Marcia L. Talvitie, P.E.	<b>Inspector's Signature:</b>

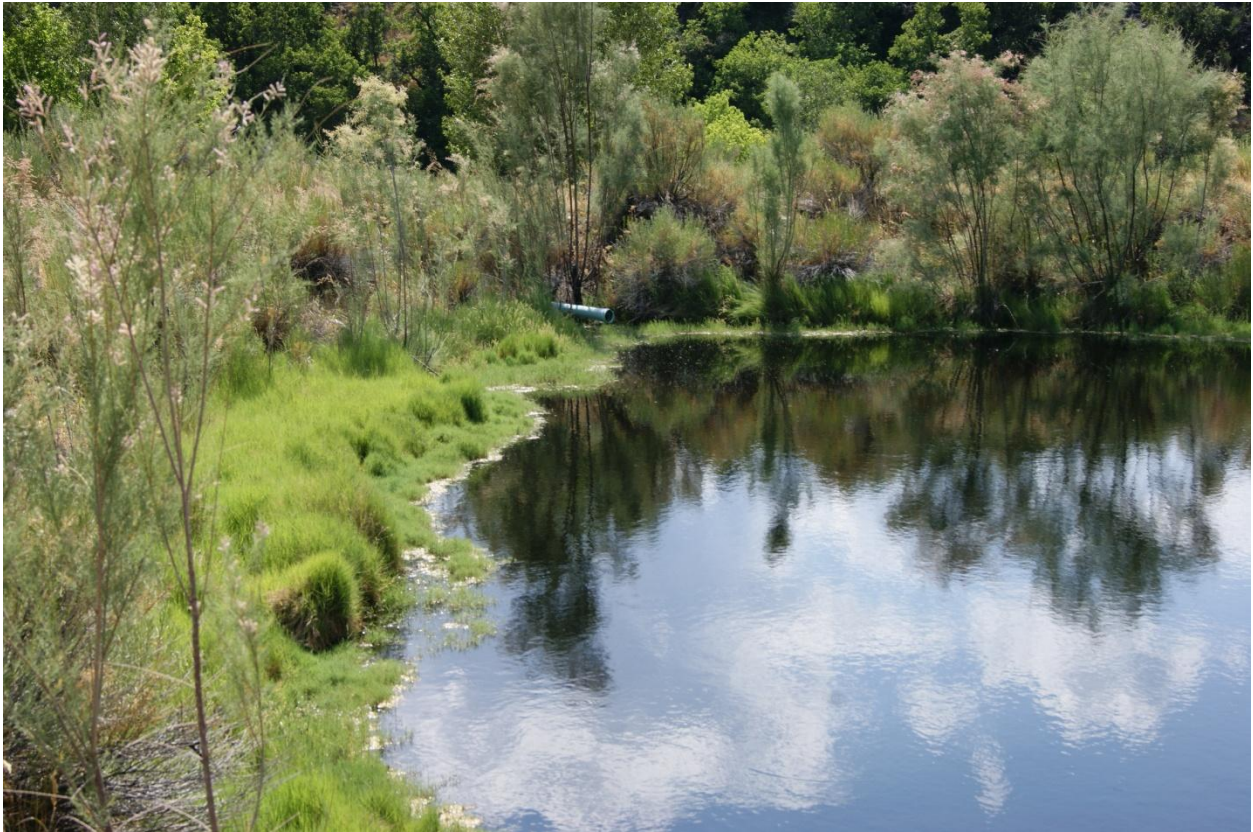
Photo 1 – Treatment Pond

- Recent conditions on the western slope have been dry, and the entire ground surface within the permit area was extremely dry.
- The hillside seep was flowing at a small trickle.
- The treatment pond held water (Photo 1), but the sedimentation pond was dry.

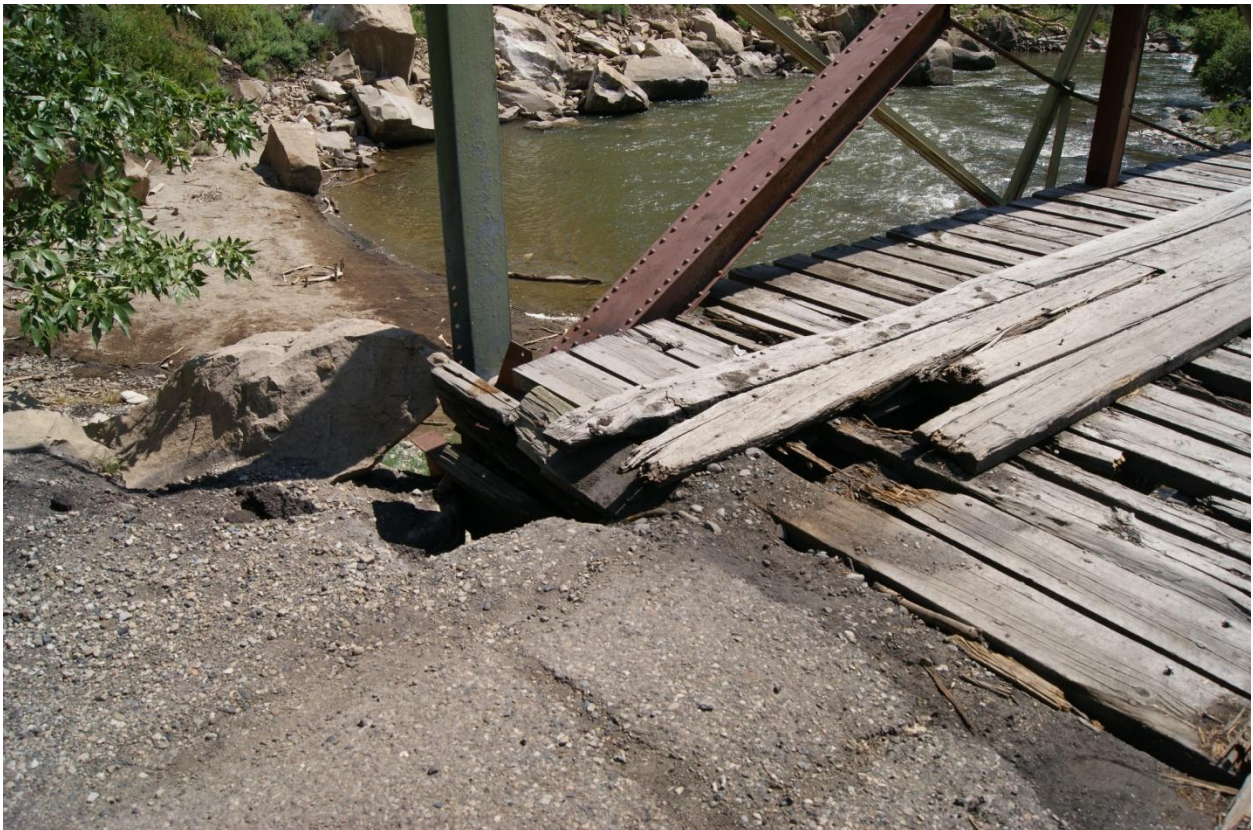
Photo 2 – Bridge Deck

- Access to the permit is gained by a bridge that crosses the North Fork of the Gunnison River. The timber bridge deck is in poor condition at both ends of the structure (Photo 2).
- There is no barrier in place to prohibit vehicular access to the permit area, although a sign is posted at the bridge.

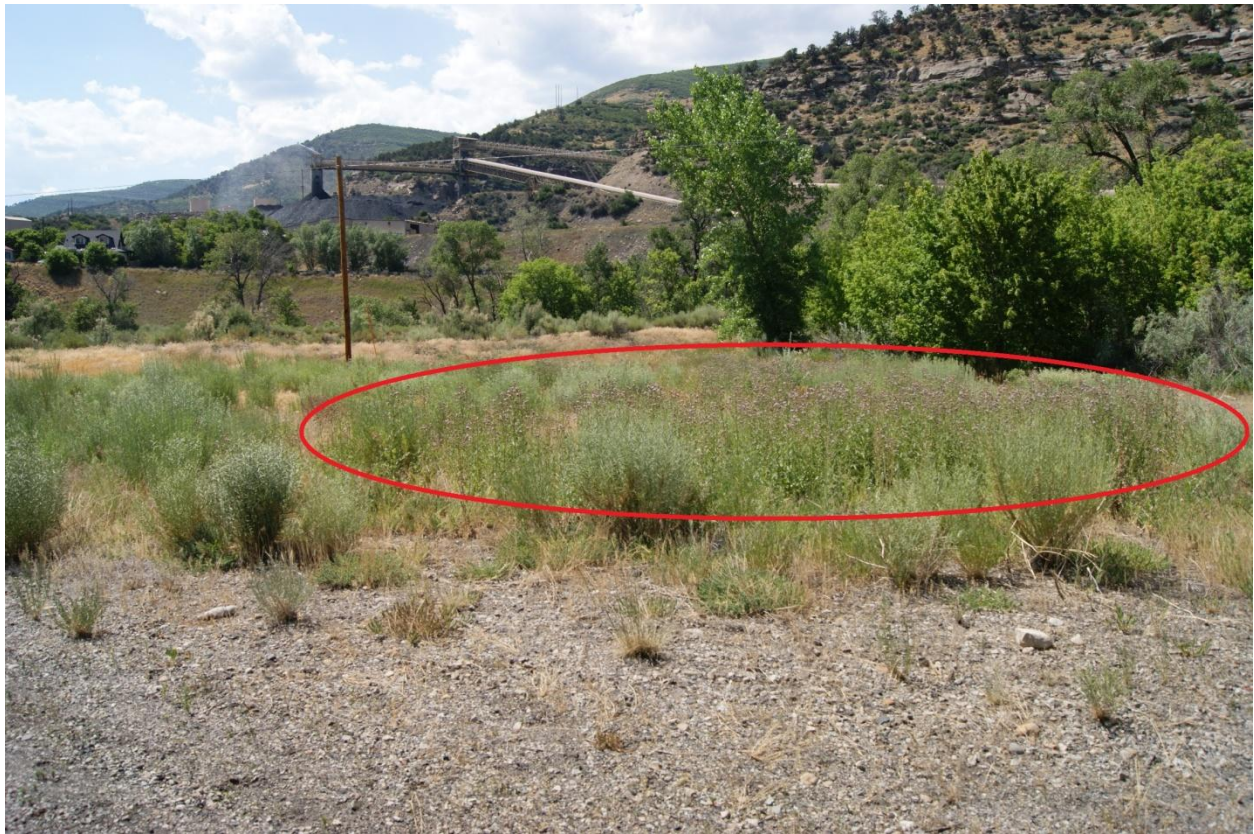
- Vegetation within the permit area is largely dominated by weeds. It is probably too late this season to address the issue, but weed control measures should be vigorously implemented next spring to begin to reverse the situation.
- The yard area is covered with Cheat grass, Jointed goat grass, and a low-lying mustard. A stand of Hoary cress was also observed.
- A zone of Canada thistle is thriving in the vegetation east of the treatment pond (Photo 3).
- Tamarisk is well established on the pond banks and on the hillside where the seep emanates from the slide (Photo 4).

Photo 3 – Canada thistle stand

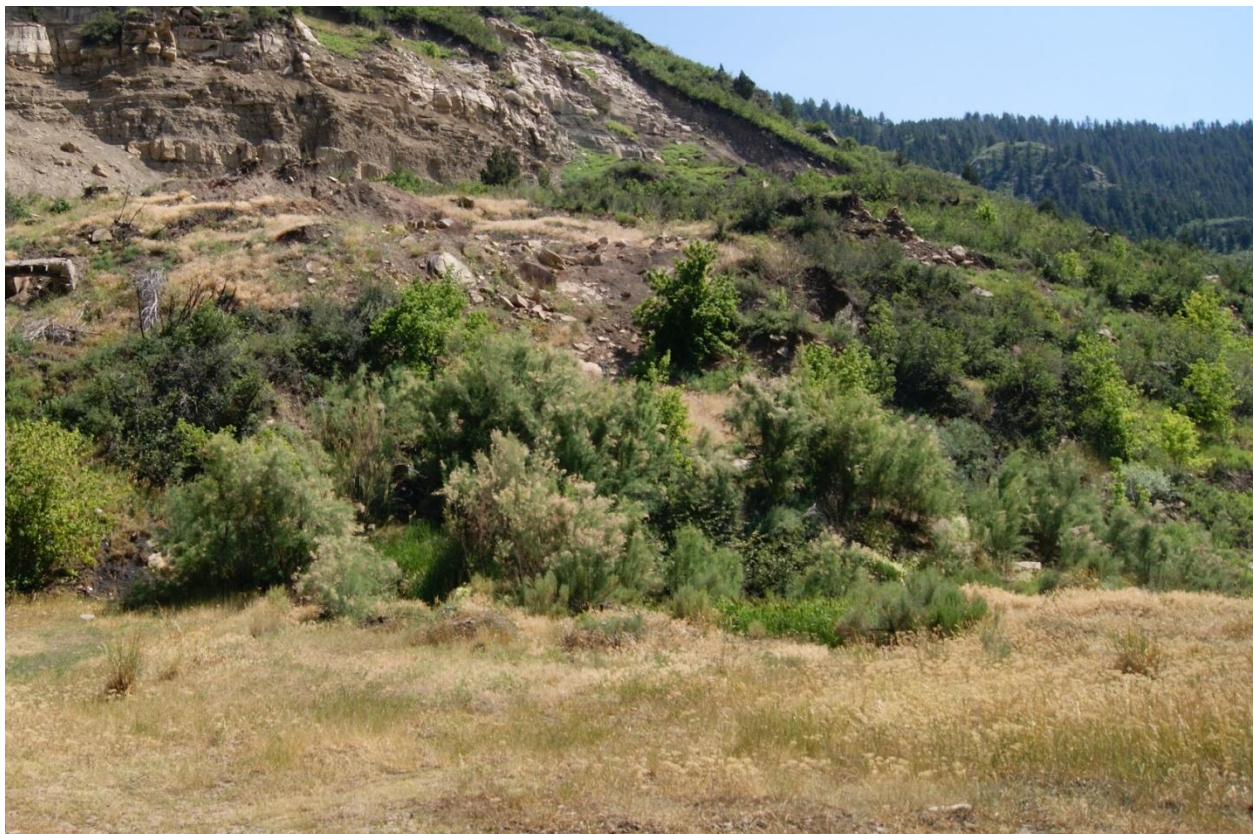
Photo 4 – Hillside seep area, with Tamarisk trees
