COLORADO DIVISION OF RECLAMATION, MINING AND SAFETY COAL PROGRAM INSPECTION REPORT

Permit Number: C-1981-022 Mine Name: Elk Creek Mine Operator: Oxbow Mining, LLC Operator Address: Mr. Jim Kiger P.O. Box 535 3737 Highway 133 Somerset, CO 81434	County: Delta, Gunnison Operation Type: Underground Permit Status: Active Ownership: Federal
	Operator Representative Present: Jim Kiger
Operator Representative Signature: (Field Issuance Only) This report was issued electronically from the Division's Durango Field Office.

Inspection Start Date: July 10, 2013 Inspection Start Time: 10:20 Inspection End Date: July 10, 2013 Inspection End Time: 15:15		Inspection Type: Coal Partial Inspection Inspection Reason: Normal I&E Program Weather: Clear	
Joint Inspection Agency: None		Joint Inspection Contacts:	
Post Inspection Agency: None		Post Inspection Contacts:	
Inspector(s): Marcia L. Talvitie, P.E.	Inspector's Signature:

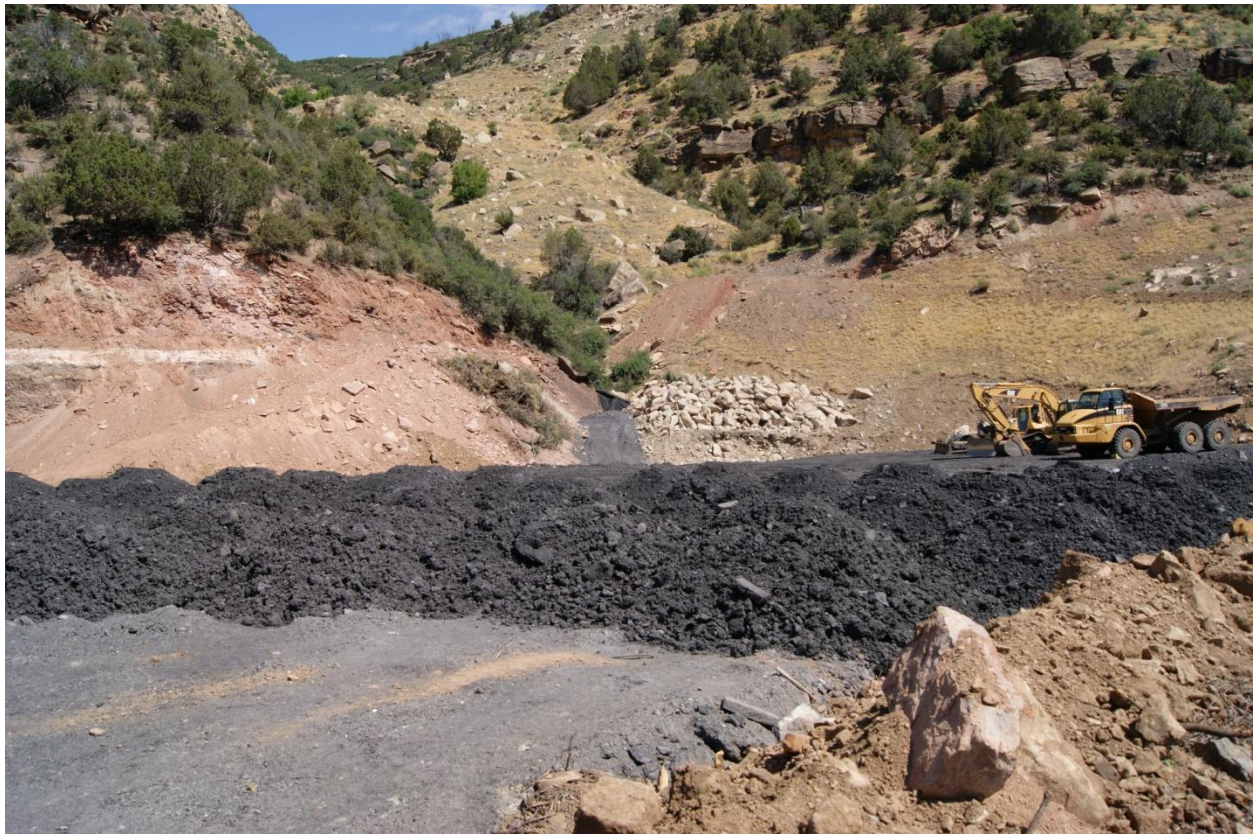
Photo 1

- Survey lath has been placed to identify the east and west ends of the 6150' Elev. bench. (The surface of the pile has not yet reached this level.)
- Compaction equipment was parked at the pile, and a number of loads of refuse had been end-dumped on the surface, awaiting final placement (Photo 1).

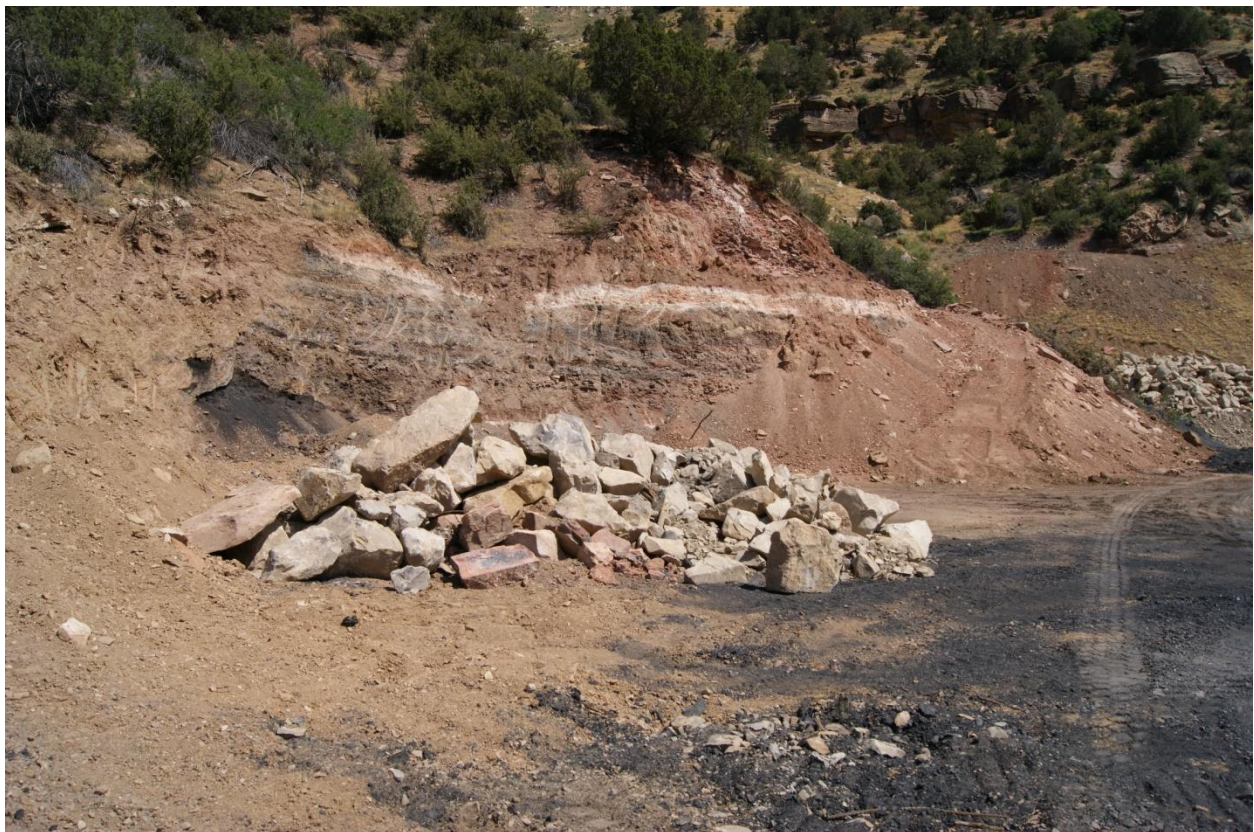
Photo 2

- Unconsolidated material has been excavated away from the western flank of the valley, exposing unweathered sedimentary rock (Photo 2). The excavated material will be utilized as cover/topsoil for reclaiming the face of the pile. A number of boulders were also produced during the excavation; Mr. Kiger said these would be used in construction of the underdrain as the fill progresses further up the valley.

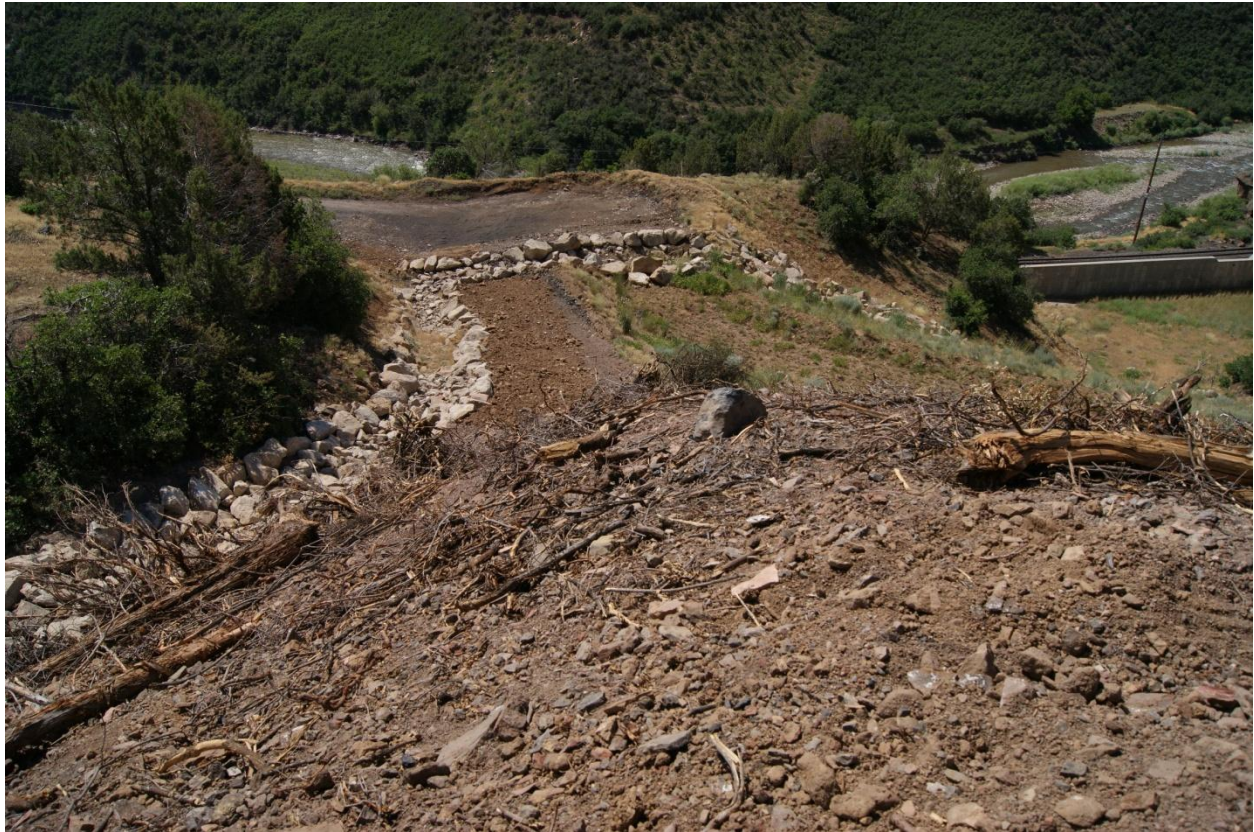
Photo 3

- Lower portions of the pile face, which were seeded in previous years, are becoming well-vegetated. On the upper slope, Oxbow is experimenting with the placement of slash material on top of the soil (Photo 3). This will serve to provide some erosion protection, encourage moisture retention, and add extra organics to the soil. Mr. Kiger said these slopes will be seeded later this year.

- Riprap-lined Ditch IIW-2 has been constructed along the eastern flank of the facility, and a berm of soil prevents runoff from cascading down the front face of the fill (Photo 3).

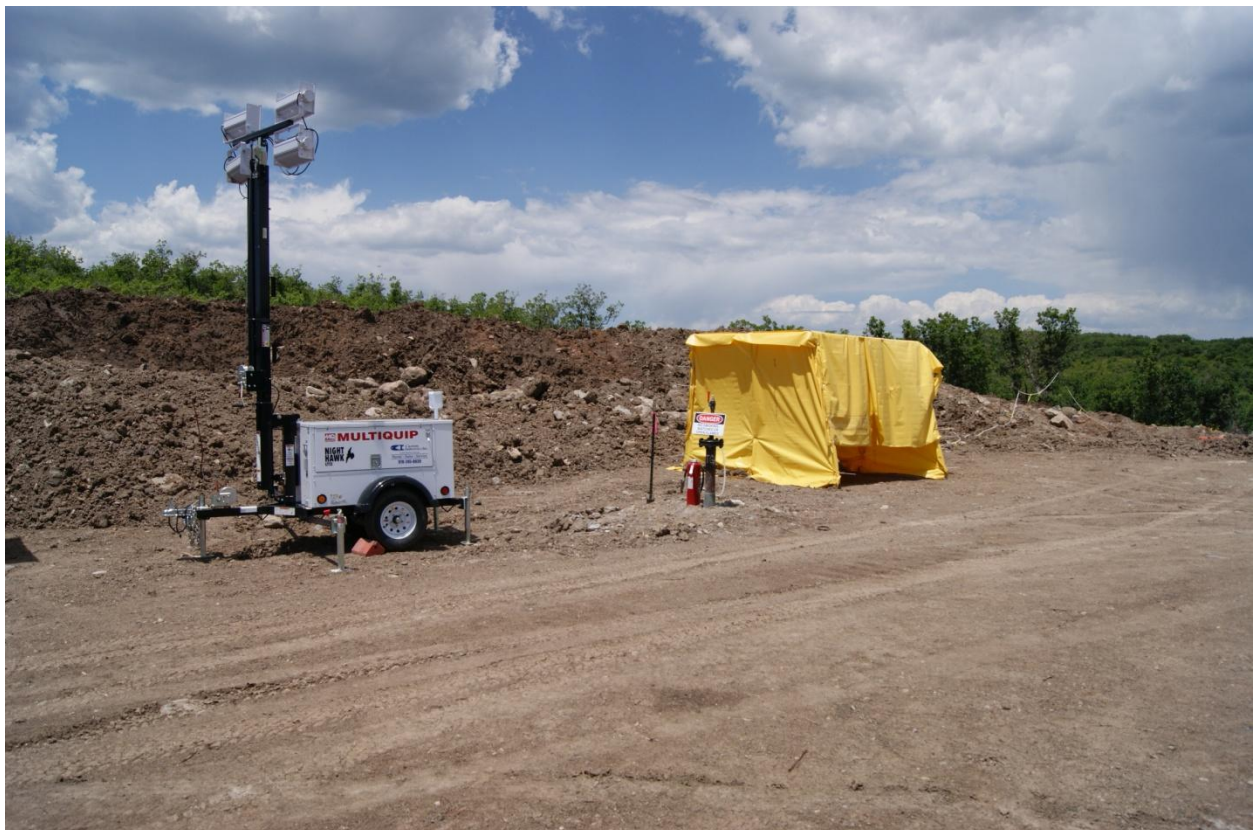
Photo 4

- A number of the new boreholes were required in order to monitor gases within the sealed workings. We observed these sites during the course of the inspection. Each borehole has been fitted with tubing which allows gas from within the mine to be drawn to the surface and evaluated. A typical setup is shown in Photo 4.

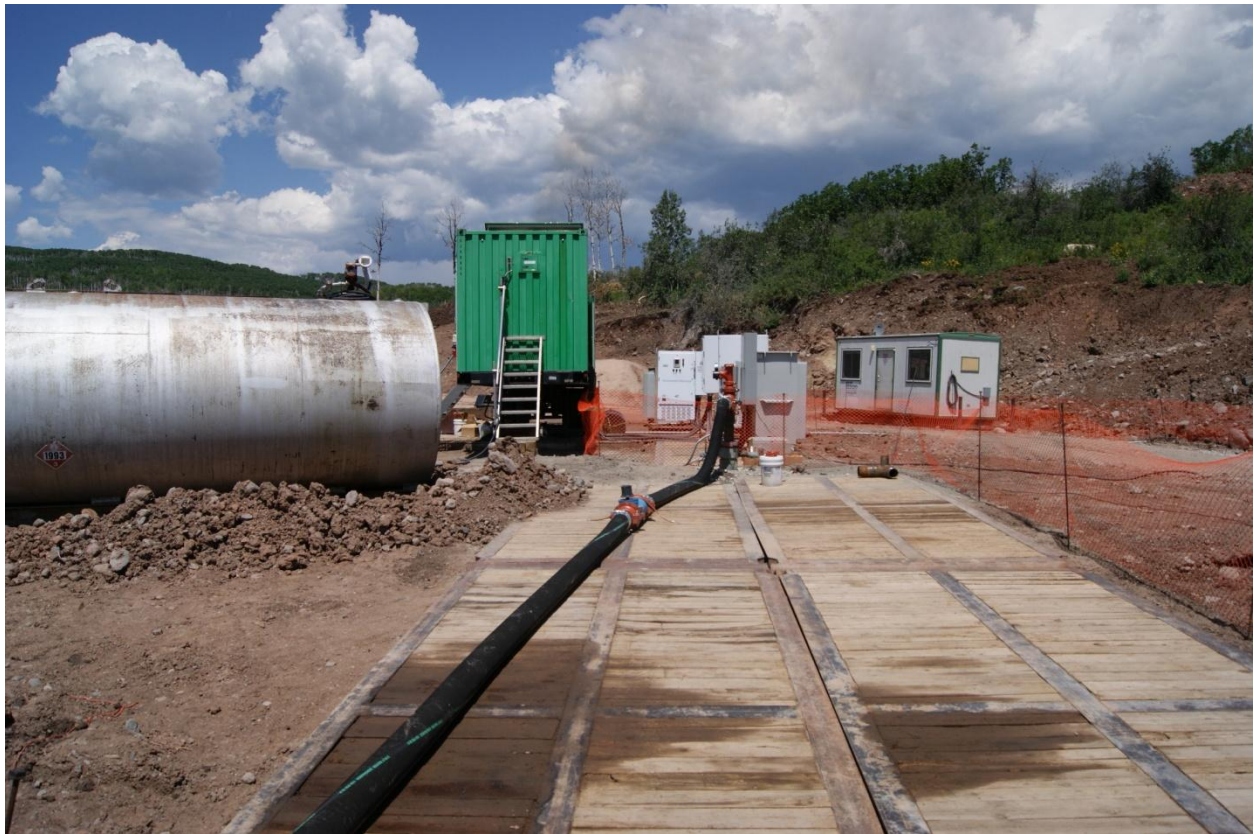
Photo 5

- The water pumps were lowered through the boreholes into the workings, and are supplied power by a generator trailer situated on the pad's surface. A large, double-walled tank has been situated at the site in order to fuel the generator (Photo 5). A mine employee was filling the fuel tank during our visit. He said they return to the site with fuel 2 to 3 times a week in order to ensure that the generator and pumps do not shut down.

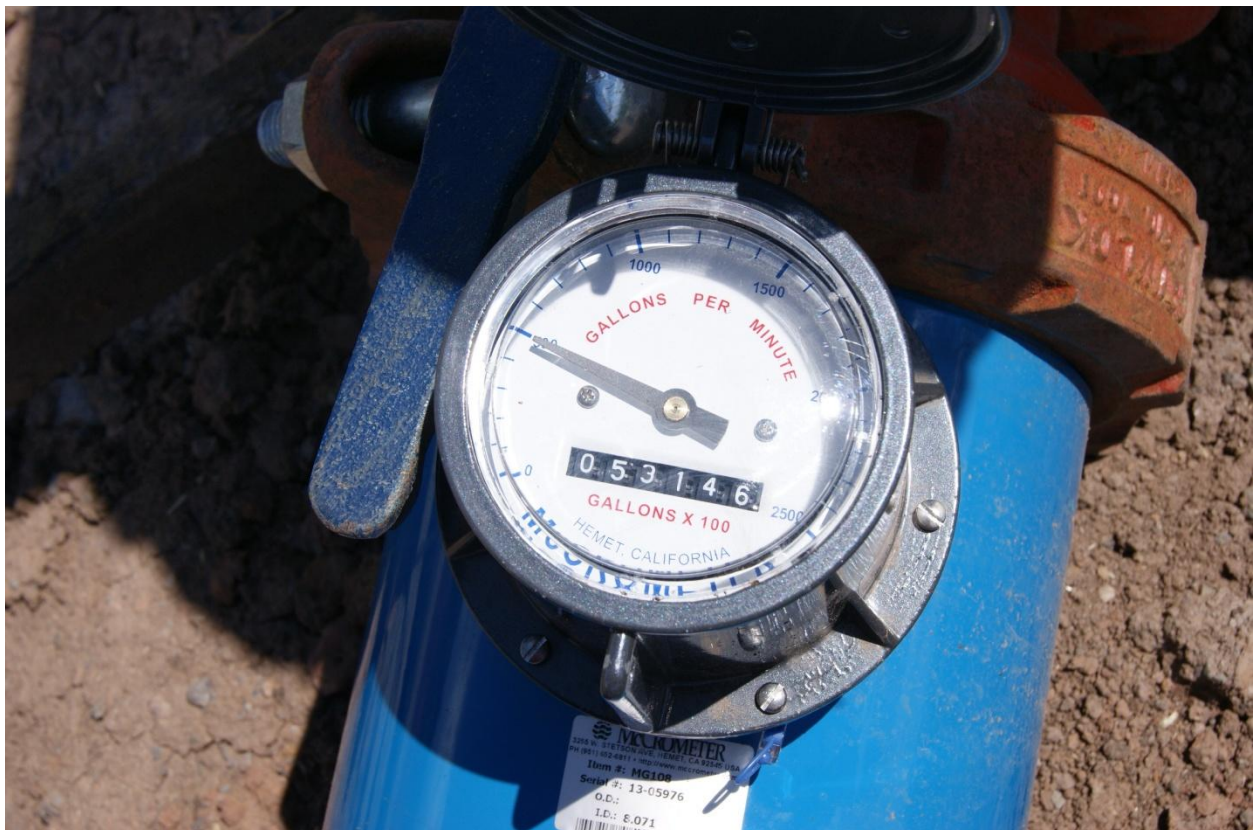
Photo 6

- Each well has been fitted with a totalizing flow meter (Photo 6). The combined flow, at the time of the inspection, was between 900 and 1000 gallons per minute, which equates to 2.0 to 2.2 cubic feet per second.

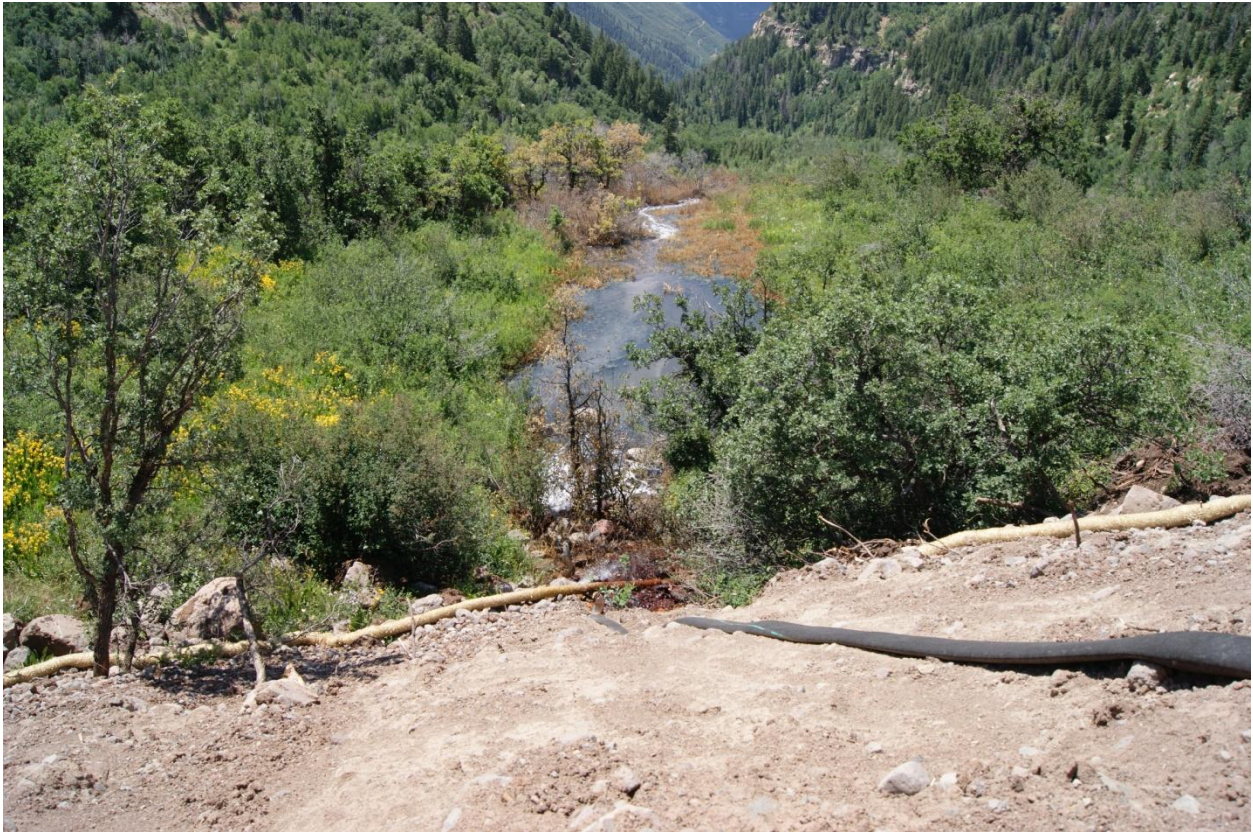
Photo 7

- Water discharged from the pumps is carried by a hose away from the pad, down the fill slope, and into a pre-existing “sump” area that serves to dissipate the energy of the flow (Photo 7). The water then proceeds toward Elk Creek. We did not attempt to trace the flow down the hill below the sump.

- The water itself has a distinctive coal mine odor, and Mr. Kiger said it is high in total dissolved solids (TDS), particularly bicarbonate. They anticipate that they will have difficulty meeting the WET requirements. The Discharge permit has been issued by the CDPHE WQCD, and submitted to the Division.

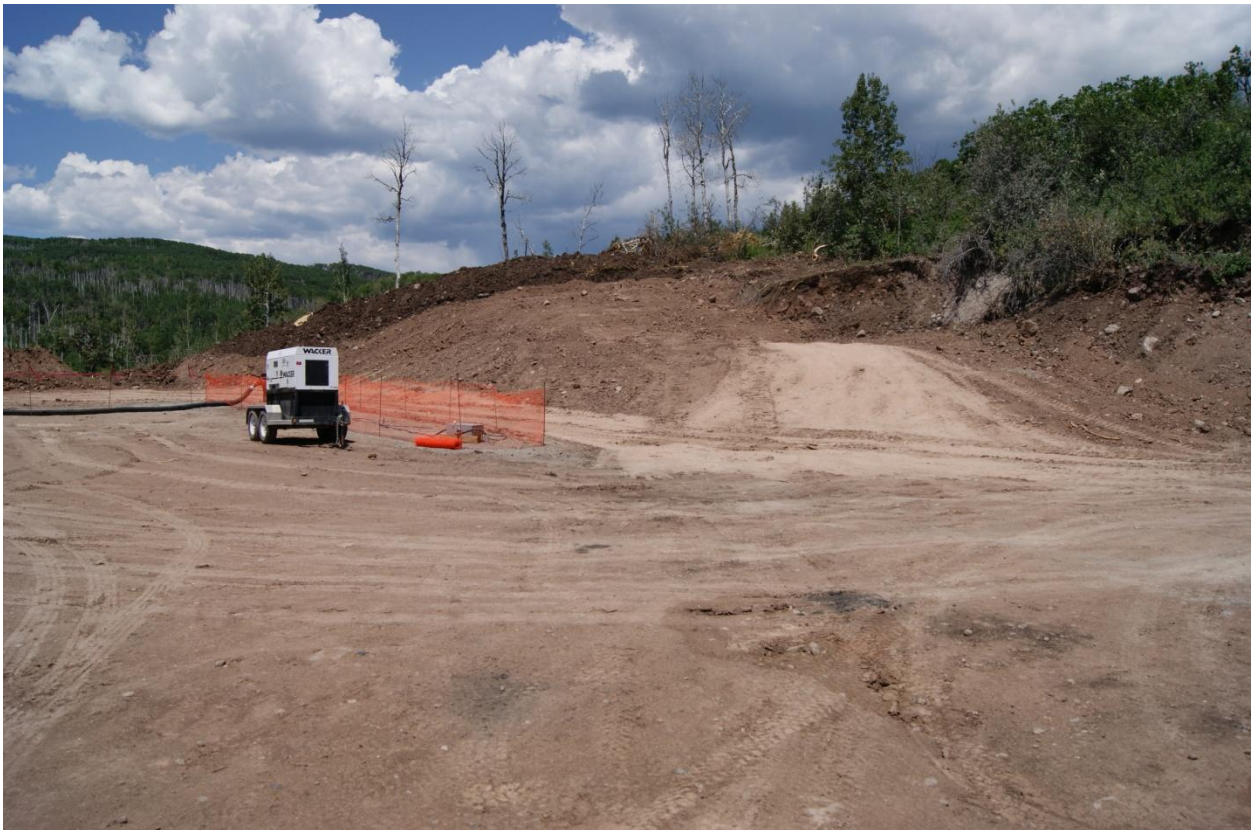
Photo 8

- Topsoil has been salvaged from the pad area, stockpiled (Photo 8), and is marked with an identification sign.
