COLORADO DIVISION OF RECLAMATION, MINING AND SAFETY COAL PROGRAM INSPECTION REPORT

Permit Number: C-1996-083 Mine Name: Bowie No. 2 Mine Operator: Bowie Resources, LLC Operator Address: Mr. William A Bear P.O. Box 483 Paonia, CO 81428	County: Delta Operation Type: Underground Permit Status: Active Ownership: Federal and Forest
Operator Representative Present: Bill Bear	
Operator Representative Signature: (Field Issuance Only) This report was issued electronically from the Division's Durango Field Office.

Inspection Start Date: July 10, 2013 Inspection Start Time: 08:00 Inspection End Date: July 10, 2013 Inspection End Time: 10:20	Inspection Type: Coal Partial Inspection Inspection Reason: Normal I&E Program Weather: Clear
Joint Inspection Agency: None	Joint Inspection Contacts:
Post Inspection Agency: None	Post Inspection Contacts:
Inspector(s): Marcia L. Talvitie, P.E.	Inspector's Signature:

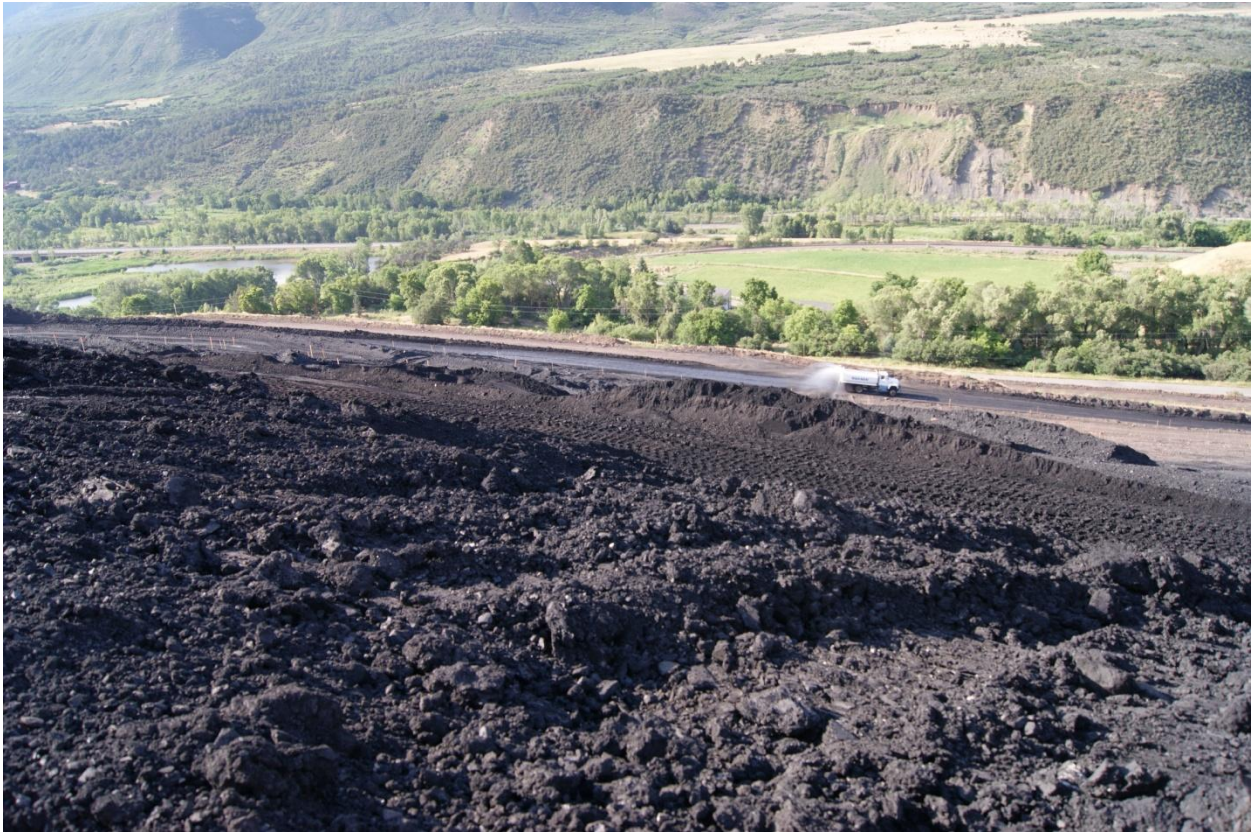
- A water truck was spraying down the haul roads at the Coal Waste Disposal Areas to control dust (Photo 1).

Photo 1 – Water truck spraying haul road on CWDA No. 2

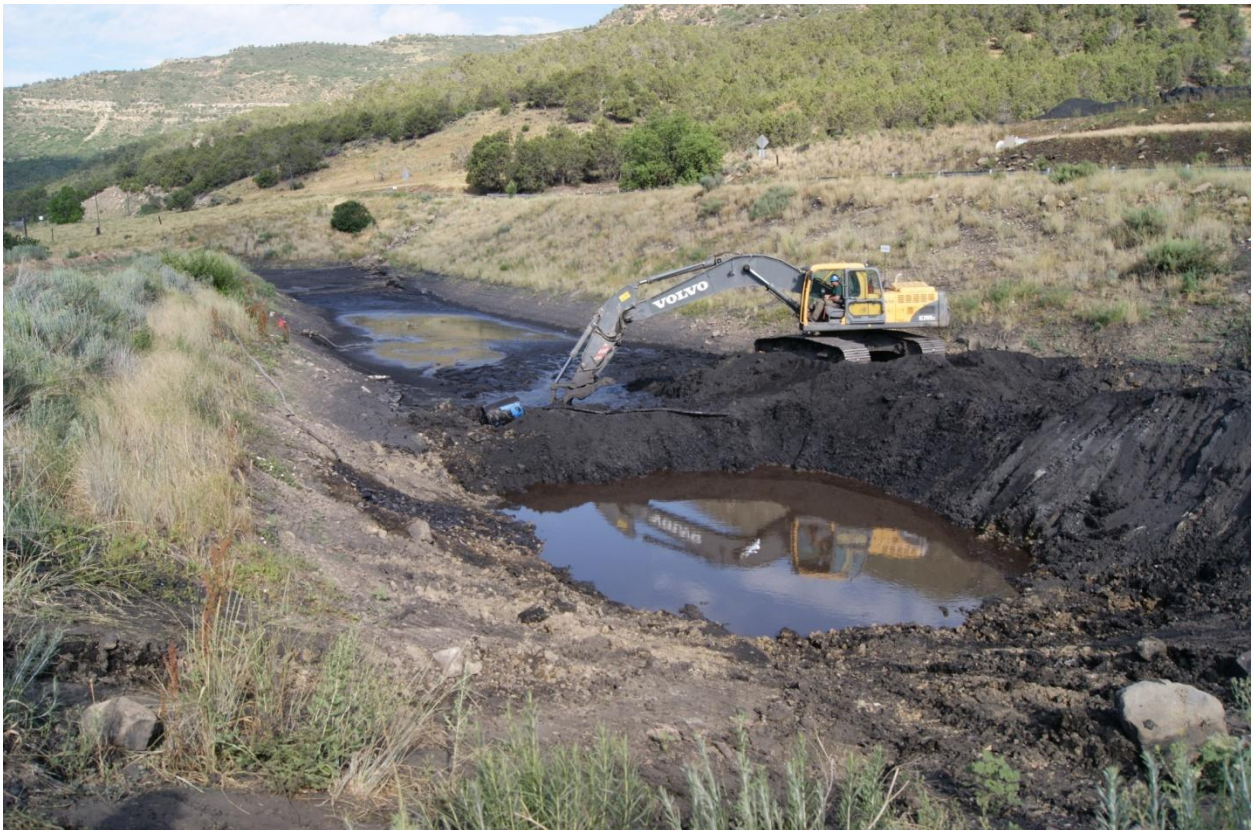
- Bowie is in the process of cleaning the various sedimentation ponds. Mr. Bear said this generally takes most of the summer to complete. A progress summary is as follows:
- Pond B: This pond was being mucked out at the time of the inspection. A track-mounted excavator is used to accomplish the work (Photo 2). Sediment is loaded into a haul truck, which transports it to CWDA No. 2. The material is dumped out and allowed to dry before being permanently placed and compacted.
- Pond C: Water is being drained to Pond D, by gravity, in preparation for this pond being cleaned out.
- Pond D: Sediment has been recently removed. Water from Pond C was flowing into this pond.

Photo 2 – Pond B clean-out operations

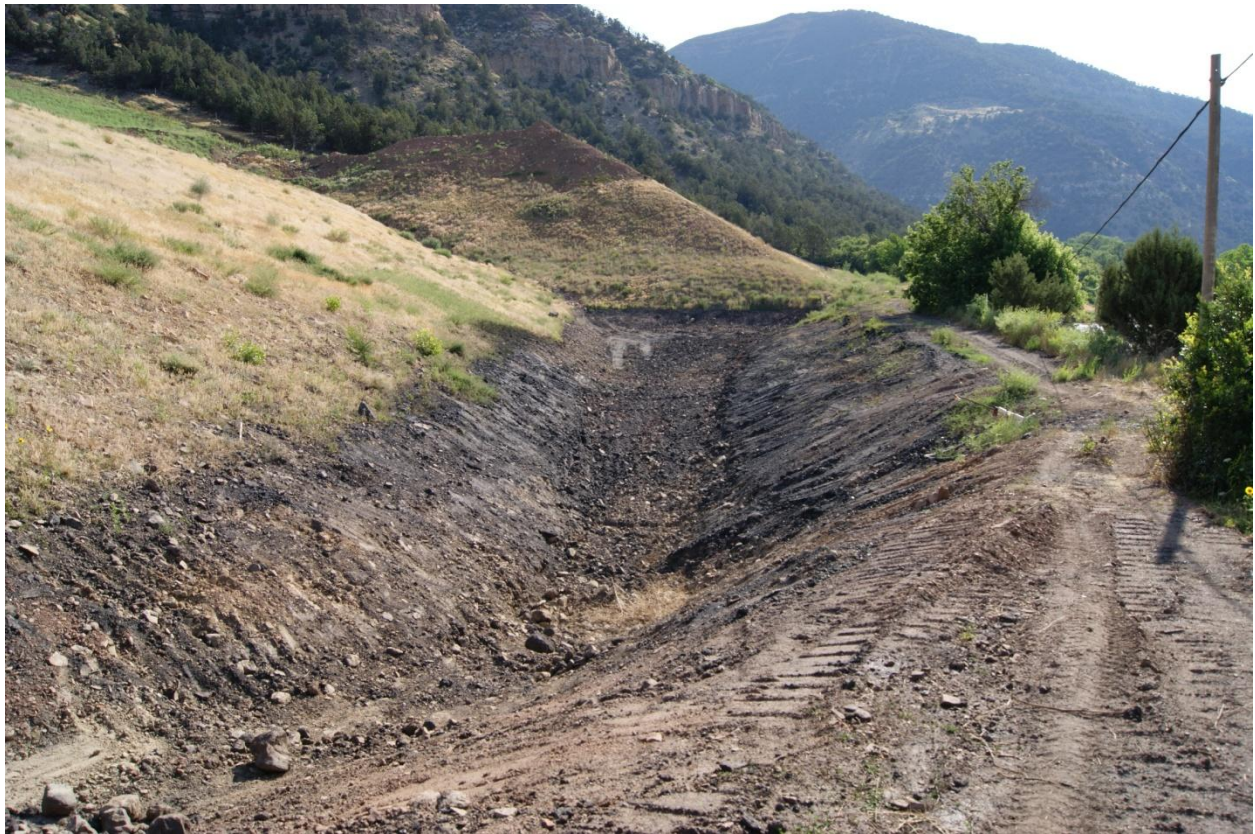
- Pond F: This pond has been cleaned out (Photo 3). The sediment accumulation markers have not yet been reinstalled. Mr. Bear indicated that would be accomplished within the next week.
- Pond J: There was some water in the pond; Mr. Bear indicated that it is irrigation runoff from the adjacent area.
- Pond K: This pond was dry.

Photo 3 – Pond F

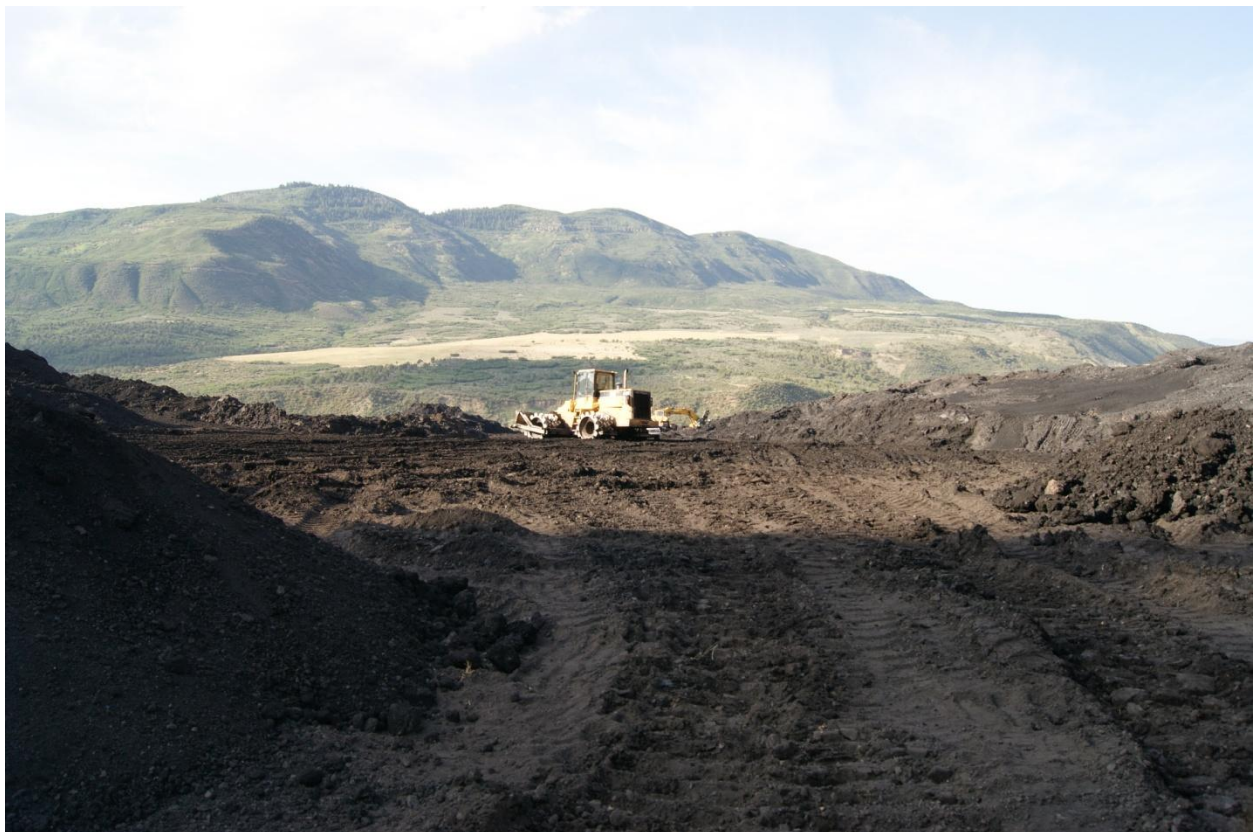
- Placement and compaction activities were occurring in the valley fill (northern) portion of CWDA No. 2 (Photo 4). The stockpiled CMW has been removed from this area, and the material is being compacted in lifts, as required. A sheepsfoot roller and D8 dozer were in use. The mine's large excavator was down for repairs.

- Having proper moisture content in a material (not too dry or too wet) greatly contributes to ease of compaction. The moisture content of the material being placed generally appeared to be satisfactory.

Photo 4 – Compaction equipment working CWDA No. 2

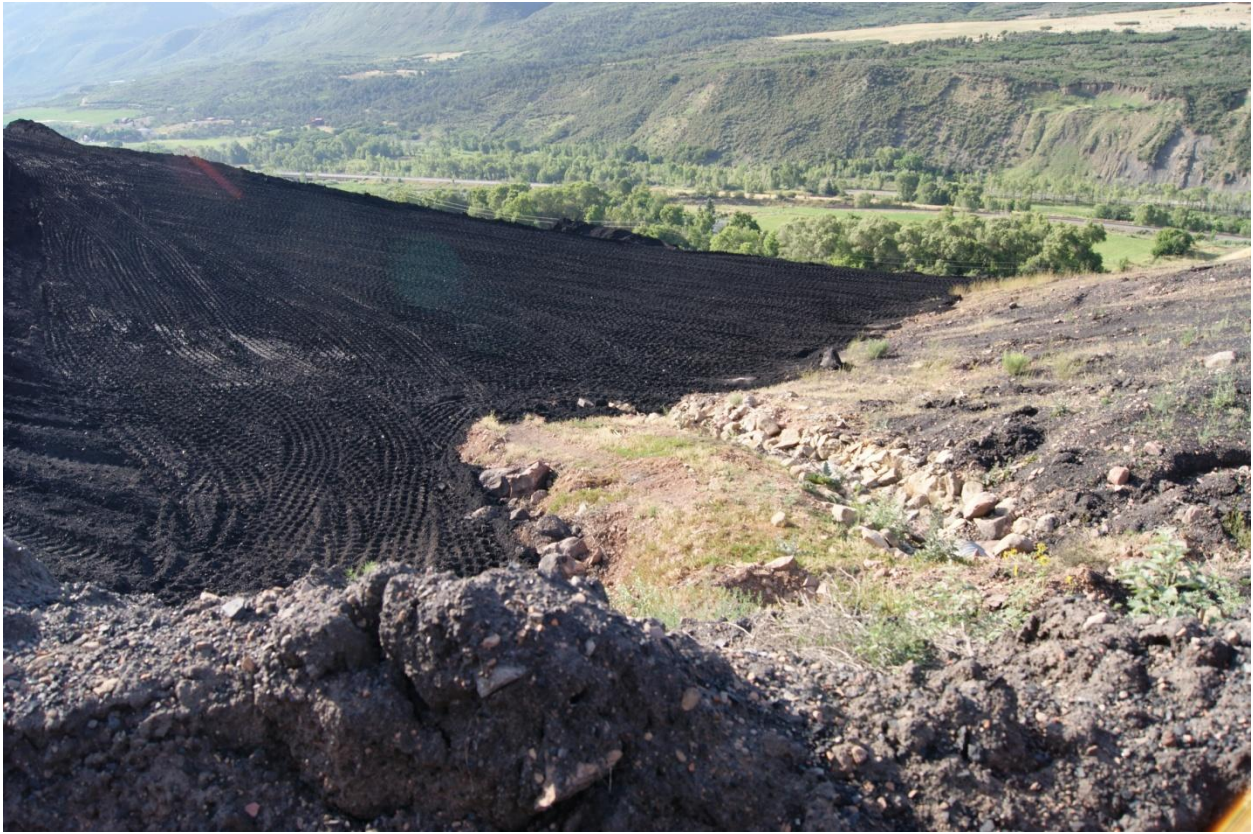
- Compaction has been recently accomplished across a sizeable area of the southwest corner of CWDA No. 2 (Photo 5).
- Mr. Bear said that a representative of Buckhorn Geotech has been on-site two times a week to evaluate the level of compaction. A surveyor accompanies the technician, and determines the X-Y-Z coordinates of each compaction test. This provides for close tracking of the compaction process, and enables the operator to locate, rework, and retest and areas where the compaction tests have failed.

Photo 5 – Recent compaction on CWDA No. 2

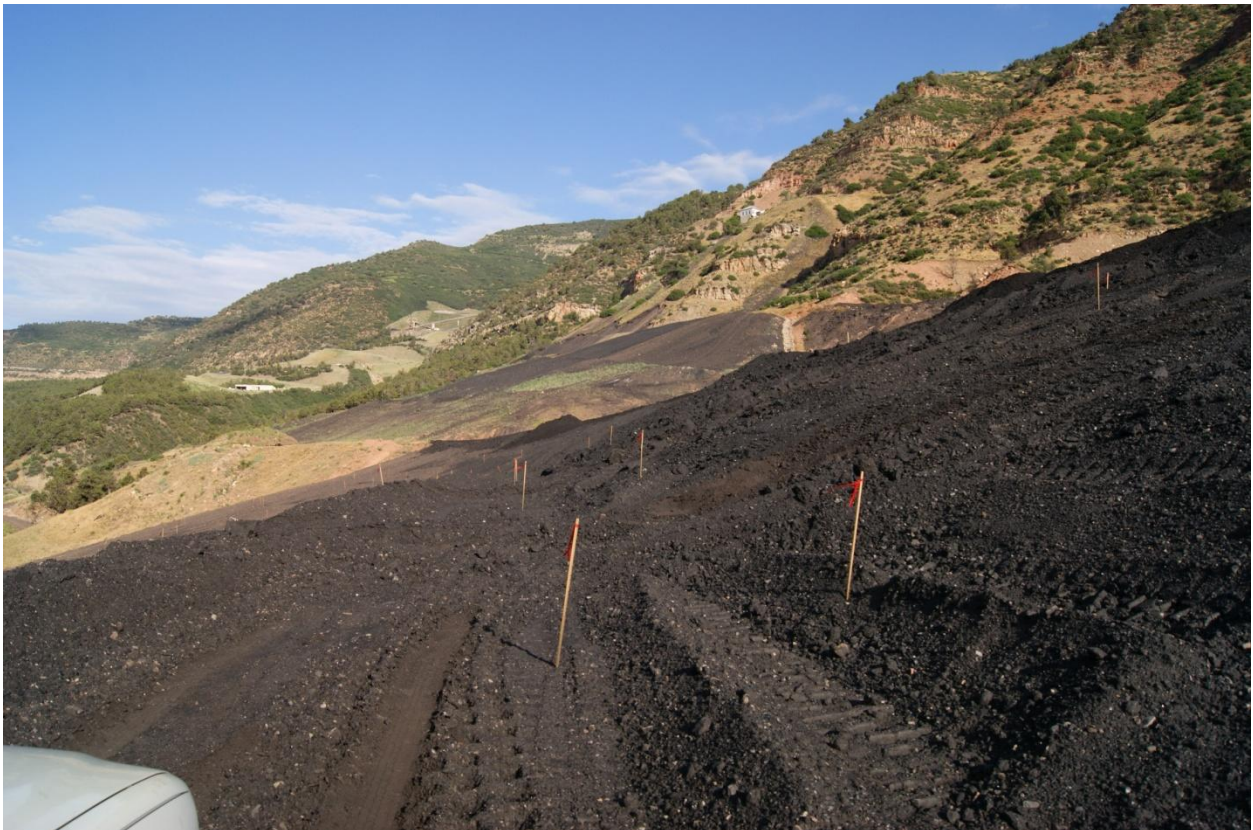
- Mr. Bear also said that a consulting engineer has been visiting the site on a weekly basis to monitor the progress.
- Slope stakes were in place on the rough-graded outcrops of the pile (Photo 6). These indicated where cut or fill will be necessary in order to achieve the approved slope surface.

Photo 6 – Slope stakes on outslope of CWDA No. 2
