**COLORADO DIVISION OF RECLAMATION, MINING AND SAFETY
COAL PROGRAM INSPECTION REPORT**

Permit Number: C-1982-056 Mine Name: Foidel Creek Mine Operator: Twentymile Coal, LLC Operator Address: Mr Jerry Nettleton 29515 Routt County Road No. 27 Oak Creek, CO 80467	County: Routt Operation Type: Underground Permit Status: Active Ownership: Federal
	Operator Representative Present: Brian Watterson
Operator Representative Signature: (Field Issuance Only)

Inspection Start Date: July 10, 2013 Inspection Start Time: 09:00 Inspection End Date: July 10, 2013 Inspection End Time: 13:00	Inspection Type: Coal Partial Inspection Inspection Reason: Normal I&E Program Weather: Clear
Joint Inspection Agency: None	Joint Inspection Contacts:
Post Inspection Agency: None	Post Inspection Contacts:
Inspector(s): Jason D. Musick	Inspector's Signature:

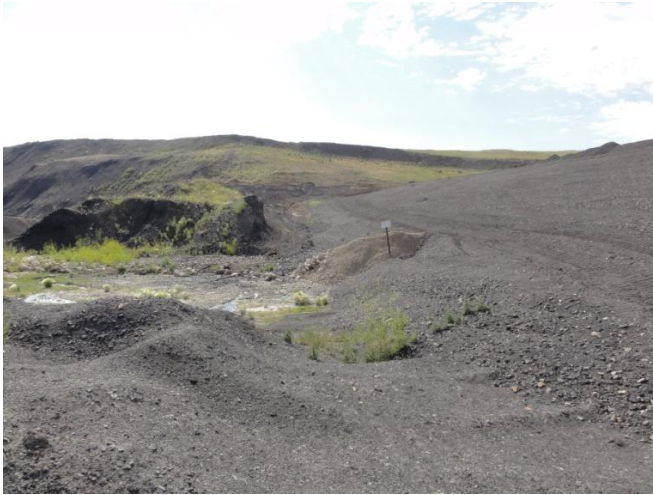
Toe Drain Outlet

The CRDA has been designed with a toe-drain to prevent any significant build-up of hydrostatic pressure within the pile. The toe-drain is designed to discharge into the Area #1 Pit. The Northern end of the toe-drain has been covered with refuse and no discharge was noted at the outlet and into the Area #1 Pit. No problems were noted. The southern end of the toe drain remains uncovered. The toe-drain construction will continue south upon the initiation of Phase II of the RDA Expansion.

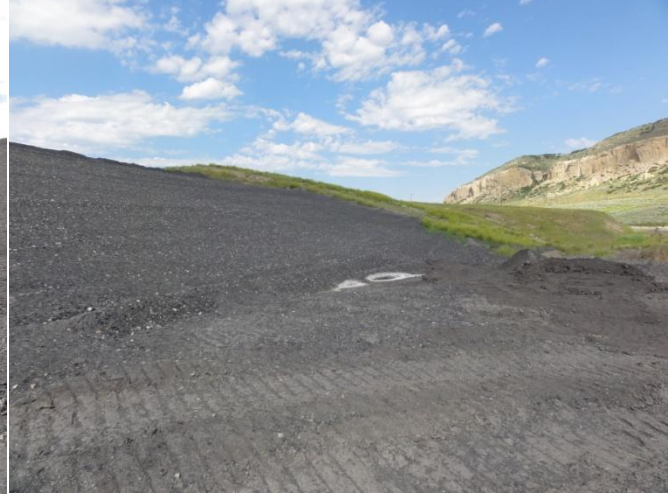
Outslope of Bench 1

The first bench has been completed and the second bench is near elevation. The out slope of the first bench is stable and the outslope of the second bench is stable. Piezometers will be installed during the summer of 2013 in the RDA. No problems were noted with the exception of the following:

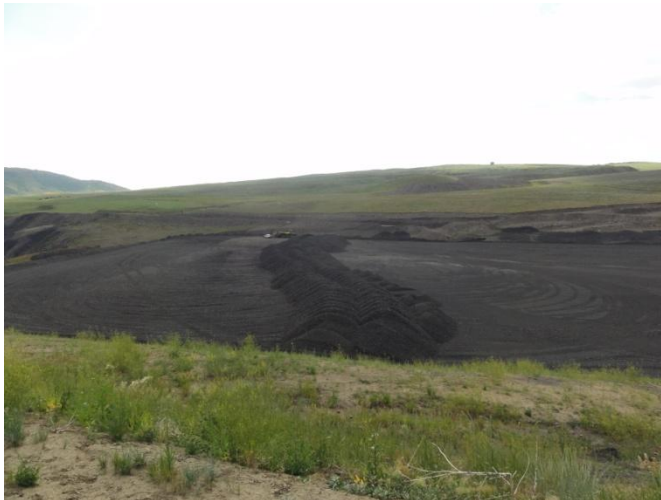
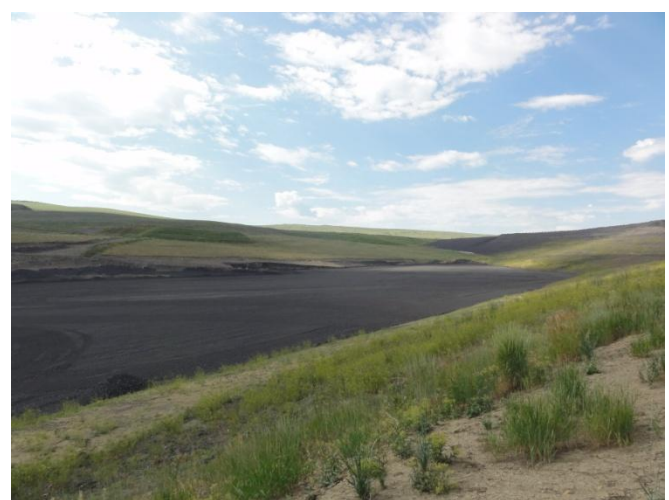
RDA Expansion

Refuse material continues to be placed in the RDA expansion area. Material has been stockpiled towards the middle of the Phase 1 area of the RDA expansion area and approximately midway in the RDA with evidence of grading having been conducted during the inspection. The RDA was well compacted and stable at the time of the inspection. The refuse material had not yet reached the head of the under-drain of the RDA. The exposed under-

drain was stable and constructed as designed. Phase 1 of the RDA expansion is nearing completion. TR67 was approved with a stipulation that future bonding for each phase of construction will be required prior to the initiation of the next Phase.
