**COLORADO DIVISION OF RECLAMATION, MINING AND SAFETY  
COAL PROGRAM INSPECTION REPORT**

<b>Permit Number:</b> X-2011-231-02 <b>Mine Name:</b> Peabody Sage Creek 2011 Exploration Project <b>Operator:</b> Peabody Sage Creek Mining, LLC <b>Operator Address:</b> Mr. Scott Cowman 36600 Routt County Road 27 Hayden, CO 81639	<b>County:</b> Routt <b>Operation Type:</b> Coal exploration <b>Permit Status:</b> Active <b>Ownership:</b> Federal
	<b>Operator Representative Present:</b>  Scott Cowman
<b>Operator Representative Signature: (Field Issuance Only)</b>

<b>Inspection Start Date:</b> July 10, 2013 <b>Inspection Start Time:</b> 07:00 <b>Inspection End Date:</b> July 10, 2013 <b>Inspection End Time:</b> 16:30		<b>Inspection Type:</b> Coal Exploration Inspection <b>Inspection Reason:</b> Surety Release Requested <b>Weather:</b> Clear	
<b>Joint Inspection Agency:</b>  None		<b>Joint Inspection Contacts:</b>  	
<b>Post Inspection Agency:</b>  None		<b>Post Inspection Contacts:</b>  	
<b>Inspector(s):</b>  Elliott R. Russell	<b>Inspector's Signature:</b>

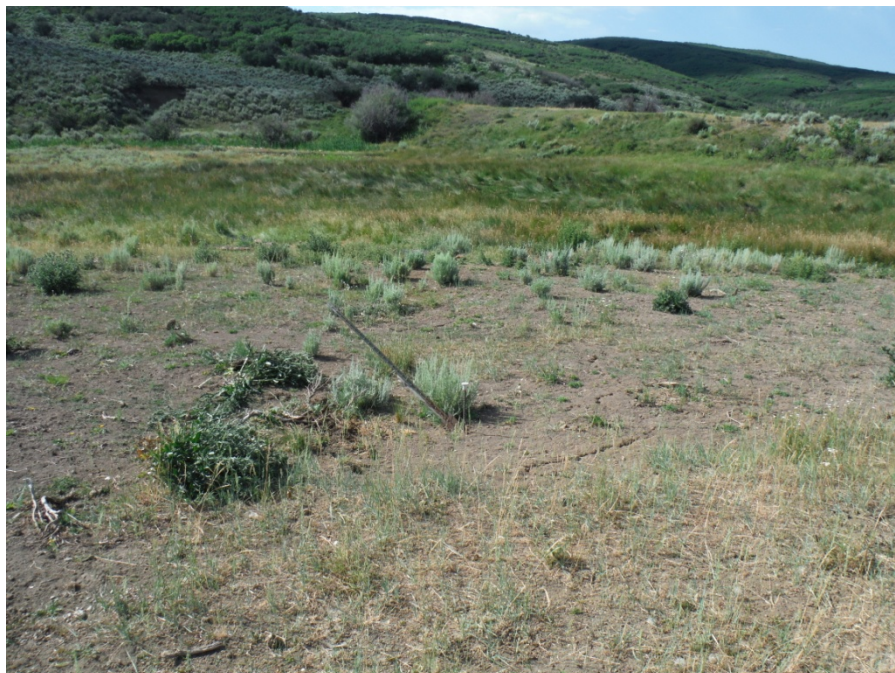
CCU070 was located in a small drainage just north of the Whetstone Reservoir No.3. This site's area of disturbance showed no signs of erosion or any other problems as a result of exploration except the presence of Bull and Canadian Thistle. Scott dug these up and spot sprayed the remaining rosettes. This site had an approved borehole marker which was a rebar and survey cap, with the site ID stamped into it. A t-post was also near the borehole marker.

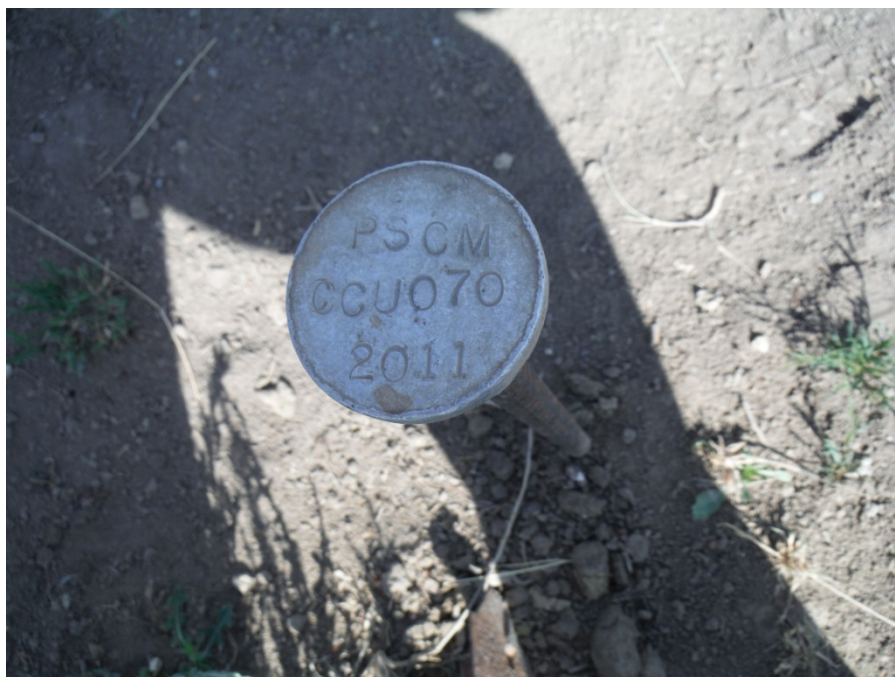
Borehole marker at CCU070

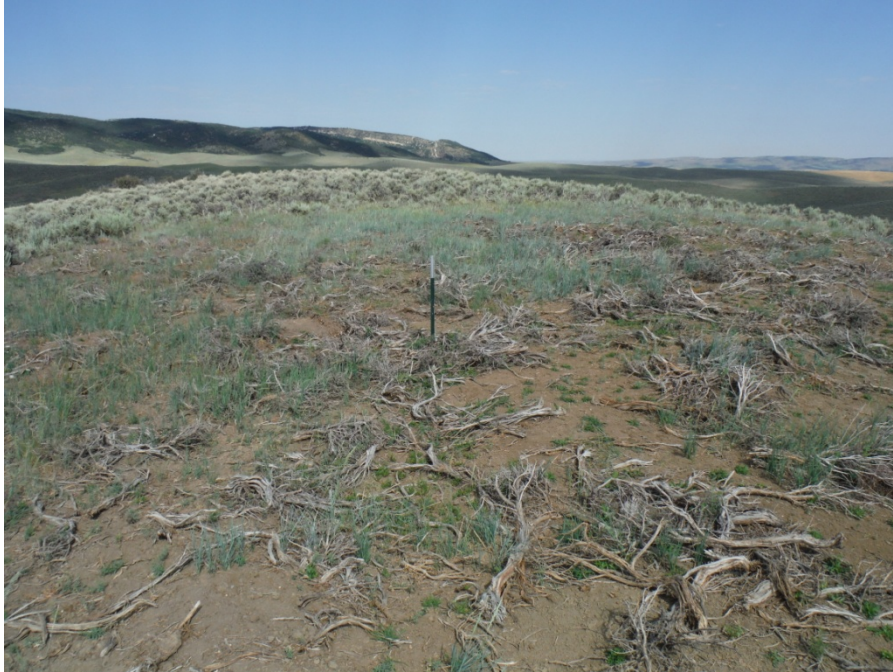
CCU064 was located on top of a small hill approximately 1 mile north east of CCU070. The drill pad was reclaimed and showed no signs of erosion, evidence of noxious/invasive species, or any other problems as a result of exploration. Straw wattles were present on boundaries of the site. This site also had an approved borehole marker

which was a rebar and survey cap, with the site ID stamped into it. A t-post was also near the borehole marker.
