COLORADO DIVISION OF RECLAMATION, MINING AND SAFETY COAL PROGRAM INSPECTION REPORT

Permit Number: C-1980-005 Mine Name: Seneca II Mine Operator: Seneca Coal Company, LLC Operator Address: Mr Roy Karo P.O. Box 670 Hayden, CO 81639	County: Routt Operation Type: Surface Permit Status: Inactive Ownership: Private
	Operator Representative Present: None
Operator Representative Signature: (Field Issuance Only)

Inspection Start Date: July 9, 2013 Inspection Start Time: 08:00 Inspection End Date: July 9, 2013 Inspection End Time: 10:30	Inspection Type: Coal Complete Inspection Inspection Reason: Normal I&E Program Weather: Clear	
Joint Inspection Agency: None	Joint Inspection Contacts:	
Post Inspection Agency: None	Post Inspection Contacts:	
Inspector(s): Jason D. Musick	Inspector's Signature:

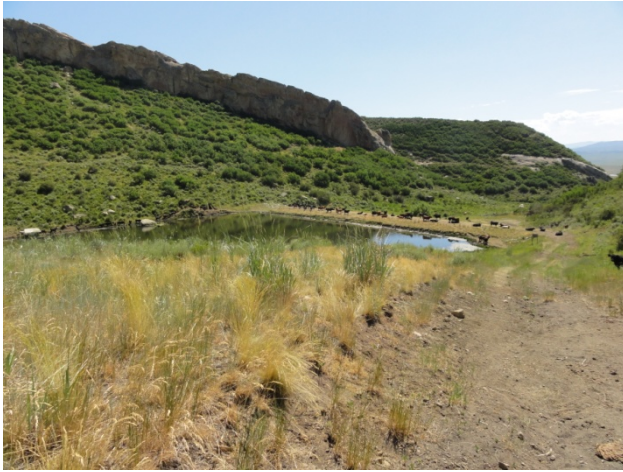
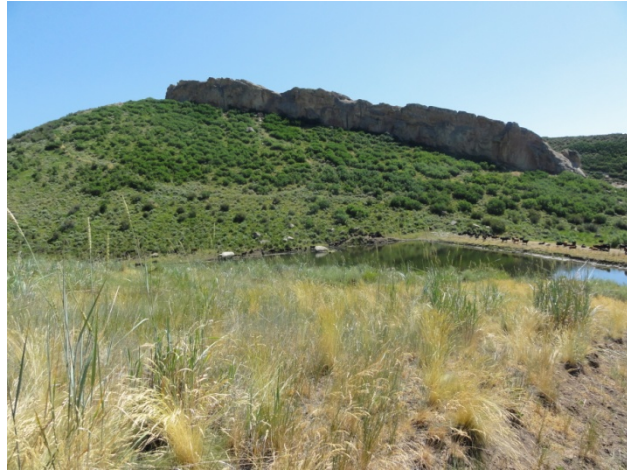
Pond 008 was stable and discharging through the 12” baski flume at the time of the inspection. Embankments are stable and well vegetated, with the exception identified below.. The water in the pond and through the discharge was clear. No problems were noted, with the exception of the following:

- A heavy amount of cattle were observed on the crest of the Pond 008 embankment and along the southern end of the embankment. The cattle presence has reduced the vegetation growth on the crest of the embankment and had caused “trails” to be created down the side of the embankment to the water’s edge. The presence of cattle should be minimized if the vegetation on the embankment is reduced to bare ground or if the structure of the embankment

is compromised.

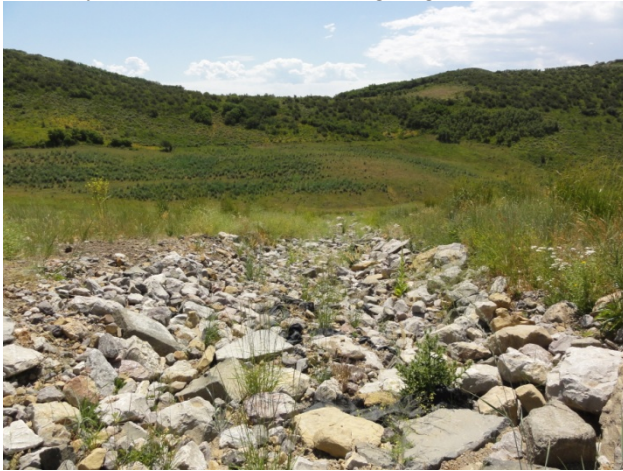
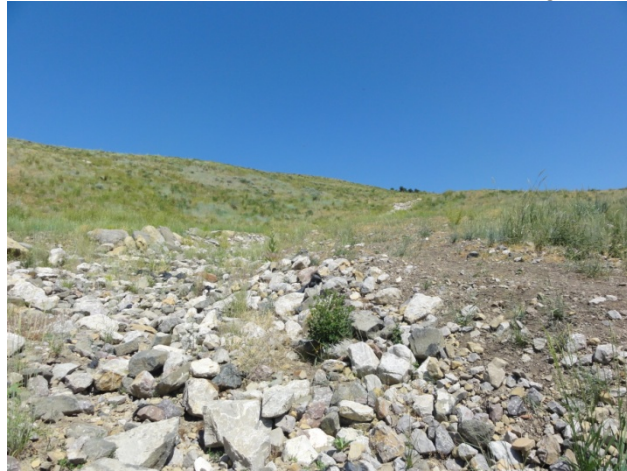
Established drainage SIIPM-8 was stable with no problems noted. The areas of repair work disturbance displayed a small amount of vegetative growth. The disturbed areas will require monitoring for the development of rills and gullies due to low vegetation establishment. No problems were noted, with the exception of the following:

- Heavy thistle and houndstongue growth in the area of disturbance and within the SIIPM-8 drainage.
