## COLORADO DIVISION OF RECLAMATION, MINING AND SAFETY COAL PROGRAM INSPECTION REPORT

<b>Permit Number:</b> X-1983-169-08 <b>Mine Name:</b> Twentymile Fish Creek <b>Operator:</b> Twentymile Coal Company <b>Operator Address:</b> Mr Scott Cowman PO Box 250, 36600 Routt County Road 27 Hayden, CO 81639	<b>County:</b> Routt <b>Operation Type:</b> Coal Exploration <b>Permit Status:</b> Active <b>Ownership:</b> Private
	<b>Operator Representative Present:</b>  Scott Cowman
<b>Operator Representative Signature:</b> (Field Issuance Only)

<b>Inspection Start Date:</b> July 10, 2013 <b>Inspection Start Time:</b> 07:00 <b>Inspection End Date:</b> July 10, 2013 <b>Inspection End Time:</b> 16:30		<b>Inspection Type:</b> Coal Exploration Inspection <b>Inspection Reason:</b> Surety Release Requested <b>Weather:</b> Clear	
<b>Joint Inspection Agency:</b>  None		<b>Joint Inspection Contacts:</b>	
<b>Post Inspection Agency:</b>  None		<b>Post Inspection Contacts:</b>	
<b>Inspector(s):</b>  Elliott R. Russell	<b>Inspector's Signature:</b>

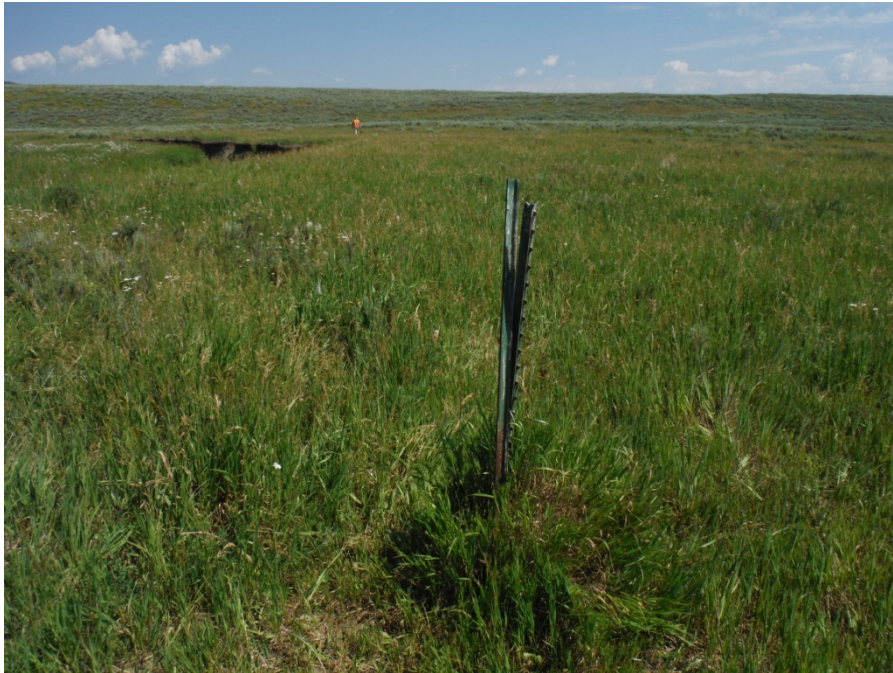
Alluvial Transect A was located and identified by two single T-posts on either side of the Fish Creek valley bottom. Between these two T-posts there were four locations identified by either a single T-post or two that crossed. These were the only remaining sign of where the alluvial wells were located. These wells were either reclaimed following exploration activities or reclaimed and abandoned in the summer of 2010, which was discussed in the 2012 Bond Release Request.

Alluvial well location on Alluvial Transect A. Scott standing at next T-post location. Seismic Line FSS-2 located between these two locations.

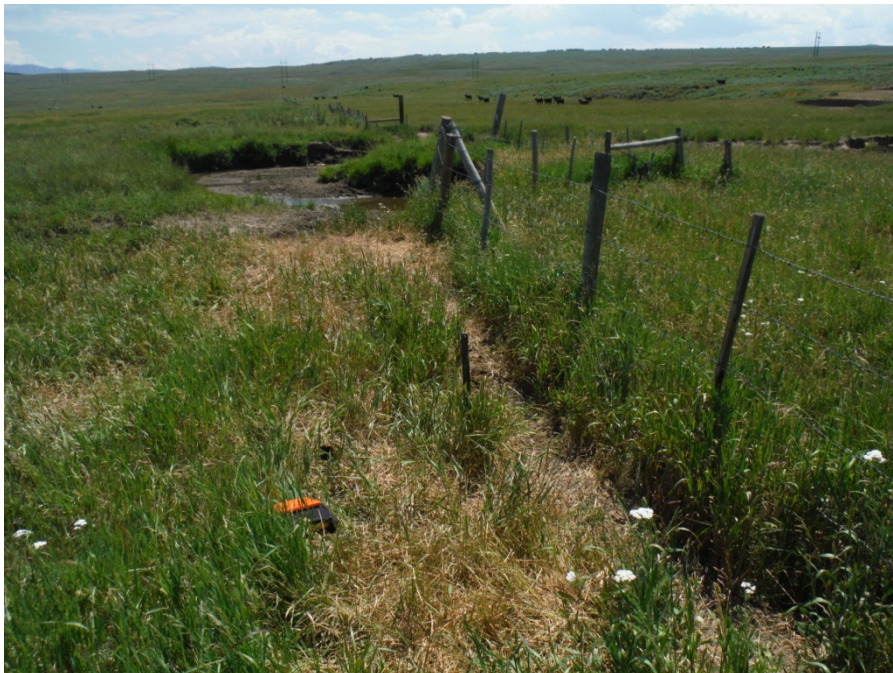
Alluvial Transect C was identified by three T-posts identifying three of the four alluvial wells.

Sothorn most T-post marking the location of a reclaimed alluvial well on Alluvial Transect C. Looking perpendicular of the transect.

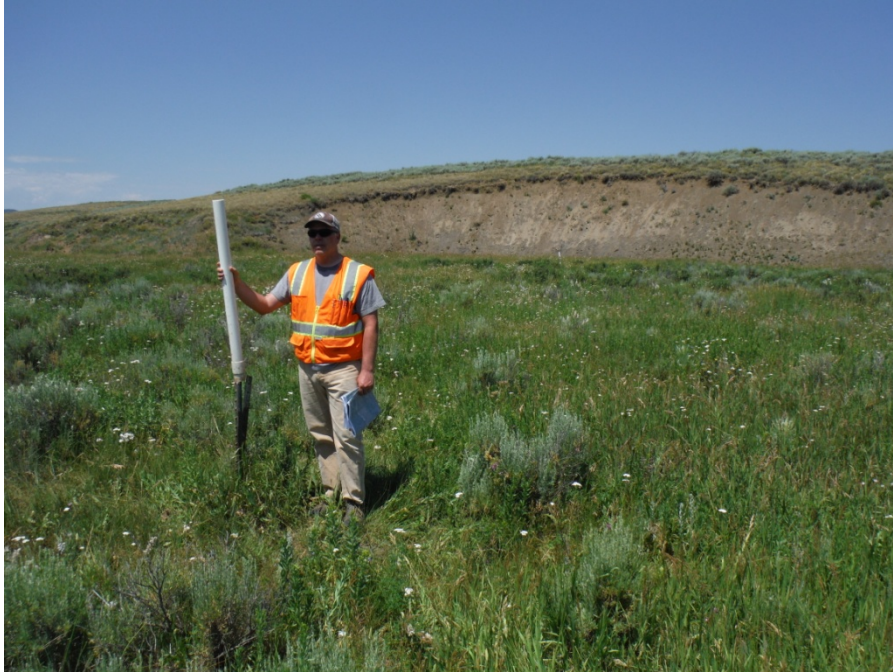
Alluvial Transect D was identified by three locations where two T-posts were crossing. These sites also had old remnants of the 2" PVC casing.

Two T-posts and PVC remnant of alluvial well location on Alluvial Transect D. Northern most location and marker in background near the large cut-bank.

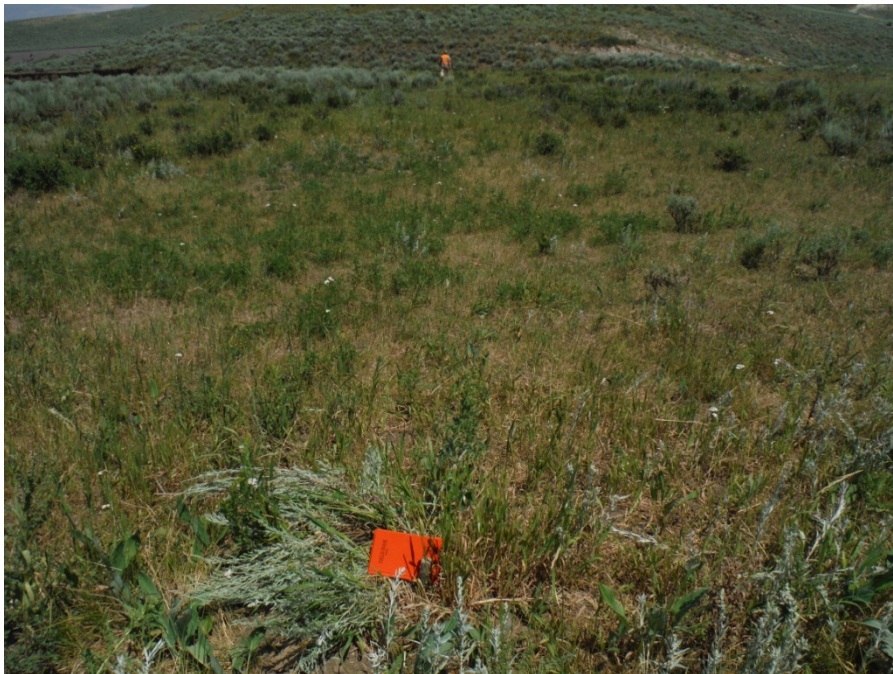
Alluvial Transect E was identified by three locations. Two had a small wood stake and the third only had remnants of the 2" PVC casing. This transect was east of Fish Creek and west of the railroad.

Wood stake identifying an alluvial well location on Alluvial Transect E.

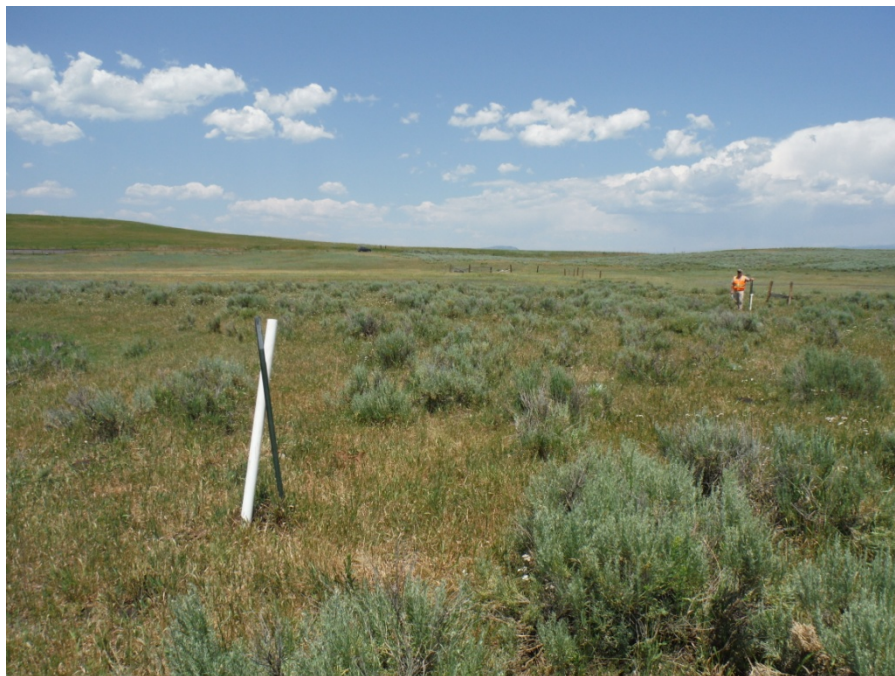
Alluvial Transect F was located near Foidel Creek. Only the two southern most alluvial well locations were identified by crossing T-posts with PVC casing remnants. The other six alluvial well locations were not marked and could not be found.

Two southern most locations of reclaimed alluvial wells on Alluvial Transect F.

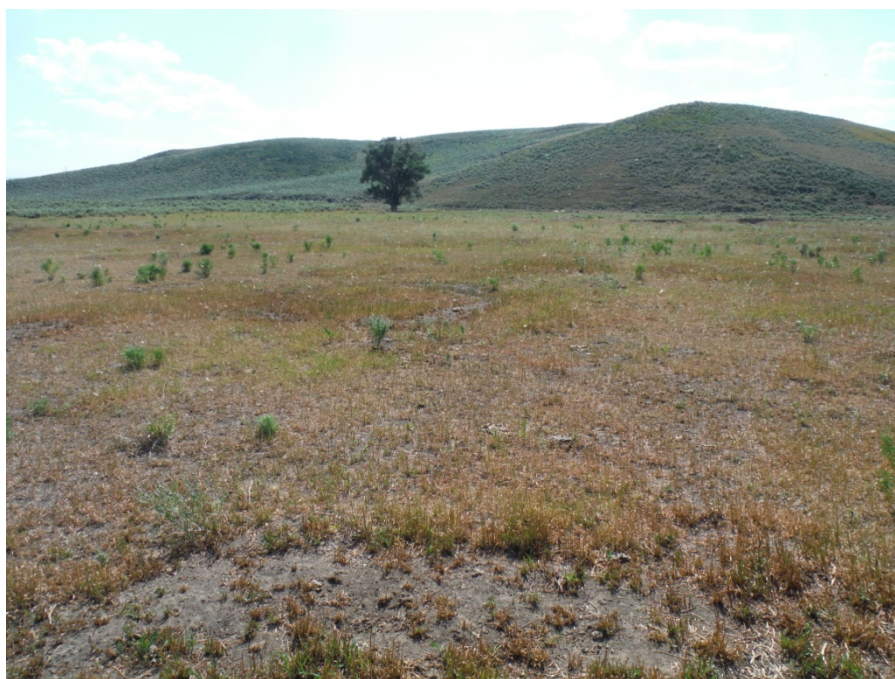
Approximate location of Seismic Line FSS-10.

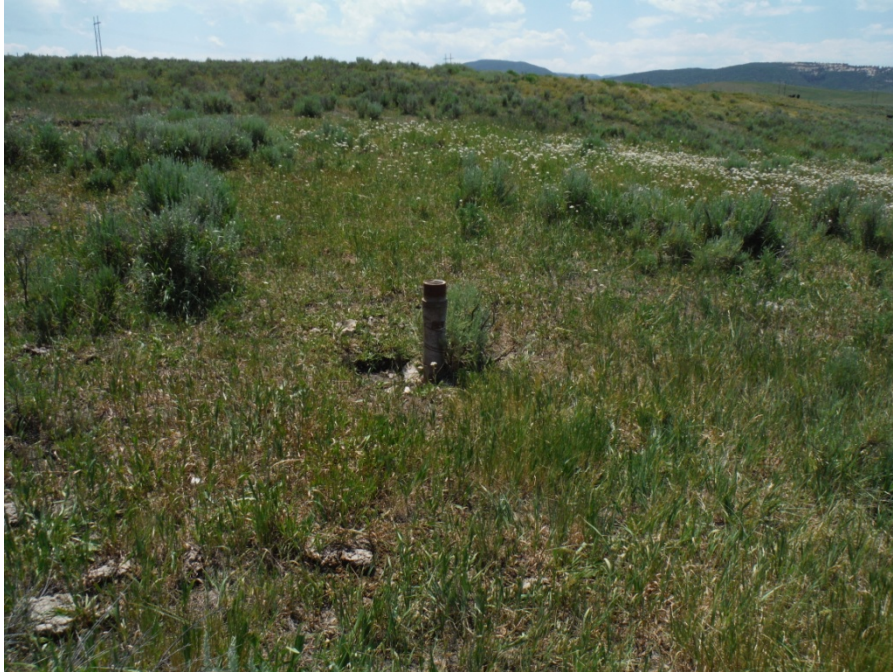
FBR-12

Six of the nine bedrock wells have yet to be reclaimed. The well ID numbers and locations (NAD83 UTM Zone 13N meters) for the remaining bedrock wells with 4" fiberglass casing are as follows: FBR-12A (4473161.3N, 328703.9E), FBR-12B (4473178.2N, 328711.0E), FBR-13(4474593.2N, 329079.7E), FBR-14 (4475194.8N, 328868.3E), FBR-15A (4476189.5N, 327907.7E), and FBR-15B (4476193.8N, 327930.6E). The three remaining wells, FBR-11A, FBR-11B, and FBR-11C, could not be found after thoroughly searching the location of these well cluster. These must have also been the wells reclaimed and abandoned in the summer of 2010, which were discussed in the 2012 Bond Release Request. All the bedrock well areas showed no signs of erosion, evidence of noxious/invasive species, or any other problems as a result of exploration. It is noted that the temporary plug on FBR-15B is bad and has gone artesian; at the time of the inspection there was a small leak causing the surface around the well to pool with water.

Based on this inspection, the Division determines that the exploration activities associated with X-1983-169-08 have been adequately reclaimed, except the 6 bedrock wells that remain. The Division recommends the reclamation bond release for all activities except for wells **FBR-12A, FBR-12B, FBR-13, FBR-14, FBR-15A, and FBR-15B.**

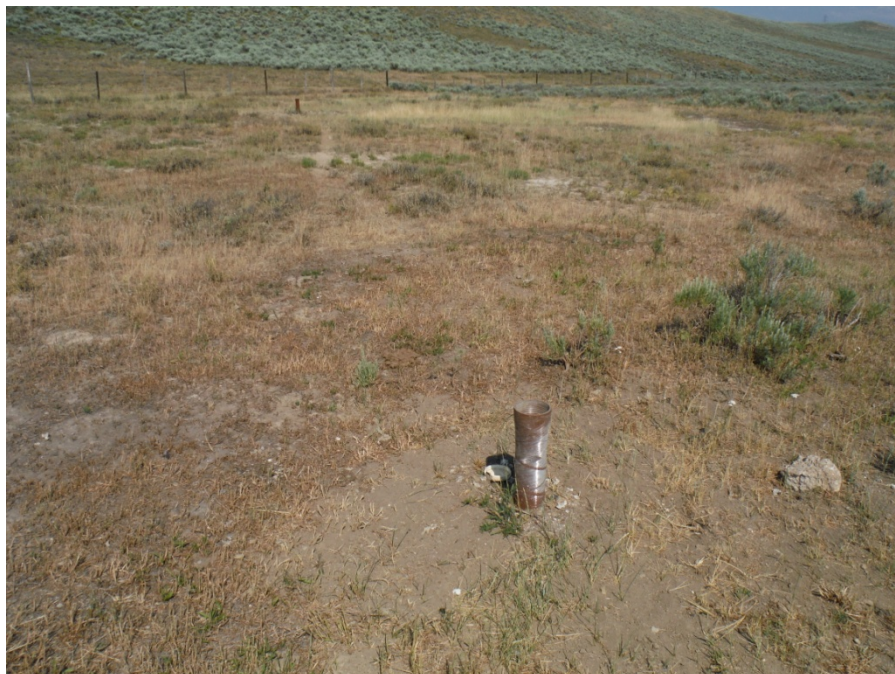
FBR-15A. FBR-15B located in background.

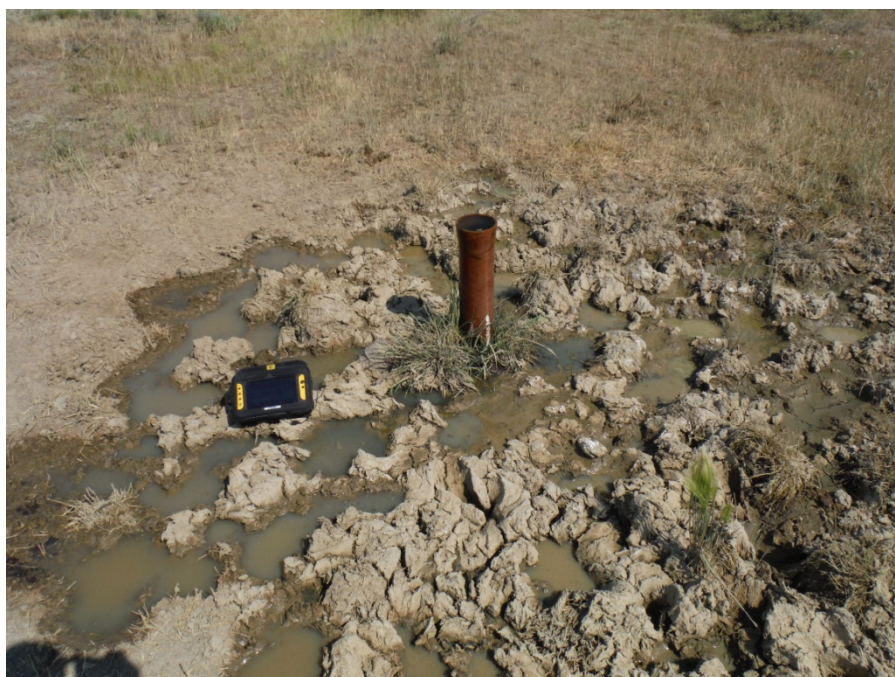
FBR-15B. Note that the temporary plug is bad and artesian well is leaking.

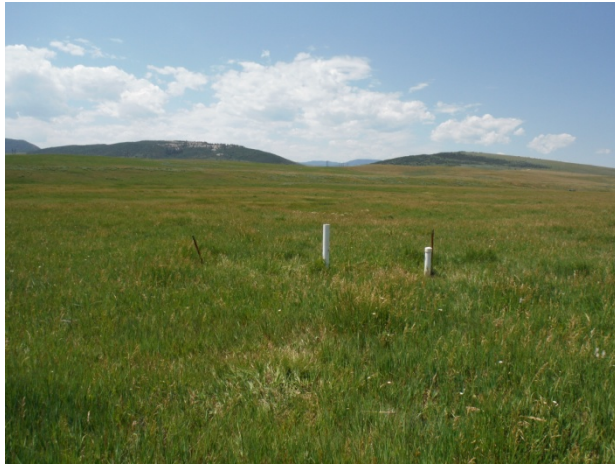
FI-1

During the inspection, some wells and structures were identified, even though unrelated to this NOI. These were: Well FI-1, consisting of two 4" PVS casings, two T-posts, and a rebar (4472575.7N, 327480.9E); Monitoring Well 14, identified with writing under cap of a 2" monitoring well in an 8" casing (4473050.9N, 327480.9E); Well FI-2, a 4" PVC casing and T-post (4473248.0N, 328576.8E); Reclaimed Well FO-1, marked by a T-post and a rebar with a stamped cap; Stream gagging station FO-A. All of these besides MW-14 were also identified on the 1988 Final Reclamation Map.

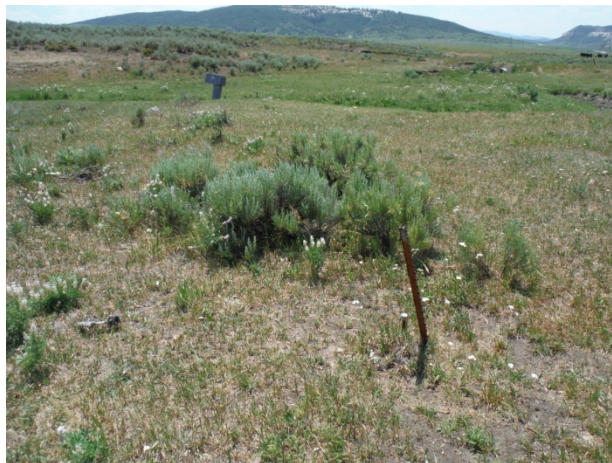
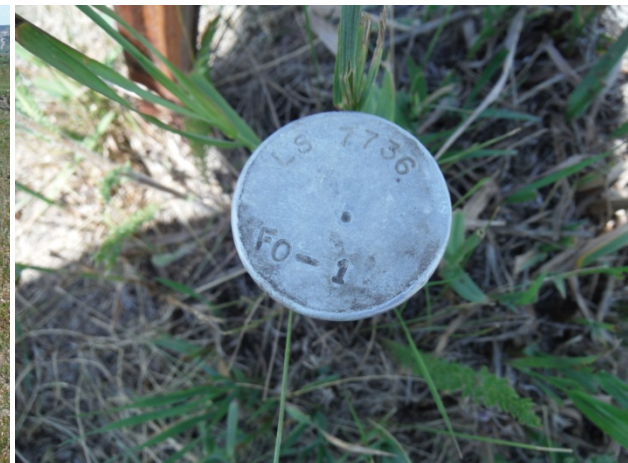
Reclaimed well FO-1. Site and marker.
