**COLORADO DIVISION OF RECLAMATION, MINING AND SAFETY
COAL PROGRAM INSPECTION REPORT**

Permit Number: C-2009-087 Mine Name: Peabody Sage Creek Mine Operator: Peabody Sage Creek Mining, LLC Operator Address: Mr B. Scott Cowman P.O. Box 250 36600 Routt County Road 27 Hayden, CO 81639	County: Routt Operation Type: Underground Permit Status: Active Ownership: Federal
	Operator Representative Present: Scott Cowman
Operator Representative Signature: (Field Issuance Only)

Inspection Start Date: July 9, 2013 Inspection Start Time: 08:00 Inspection End Date: July 9, 2013 Inspection End Time: 14:00	Inspection Type: Coal Complete Inspection Inspection Reason: Normal I&E Program Weather: Clear
Joint Inspection Agency: None	Joint Inspection Contacts:
Post Inspection Agency: None	Post Inspection Contacts:
Inspector(s): Jason D. Musick	Inspector's Signature:

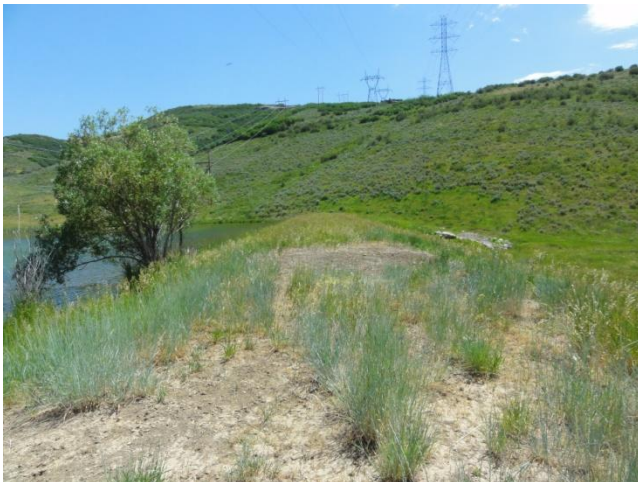
Pond 004 Embankment

- noxious and invasive vegetation was observed along the embankments of the Pecoco Pond near the inlet and outlet of the primary spillway, within the emergency spillway of the Upper Sump, the embankment of Pond 004 at the recent disturbance due to repair work, and Pond 003.

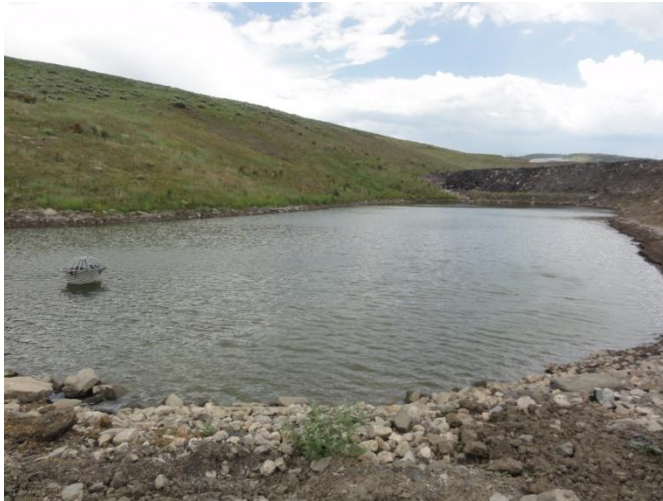
The primary spillway of the Lower Sump was damaged due to ice over the winter. The repair work to the riser pipe had been completed as of the May 2013 complete inspection. During the inspection discharge was noted out of the Lower Sump; however, the water was not at the level of the riser pipe. This indicates that there may be a leak in the primary spillway pipe and the riser pipe. If the riser pipe has been damaged, this will require repair in order to maintain compliance.

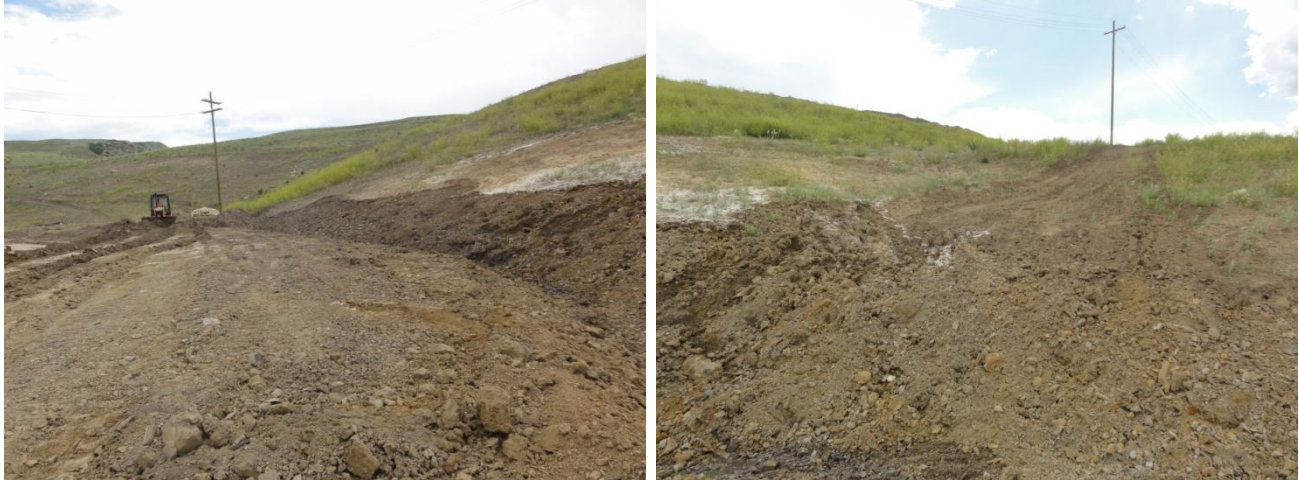
FA-D1 Ditch Maintenance

- Repair work in the area near the electrical substation around ditches FA-D1 and FA-D1A remains ongoing.
- During the April inspection, it was noted that the west side of the substation pad containment ditch had breached the upper portion of the ditch and created a small gully to the compressor building pad. This area has been repaired and is stable.
