COLORADO DIVISION OF RECLAMATION, MINING AND SAFETY COAL PROGRAM INSPECTION REPORT

Permit Number: C-1981-041 Mine Name: Roadside Portals Operator: Snowcap Coal Company, Inc. Operator Address: Ms Tonya Hammond P.O. Box 1430 Palisade, CO 81526	County: Mesa Operation Type: Underground Permit Status: Permanent Cessation Ownership: Federal
	Operator Representative Present: None Present
Operator Representative Signature: (Field Issuance Only)

Inspection Start Date: July 11, 2013 Inspection Start Time: 14:30 Inspection End Date: July 11, 2013 Inspection End Time: 16:00		Inspection Type: Coal Partial Inspection Inspection Reason: Normal I&E Program Weather: Clear	
Joint Inspection Agency: None		Joint Inspection Contacts:	
Post Inspection Agency: None		Post Inspection Contacts:	
Inspector(s): Susan L. Burgmaier	Inspector's Signature:

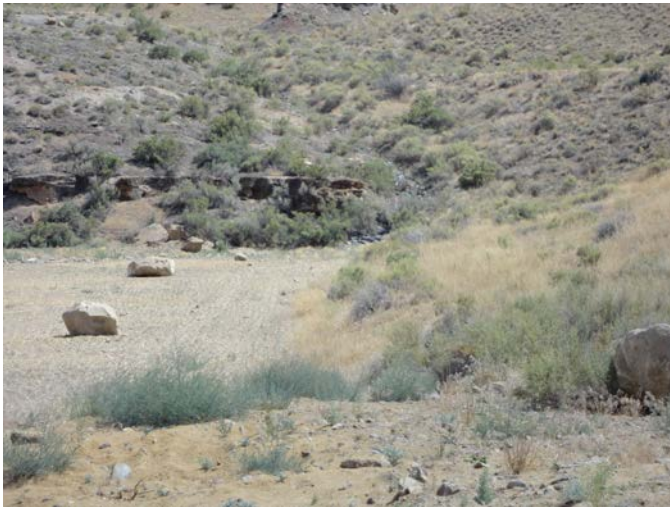
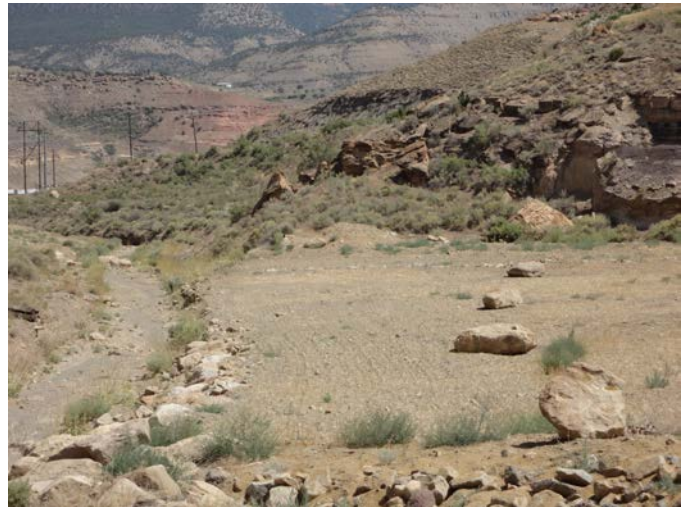
Pond 6 Reclamation

The channels through reclaimed Pond 6, 9, and 10 were also in good condition with no evidence of recent flow.

The revegetated former Ponds 6 and 10 areas were walked. Grasses, penstemon, and sage were observed in both areas, with very few weeds. There were no indications of any erosion by water or wind. Both areas were

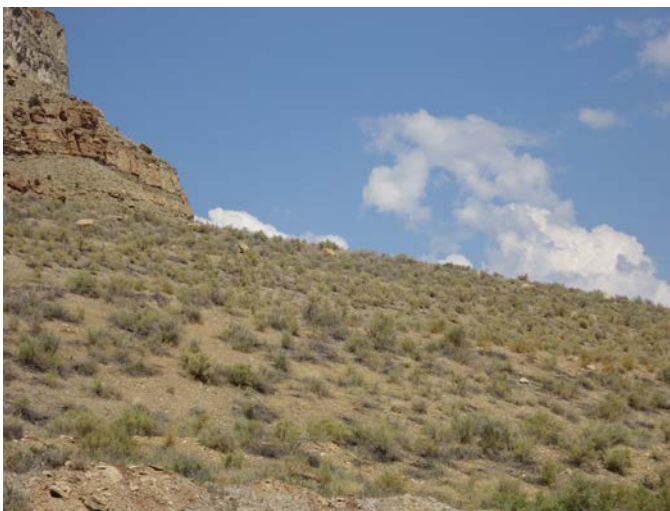
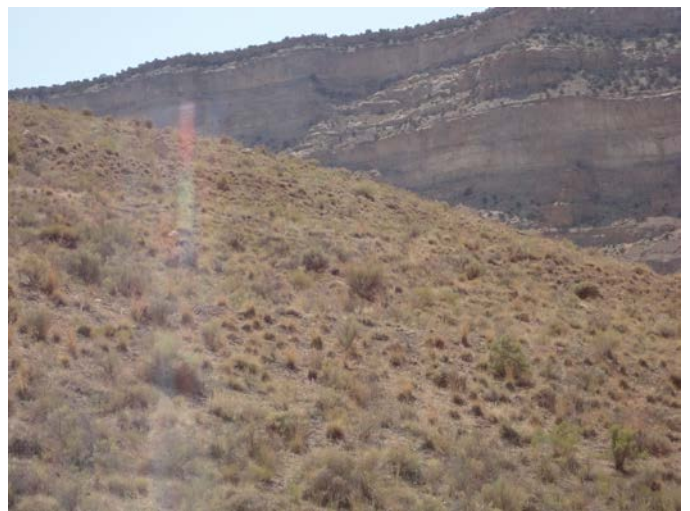
CRDA #1/#2 Reclamation

All ditches that were inspected were dry. The refuse disposal area ditches at CRDA #1 and #2 and RSRDA were in good condition with no indication of downcutting or instability.

Reclaimed refuse areas CRDA#1, CRDA#2, and RSRDA were stable and well vegetated. There were no signs of erosion or instability observed.

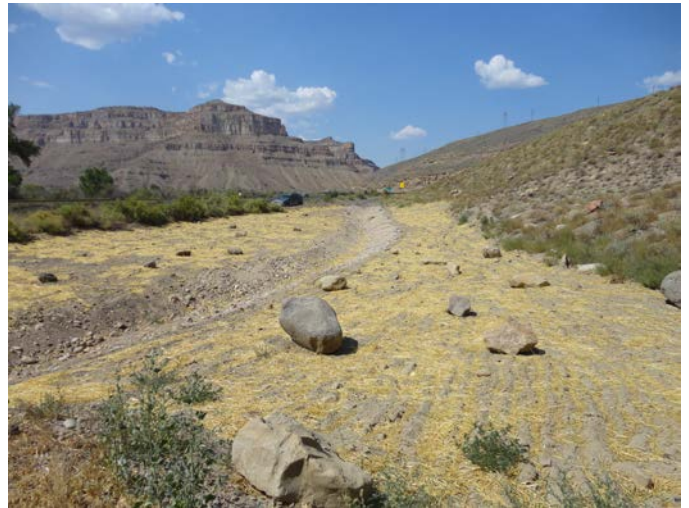
Pond 9 Reclamation

covered with straw mulch. Reclaimed Pond 9 (reclaimed earlier this year) was nearly bare. There were a few grasses and sage plants on the east end of the reclaimed pond, but nothing had germinated on the majority of the area. Nothing had germinated under the straw mulch, and the soil was very dry.
