COLORADO DIVISION OF RECLAMATION, MINING AND SAFETY COAL PROGRAM INSPECTION REPORT

Permit Number: C-1981-020 Mine Name: Munger Canyon Mine Operator: CAM Mining, LLC Operator Address: Mr Gary Isaac P.O. Box 98 Loma, CO 81524	County: Garfield, Mesa Operation Type: Underground Permit Status: Permanent Cessation Ownership: Federal
	Operator Representative Present: None Present
Operator Representative Signature: (Field Issuance Only)

Inspection Start Date: July 12, 2013 Inspection Start Time: 08:30 Inspection End Date: July 12, 2013 Inspection End Time: 10:30	Inspection Type: Coal Partial Inspection Inspection Reason: Normal I&E Program Weather: Clear
Joint Inspection Agency: None	Joint Inspection Contacts:
Post Inspection Agency: None	Post Inspection Contacts:
Inspector(s): Susan L. Burgmaier	Inspector's Signature: <i>Susan Burgmaier</i> Signature Date: 07/17/2012

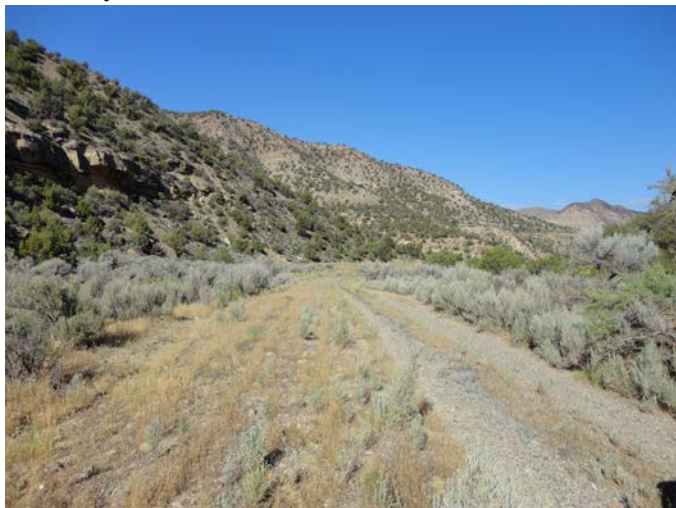
Narrowed access road

The narrowed section of the access road between Highway 139 and the reclaimed portal access road was in good condition. No rilling or gullying was observed along the road surface or adjacent areas.

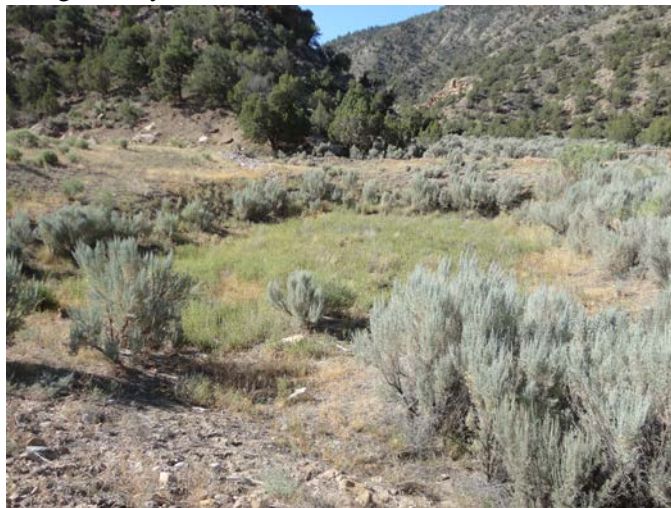
Sediment pond

The sediment pond was dry. Munger Creek and Salt Creek were both dry.

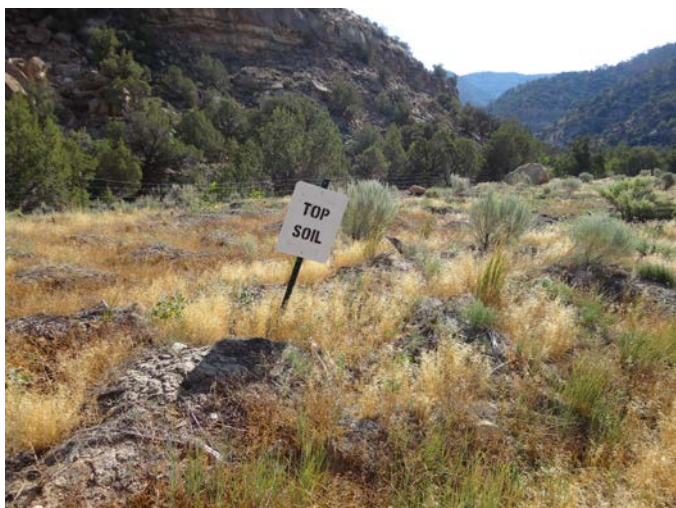
Topsoil stockpile

The topsoil stockpile near the sediment pond was stable and properly identified. The cover on the stockpile was largely cheatgrass.

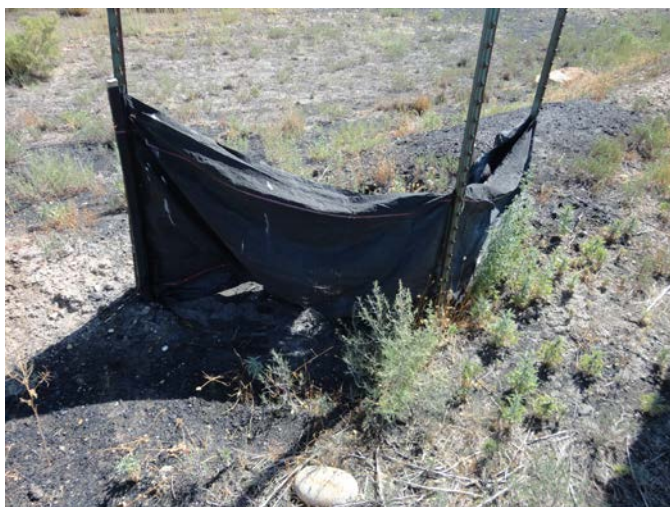
The Loma loadout area was in good condition with no signs of erosion. The silt fence at the west end of the loadout area was in need of maintenance; the lower edge of the fabric was not keyed in to the ground, so water and sediment could flow off-site untreated. There was no evidence of recent flow, but the fence should be maintained to prevent future off-site damage.

Silt fence at west end of loadout
