COLORADO DIVISION OF RECLAMATION, MINING AND SAFETY COAL PROGRAM INSPECTION REPORT

Permit Number: C-1981-038 Mine Name: Bowie No. 1 Mine Operator: Bowie Resources, LLC Operator Address: Mr. Basil Bear P.O. Box 1488 Paonia, CO 81428	County: Delta Operation Type: Underground Permit Status: Active Ownership: Federal
	Operator Representative Present: None
Operator Representative Signature: (Field Issuance Only) This report was issued electronically from the Division's Durango Field Office.

Inspection Start Date: July 11, 2013 Inspection Start Time: 08:00 Inspection End Date: July 11, 2013 Inspection End Time: 10:00		Inspection Type: Coal Partial Inspection Inspection Reason: Normal I&E Program Weather: Clear	
Joint Inspection Agency: None		Joint Inspection Contacts:	
Post Inspection Agency: None		Post Inspection Contacts:	
Inspector(s): Marcia L. Talvitie, P.E.	Inspector's Signature:

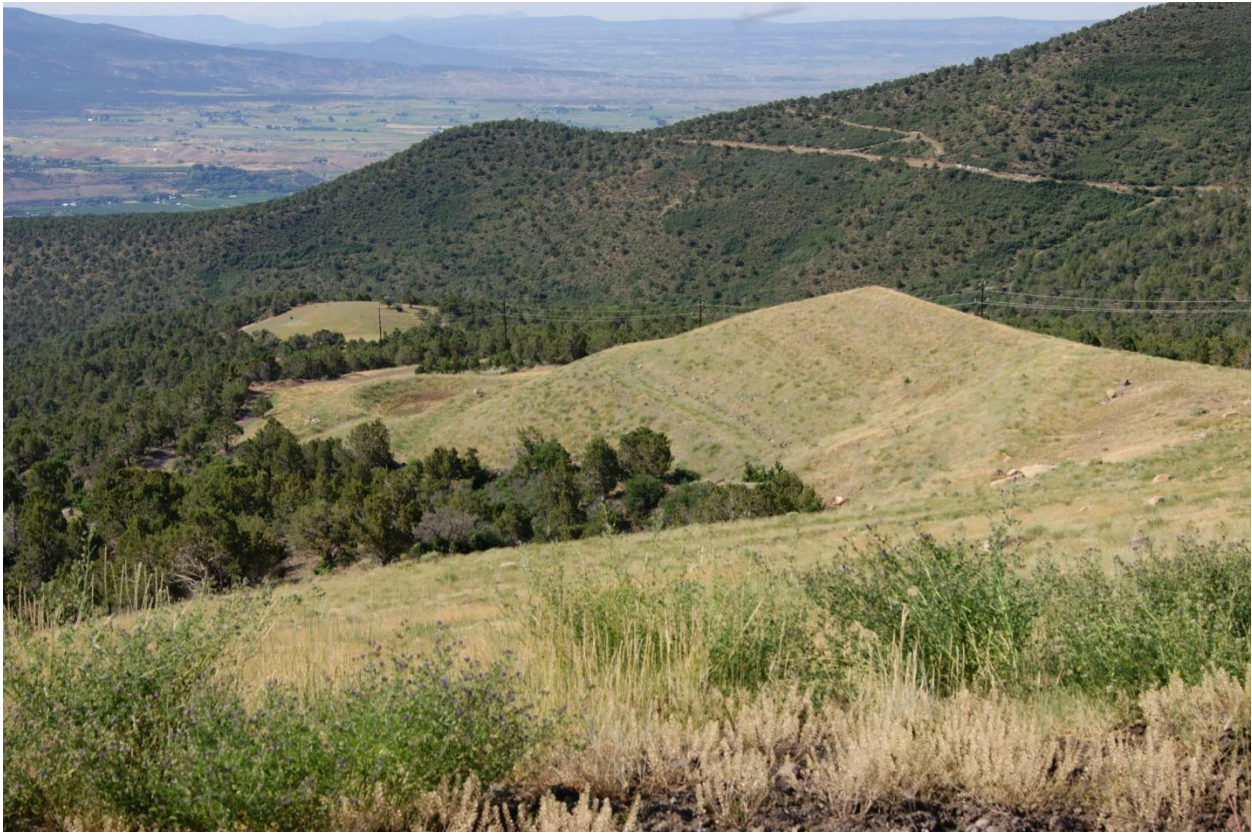
Photo 1 – West Ridge Waste Pile and Pond (East Mine)

- The West Ridge Waste Pile was well vegetated, and appeared to be stable with respect to erosion. No geotechnical instability of the pile was observed (Photo 1).

- At the West Mine, Ponds W-1 and W-2 have not been removed. Roatcap Creek continues to be confined to a culvert running beneath the ponds.
- Pond 1 at the East Mine appeared to have been cleaned out recently (Photo 3)
- The West Ridge Waste Pile pond was dry, as viewed from the reclaimed haul road above (Photo 1).

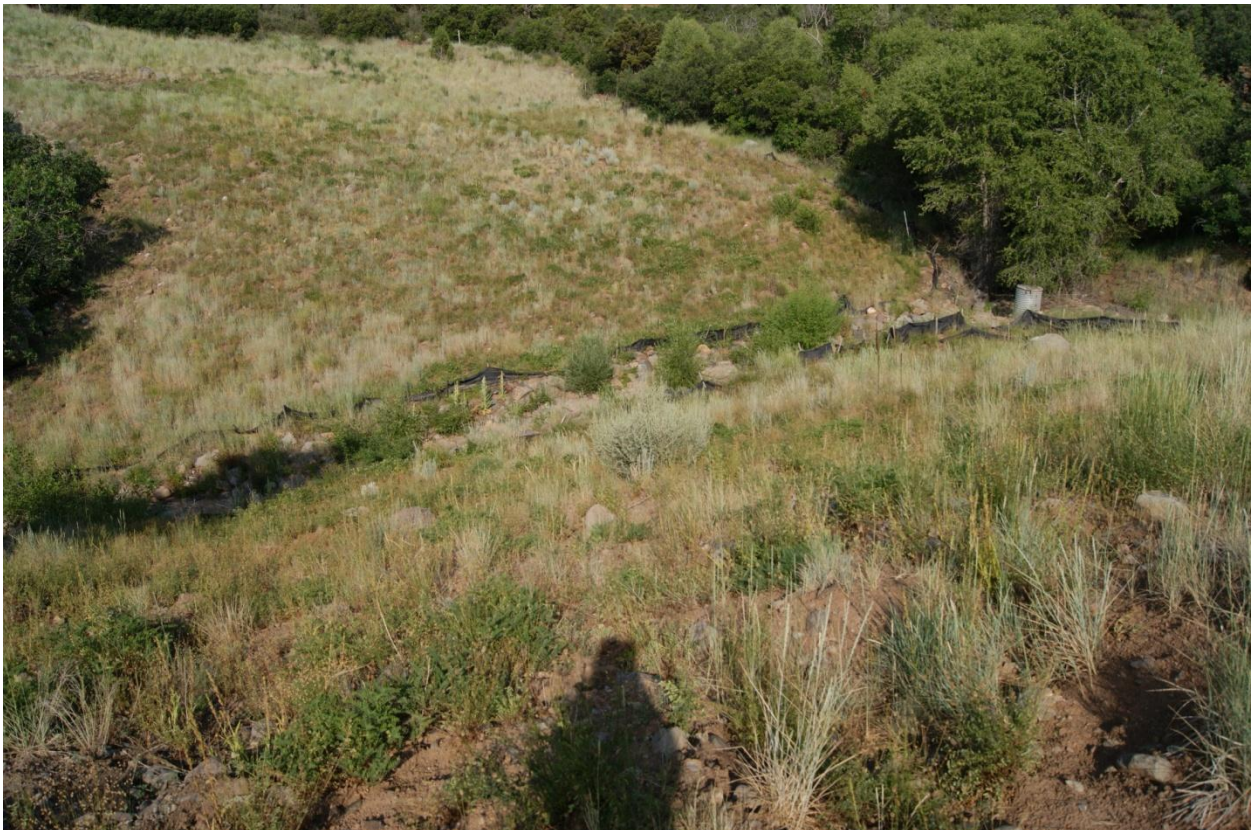
Photo 2 – Stevens Gulch at Timber Storage Area

- A segment of the Stevens Gulch channel, adjacent to the Timber Storage Area, was reconstructed with the reclamation of that area in 2009. Silt fence that was installed along the banks of the creek is still in place, but is sagging between the posts (Photo 2).
- ***Throughout the areas reclaimed in 2008-2009, silt fence should be either repaired or replaced. Conversely, alternative methods of sediment control may be installed, e.g. straw or excelsior wattles.***
- A number of Sediment Ponds were inspected, and each one was found to be dry.
- At the Loadout, the gate on the primary spillway pipe was closed; the Fire Mountain Canal was flowing into the culvert which runs beneath the pond.
- The Timber Storage Area pond was observed from the access to Stevens Gulch Road. It appeared to be well-vegetated.

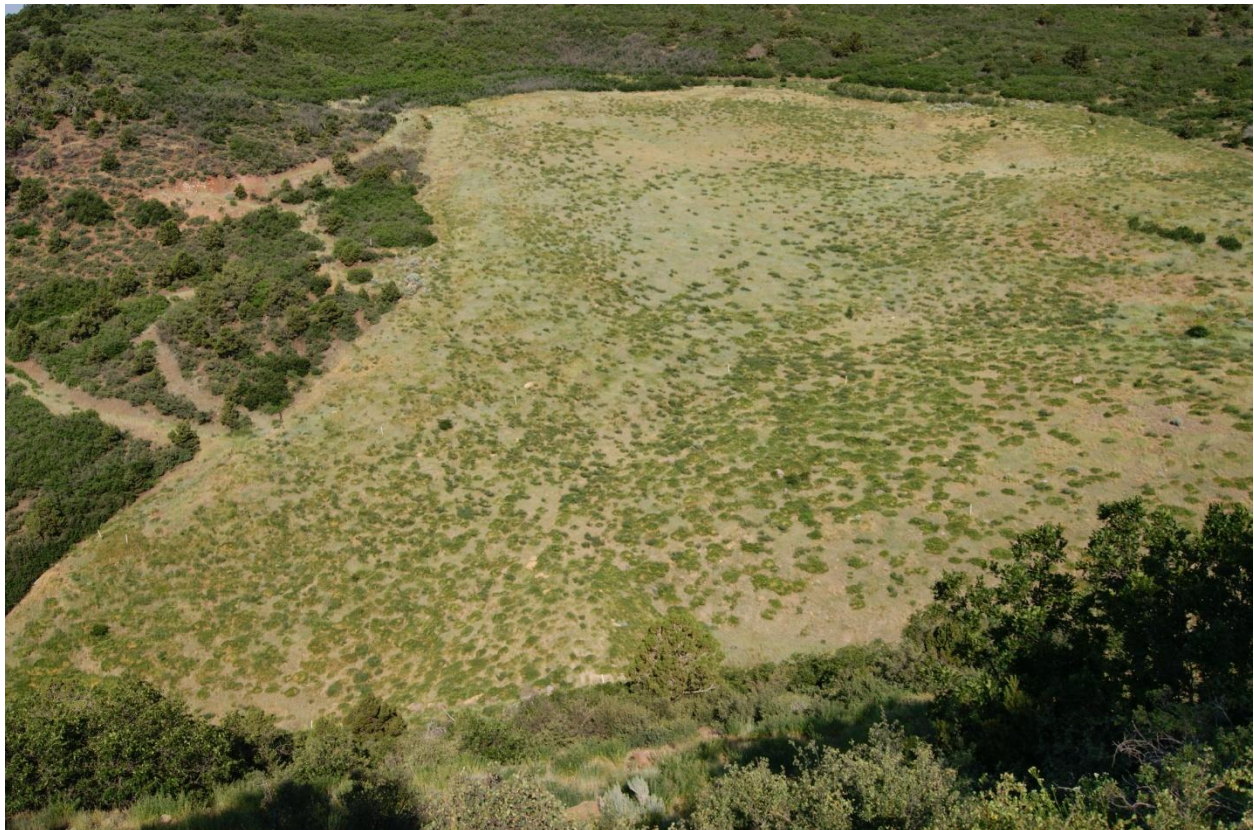
Photo 4 – West Mine reclamation

- The reclaimed slope at the West Mine was observed from the roadway above. The slope appears to be well-vegetated, and stable (Photo 4).

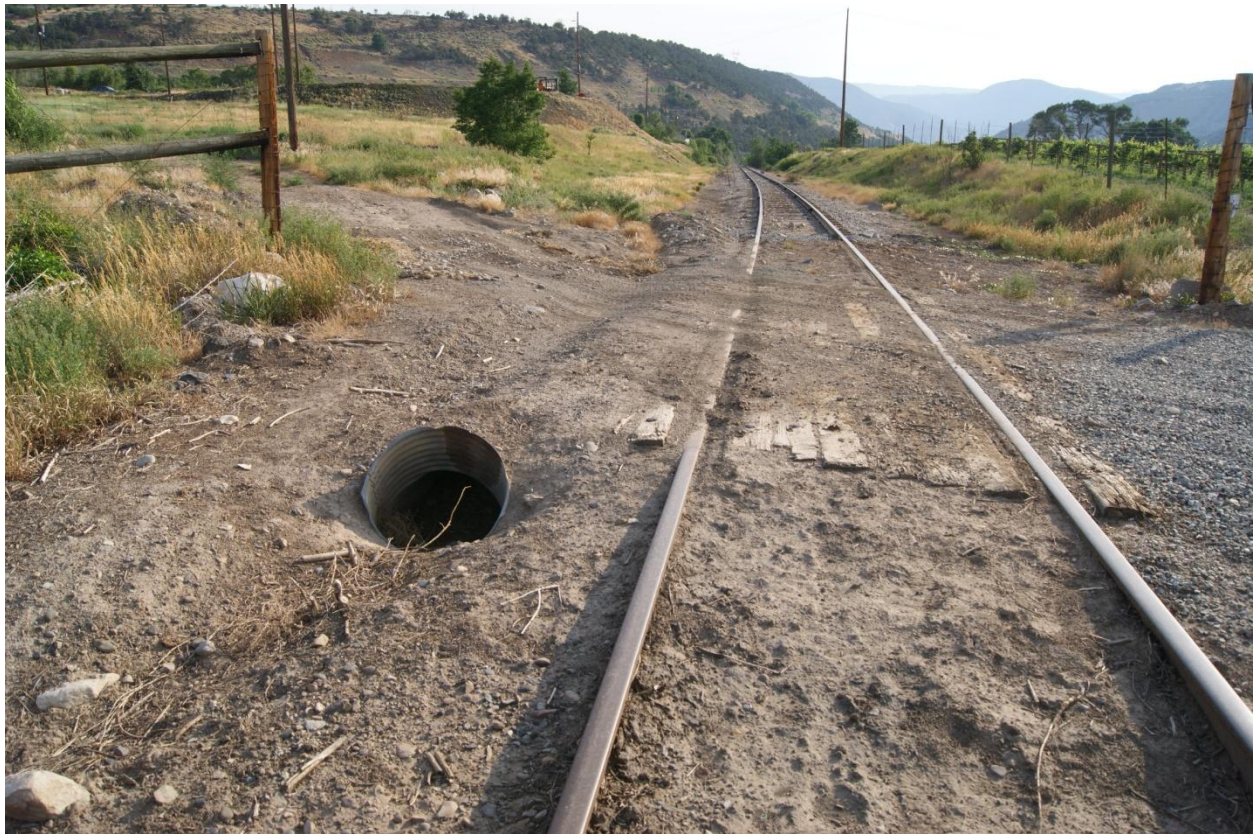
Photo 5 – Farm road crossing of RR tracks, looking NE

- No rail cars were being stored on the spur at the Loadout.
- At the location where the farm access road crosses the tracks, sediment has accumulated around the rails (Photo 5).
- Miscellaneous materials and pieces of equipment continue to be stored at the Loadout. A generator has been placed on the concrete pad next to the shop building (Photo 6). No signs of petroleum leakage were observed.
