## COLORADO DIVISION OF RECLAMATION, MINING AND SAFETY MINERALS PROGRAM INSPECTION REPORT

MINE NAME:	MINE/PROSPECTING ID#:	MINERAL:	COUNTY:
J & J Pit	M-1985-001	Sand and gravel	La Plata
INSPECTION TYPE:	INSPECTOR(S):	INSP. DATE:	INSP. TIME:
Monitoring	Kate A. Pickford	May 16, 2013	12:00
OPERATOR:	OPERATOR REPRESENTATIVE:	TYPE OF OPERATION:	
Glacier Gravel Products		110c - Construction Limited Impact

PERMIT #: M-1985-001 INSPECTOR'S INITIALS: KAP INSPECTION DATE: May 16, 2013

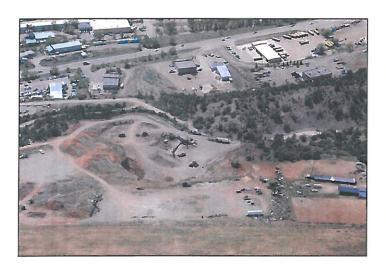
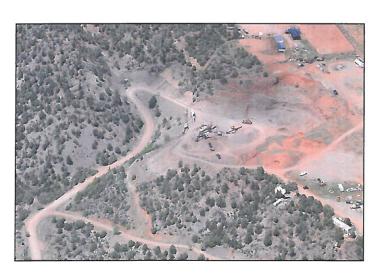
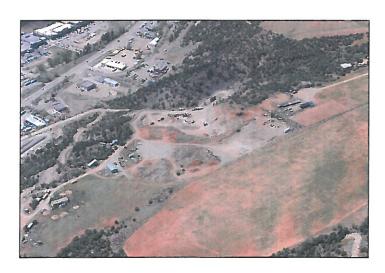
Relative to past inspections, there is more disturbance at the site. The highwall is much higher, estimated at approximately 50 feet in height and approximately 900 feet in length. There is additional acreage disturbed at the site than there was at the previous inspection, as well.

A bond calculation was conducted, based on the current amount of disturbance at the site. There is an increase in the required bond. Notice of the increase is included in this mailing.
