**COLORADO DIVISION OF RECLAMATION, MINING AND SAFETY
MINERALS PROGRAM INSPECTION REPORT
PHONE: (303) 866-3567**

MINE NAME: Pathfinder Pit	MINE/PROSPECTING ID#: M-1994-113	MINERAL: Gravel	COUNTY: San Miguel
INSPECTION TYPE: Monitoring	INSPECTOR(S): Kate A. Pickford	INSP. DATE: July 5, 2013	INSP. TIME: 14:00
OPERATOR: Pathfinder Development, Inc	OPERATOR REPRESENTATIVE:	TYPE OF OPERATION: 112c - Construction Regular Operation

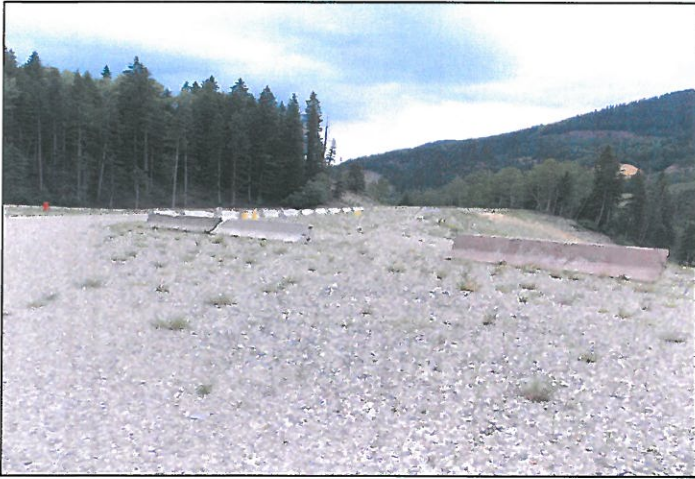
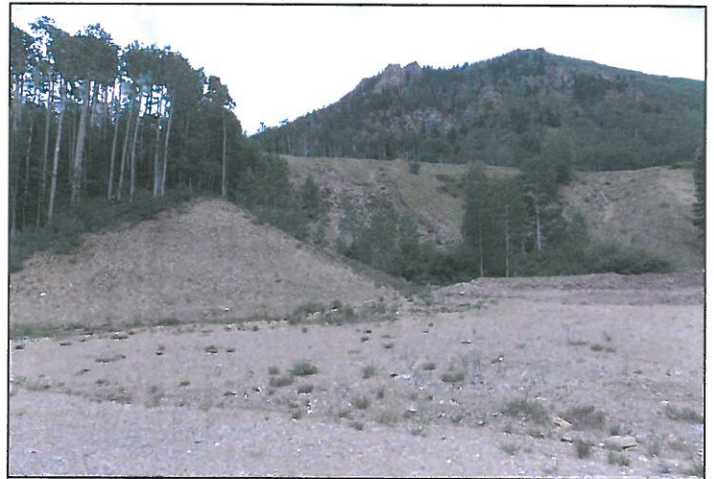
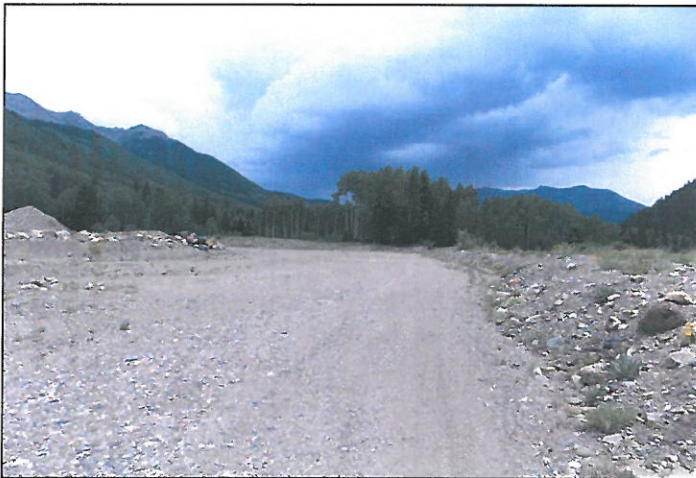
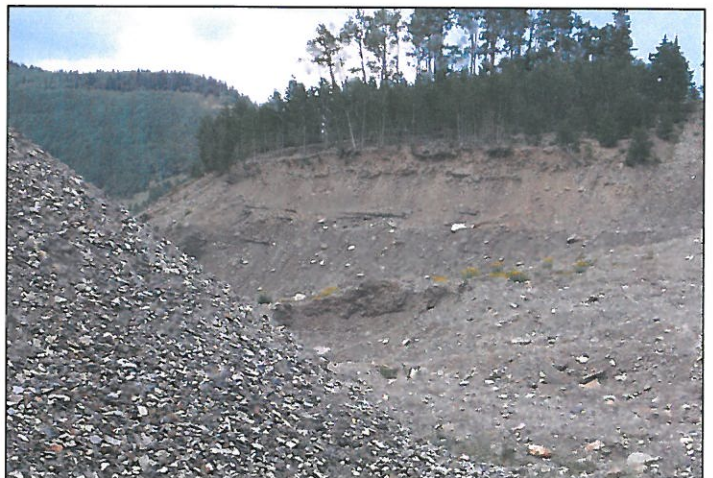
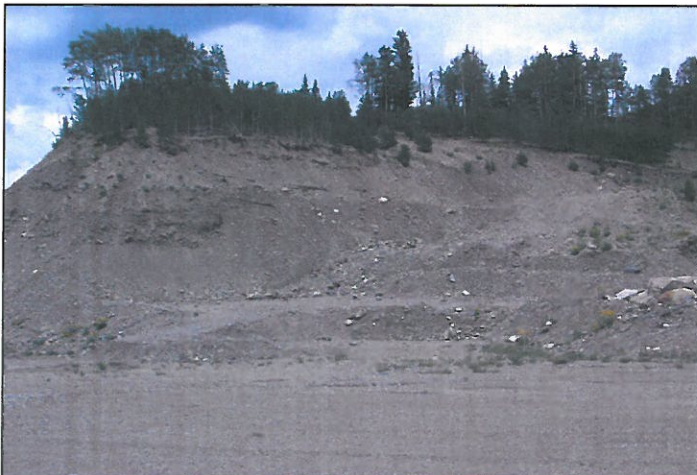
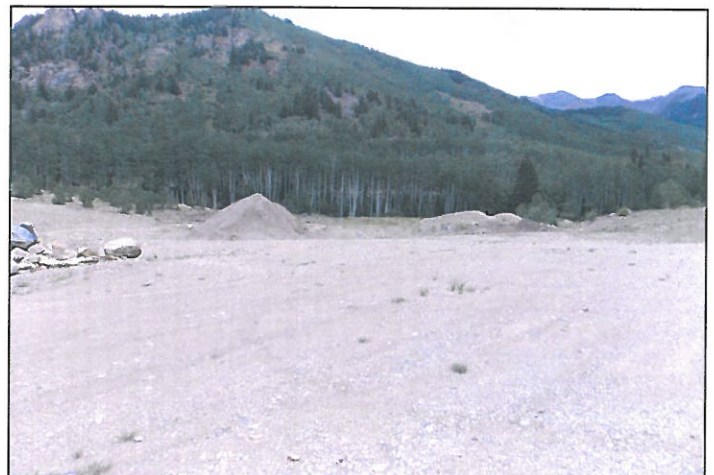
This inspection was conducted in response to an application for Temporary Cessation for the site. A sign is posted at the entrance. Roads into the site are stable and well maintained. All affected slopes appear to be stable. The slope adjacent to the main highway along the portion of the access road with the concrete barriers is showing signs of erosion. It does not appear, however, that this slope has been affected by the mining operation and this erosion appears to be a natural feature. Stockpiles on the pit floor appear to be stable and pose no risk of producing sediments that will be carried off site. Berms are installed along the road edge that is upslope from the drainage below. The site appears to be stable and poses no risk of damage during the period of temporary cessation. See enclosed documents related to temporary cessation.
