COLORADO DIVISION OF RECLAMATION, MINING AND SAFETY
MINERALS PROGRAM INSPECTION REPORT
PHONE: (303) 866-3567

MINE NAME: New Hay Camp Pit	MINE/PROSPECTING ID#: M-2013-031	MINERAL: Gravel	COUNTY: Montezuma
INSPECTION TYPE: Preoperation Inspection	INSPECTOR(S): Kate A. Pickford	INSP. DATE: July 5, 2013	INSP. TIME: 12:00
OPERATOR: McStone Aggregates	OPERATOR REPRESENTATIVE: Casey McClellan	TYPE OF OPERATION: 112c - Construction Regular Operation

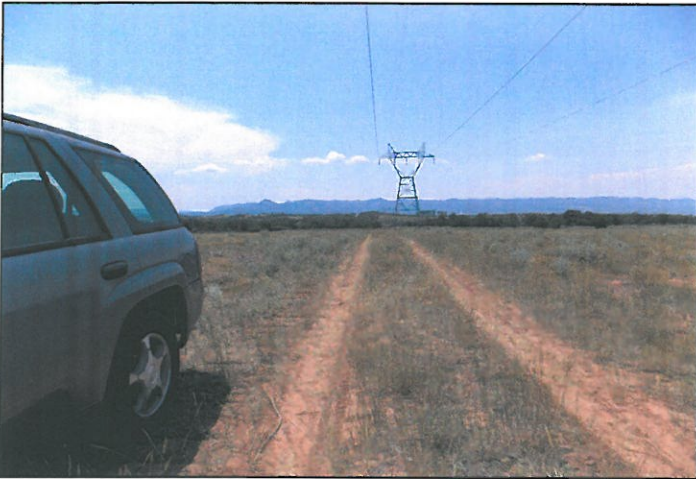
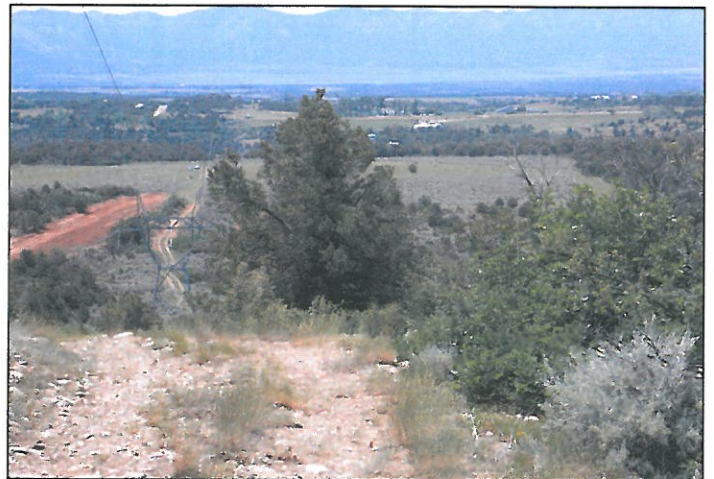
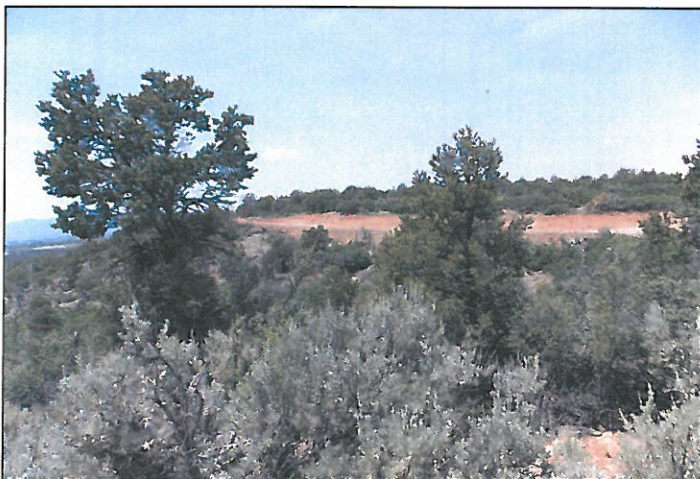
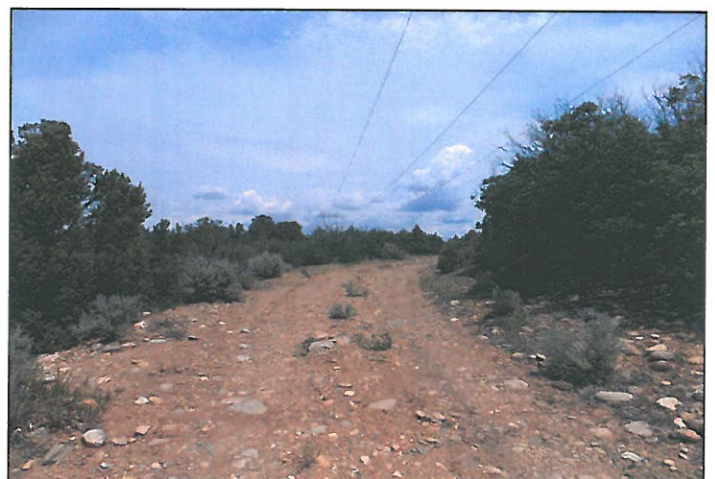
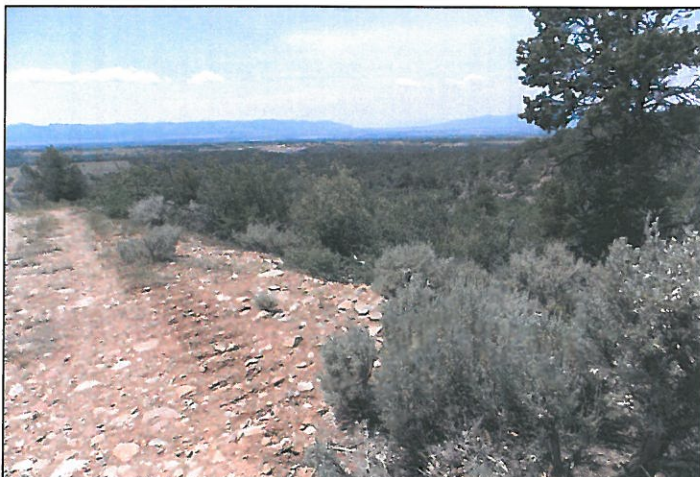
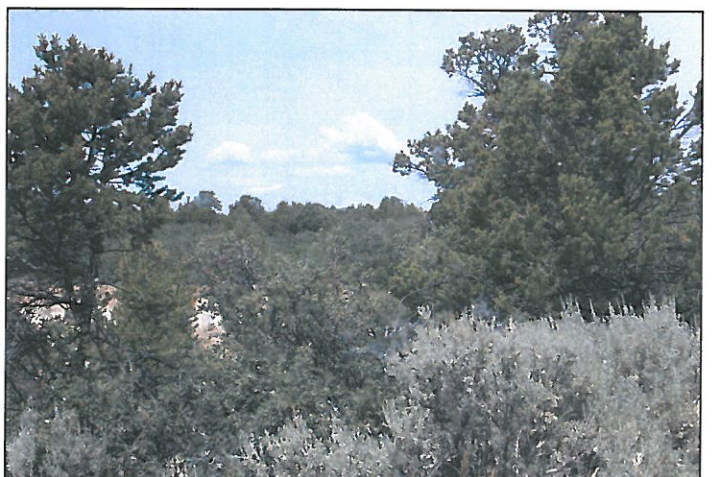
PHOTOGRAPHS

The site is located adjacent to the existing Hay Camp permit. The area consists of a lower level that is vegetated with grasses, where the access road and potential plants and stockpile areas are to be located; and an upper area that is currently vegetated with pinion/juniper, where excavation will occur.

No mining related disturbance was observed within the proposed permit area.
Review of the application is still in process.
