COLORADO DIVISION OF RECLAMATION, MINING AND SAFETY
MINERALS PROGRAM INSPECTION REPORT
PHONE: (303) 866-3567

MINE NAME: Funk & Hooker Pit	MINE/PROSPECTING ID#: M-1979-058	MINERAL: Sand and gravel	COUNTY: Routt
INSPECTION TYPE: Monitoring	INSPECTOR(S): Dustin M. Czapla	INSP. DATE: July 9, 2013	INSP. TIME: 14:00
OPERATOR: Routt County	OPERATOR REPRESENTATIVE: Tanner Caroulis	TYPE OF OPERATION: 112c - Construction Regular Operation	
REASON FOR INSPECTION: Normal I&E Program	BOND CALCULATION TYPE: None	BOND AMOUNT: NA	
DATE OF COMPLAINT: NA	POST INSP. CONTACTS: None	JOINT INSP. AGENCY: None	
WEATHER: Clear	INSPECTOR'S SIGNATURE:

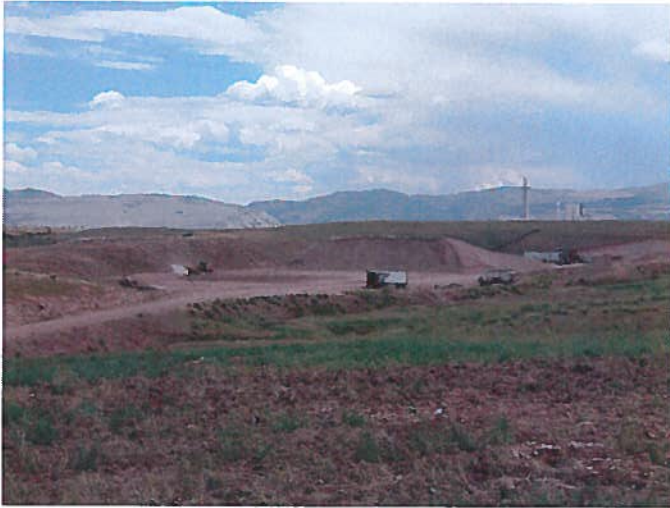
Figure 1: View of the pit from the west side of the access road.

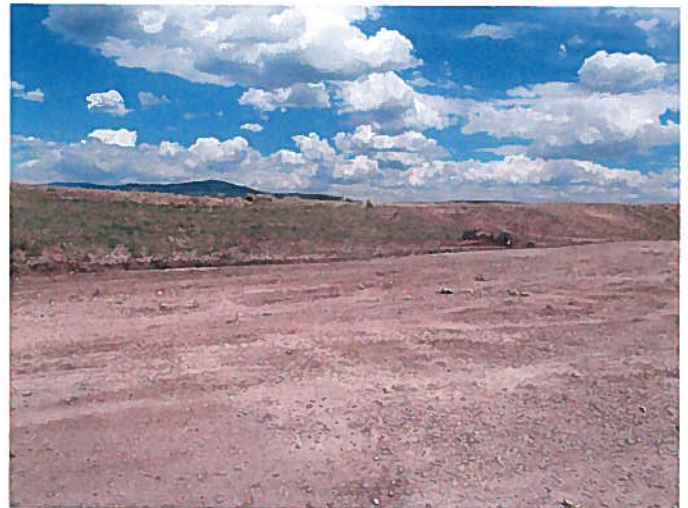
Reclaimed slopes along the north side of the pit range from approximately 2H:1V to 3H:1V. They appeared stable and vegetation is becoming well established. The active mine face in the south side of the pit area has been left at approximately 2H:1V. Materials stockpiles were located on the pit floor. Fuel storage was located in a bermed and lined containment.

Figure 2: Reclaimed slope on the north side of the pit.

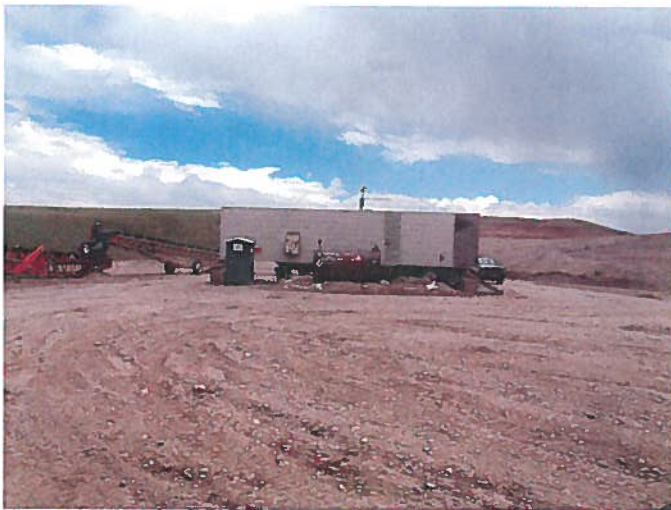
Figure 3: Fuel storage and processing area.

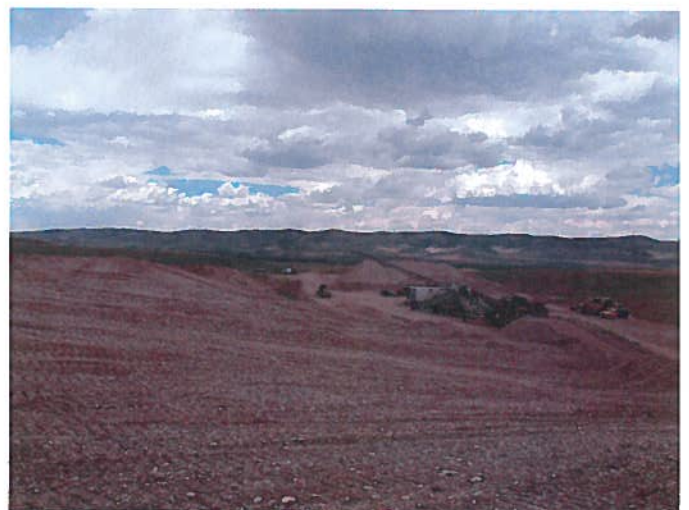
Figure 4: View from on top of the active mine face in the southeast part of the pit, facing northwest.

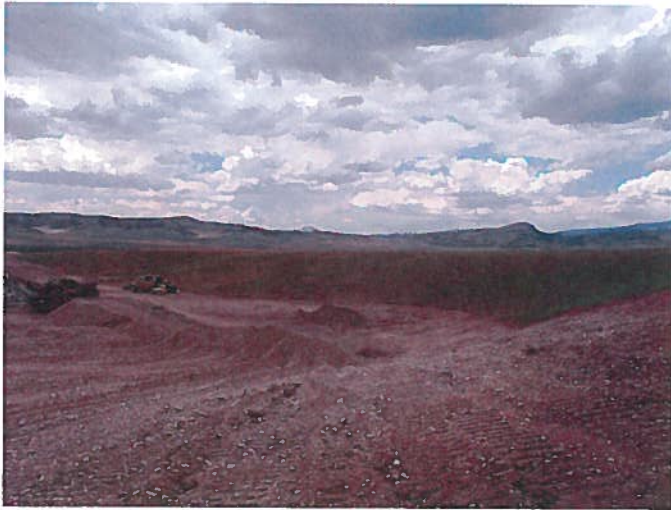
Figure 5: View from on top of the active mine face in the southeast part of the pit, facing north.

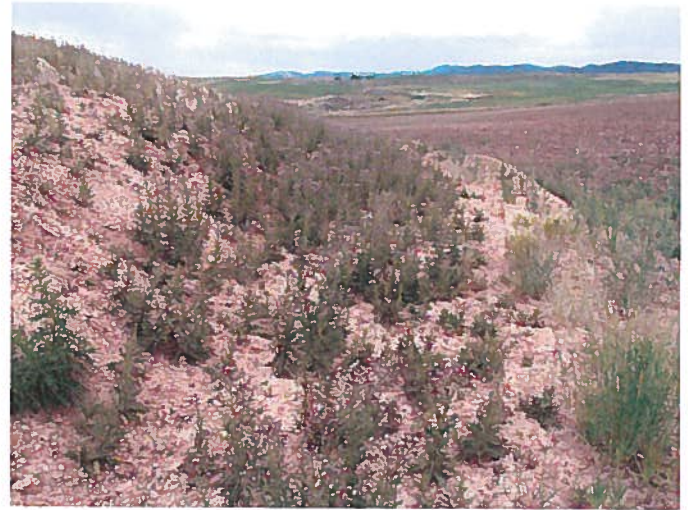
PROBLEM/POSSIBLE VIOLATION: Problem: There are state-listed noxious weeds present on site. This is a problem for failure to employ weed control methods for state listed noxious weed species within the permitted area, and to reduce the spread of weeds to nearby areas as required by Section 3.1.10 (6) of the rule.

A significant infestation of Canada thistle was observed on the overburden stockpile located in the southeast part of the site. These weeds should be treated immediately in order to prevent expansion of the infestation.

Figure 6: Canada thistle infestation on the overburden stockpile in the southeast part of the site.

CORRECTIVE ACTIONS: Implement approved weed control plan and provide proof to the Division that this has been done. If a weed control plan is not already in place, the operator shall develop a weed control and management plan in accordance with Section 3.1.10 (6) of the Rule. This plan should be developed in consultation with the county extension agency, or weed control district office and should include specific control measures to be applied, a schedule for when control measures will be applied and a post-treatment monitoring plan. This weed control plan shall be submitted to the Division as a Technical Revision to the approved plan with the appropriate Technical Revision fee of \$216.00 by the corrective action date.

CORRECTIVE ACTION DUE DATE: 8/12/13
