**COLORADO DIVISION OF RECLAMATION, MINING AND SAFETY
MINERALS PROGRAM INSPECTION REPORT
PHONE: (303) 866-3567**

MINE NAME: Camilletti Pit / Hayden Gravel Pit	MINE/PROSPECTING ID#: M-1987-164	MINERAL: Sand and gravel	COUNTY: Routt
INSPECTION TYPE: Monitoring / Pre-op	INSPECTOR(S): Dustin M. Czapla	INSP. DATE: July 9, 2013	INSP. TIME: 13:00
OPERATOR: Connell Resources, Inc.	OPERATOR REPRESENTATIVE: Tony Connell	TYPE OF OPERATION: 112c - Construction Regular Operation

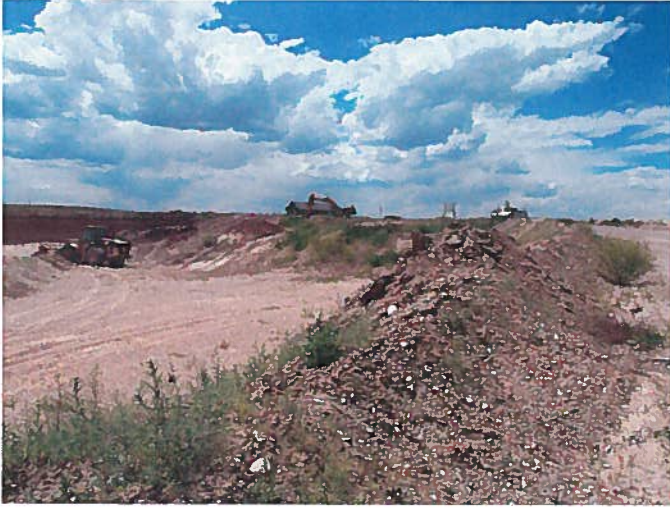
The east part of the permit area has been mined out and mining has progressed westerly through most of the AM-1 area. The pit highwalls are approximately 35 feet high. Except for the active mining area, pit perimeter slopes were approximately 1.5H:1V. Overburden stripped from the active mining area was being placed as backfill along slopes on the south side of the AM-1 area. Ground water was not observed in the bottom of the pit.

Figure 1: View of the west part of the AM-1 area.

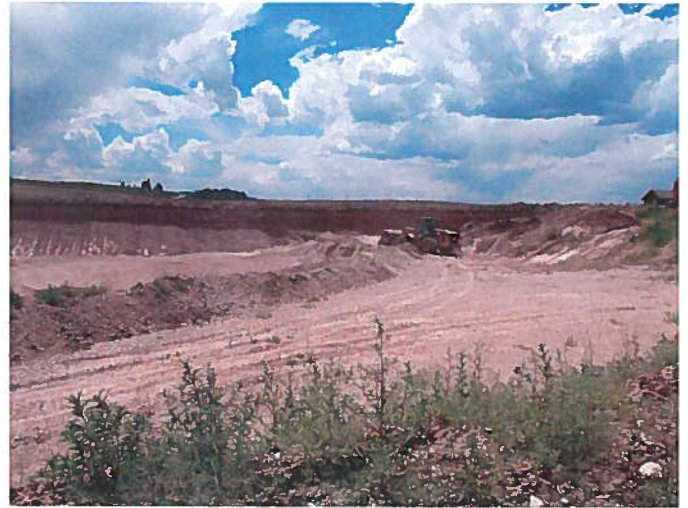
Figure 2: View of the west part of the AM-1 area.

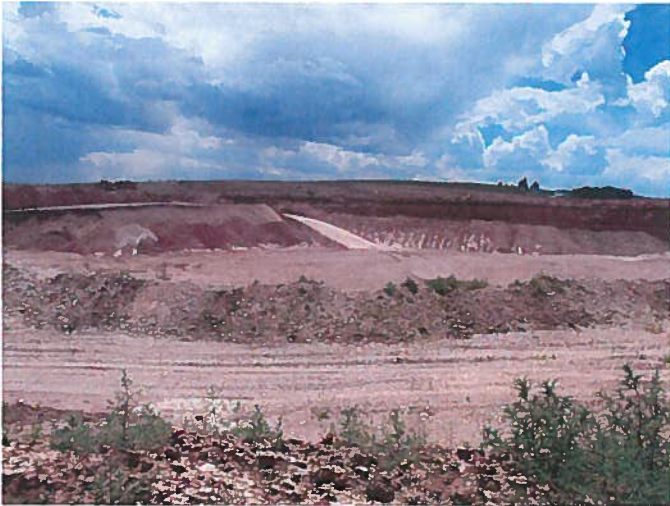
Figure 3: View toward the south highwall in the AM-1 area.

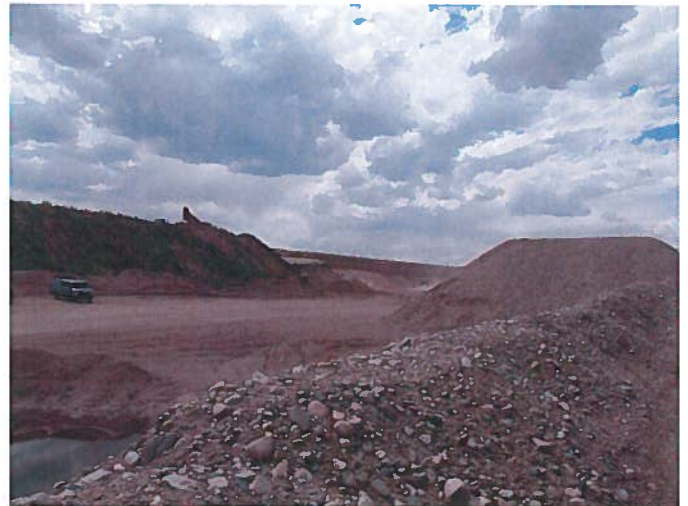
Figure 4: View toward the AM-1 area from the original pit area.

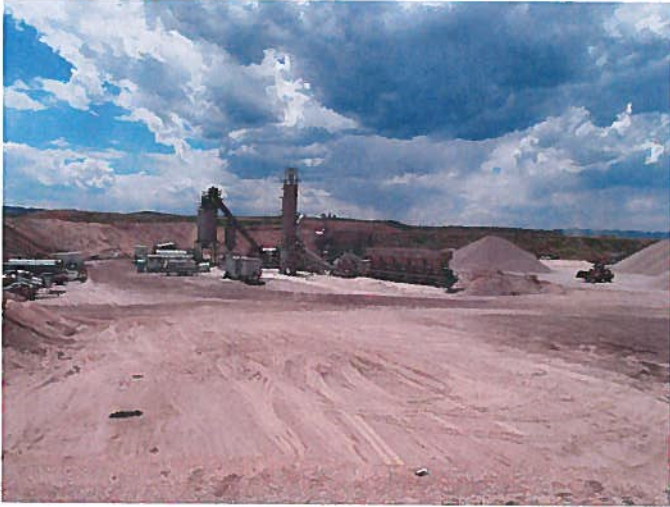
The asphalt plant is located in the eastern part of the Camilletti Pit. Fuel tanks were located on the east side of the plant in appropriate containment structures. All mining related equipment and materials observed at the site appeared to be stored in an orderly manner.

Figure 5: Plant area located in the east part of the pit.

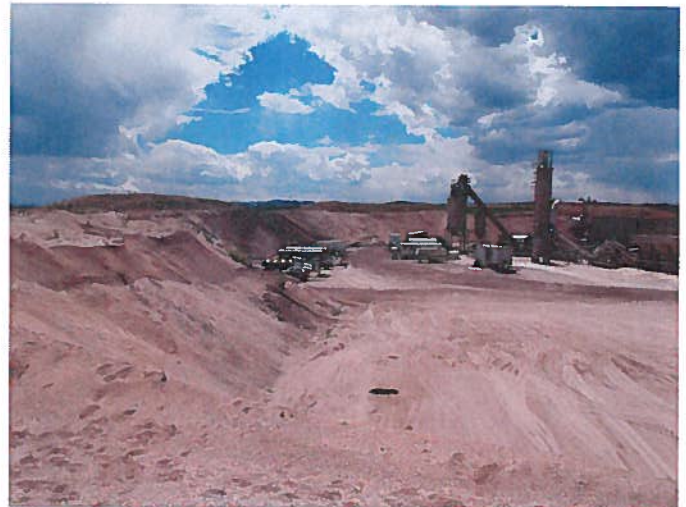
Figure 6: Plant area located in the east part of the pit.

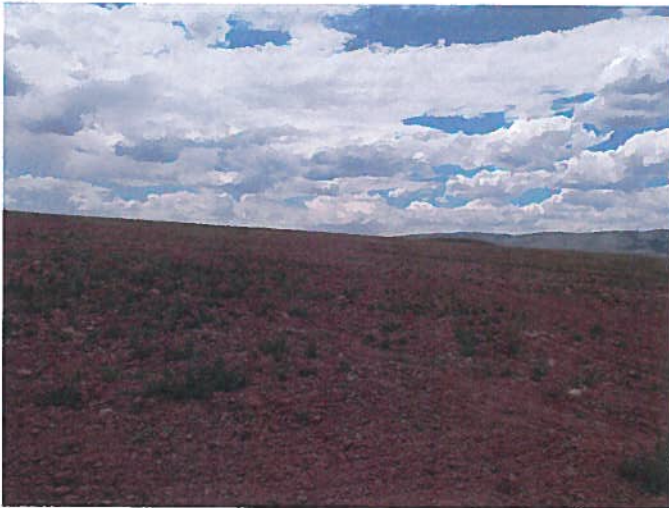
The AM-2 area is located on the east and southeast of the existing pit. The current use of the site is for hay production. At the time of this inspection the field had been recently turned.

Figure 7: Typical conditions observed in the AM-2 area.

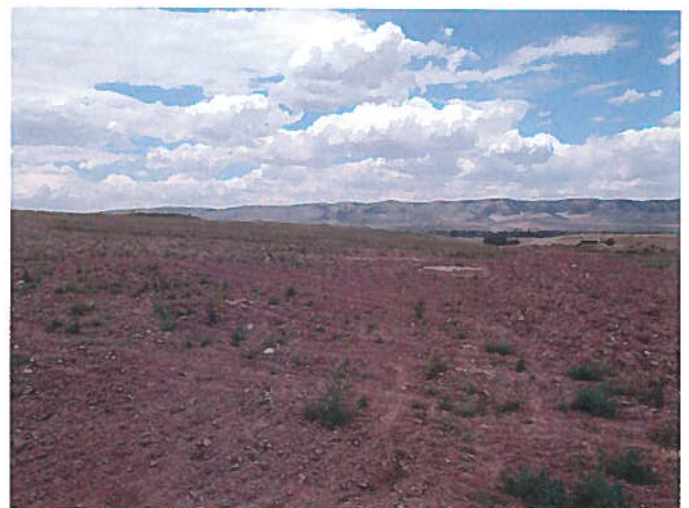
Figure 8: Typical conditions observed in the AM-2 area.
