COLORADO DIVISION OF RECLAMATION, MINING AND SAFETY
MINERALS PROGRAM INSPECTION REPORT
PHONE: (303) 866-3567

MINE NAME: Clayton Sand and Gravel	MINE/PROSPECTING ID#: M-1999-022	MINERAL: Sand and gravel	COUNTY: Saguache
INSPECTION TYPE: Monitoring	INSPECTOR(S): Bob Oswald	INSP. DATE: July 5, 2013	INSP. TIME: 11:30
OPERATOR: Eddie Clayton	OPERATOR REPRESENTATIVE: None	TYPE OF OPERATION: 110c - Construction Limited Impact

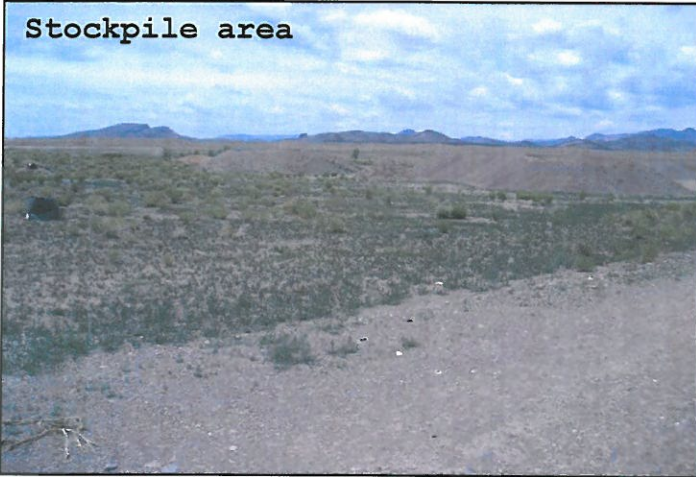
There were several stockpiles of screened and crushed gravel in the stockpile area. All piles are within the marked boundaries of the permit. The equipment ramp into the pond pit is along the south side. The permit is not in final reclamation, but the pond slopes are graded at 3:1 or less, which is in conformance with the approved plan, as well as good for stability and keeping the bond minimized.

Stockpile area

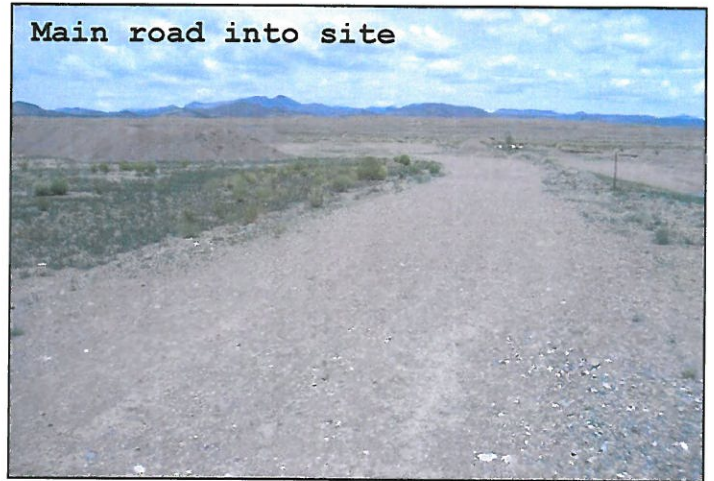
Main road into site

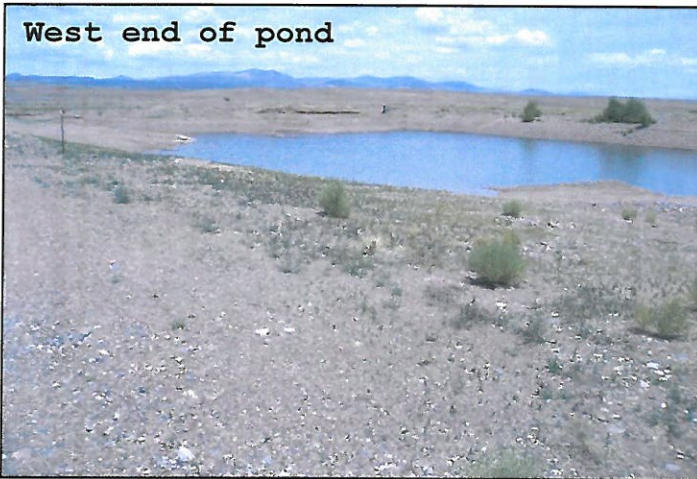
West end of pond

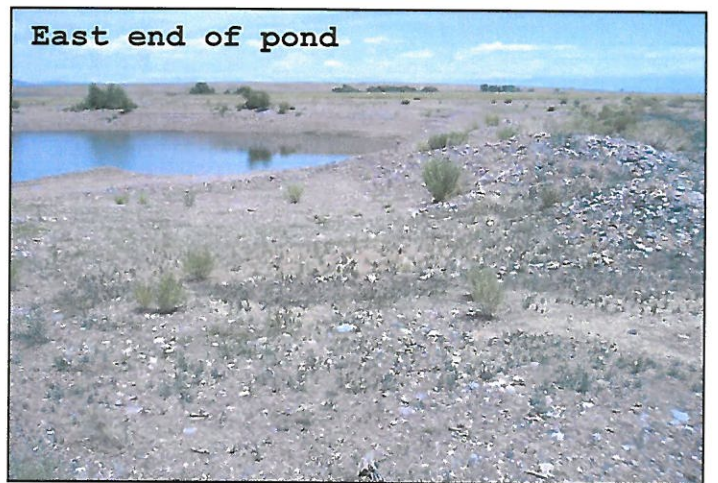
East end of pond

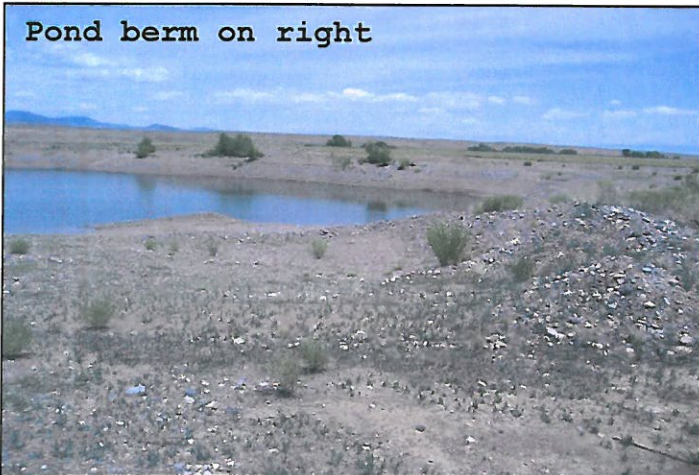
Pond berm on right

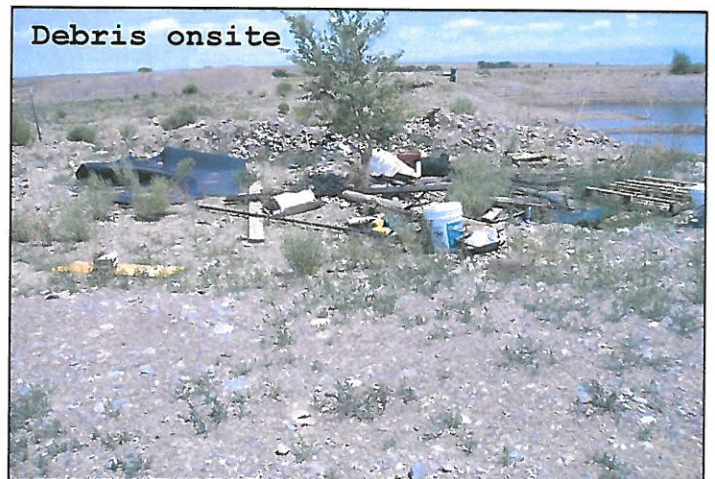
There was no fuel or oil stored on the site. The operator is limiting the amount of debris and contaminants on the site. There was a small accumulation of debris items, including empty oil/hydraulic fluid buckets, above the south slope of the pit (near the elm tree). Please be reminded that the approved plan does not include fuel or oil storage onsite, and that contaminants should be disposed of promptly. Empty oil containers should be removed, before they leak on the soil.

Debris onsite
