COLORADO DIVISION OF RECLAMATION, MINING AND SAFETY
MINERALS PROGRAM INSPECTION REPORT
PHONE: (303) 866-3567

MINE NAME: Bear River S & G	MINE/PROSPECTING ID#: M-1986-040	MINERAL: Sand and gravel	COUNTY: Routt
INSPECTION TYPE: Monitoring	INSPECTOR(S): Dustin M. Czapla	INSP. DATE: July 9, 2013	INSP. TIME: 15:30
OPERATOR: Bear River Sand & Gravel	OPERATOR REPRESENTATIVE: None	TYPE OF OPERATION: 112c - Construction Regular Operation

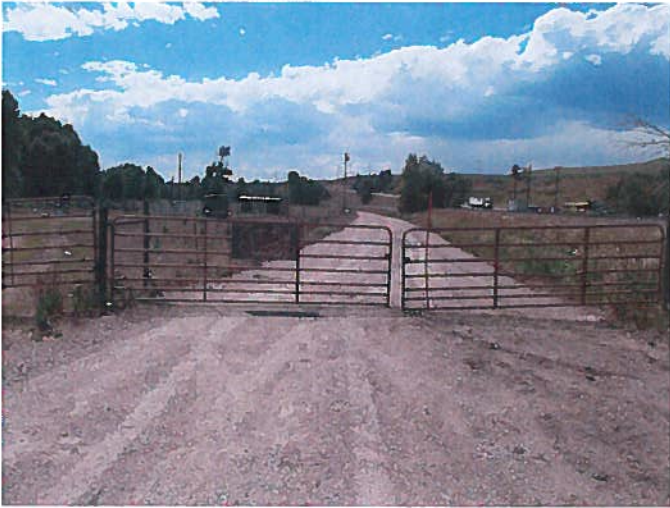
PROBLEM/POSSIBLE VIOLATION: Problem: The mine identification sign was not posted at the entrance of the mine site. This is a problem for failure to post a mine identification sign as required by Section 3.1.12(1) of the Rules.

Adequate mine identification signage was not noted at the entrance to the site. This has been noted as a problem one page one of this report.

Figure 1: A mine identification sign was not placed at the entrance to the site.

CORRECTIVE ACTIONS: The operator shall, at the entrance of the mine site, post a sign which shall be clearly visible from the access road with the following: the name of the operator, a statement that a reclamation permit for the operation has been issued by the Colorado Mined Land Reclamation Board; and the permit number. The operator shall submit photo documentation that a proper sign has been posted by the corrective action date.

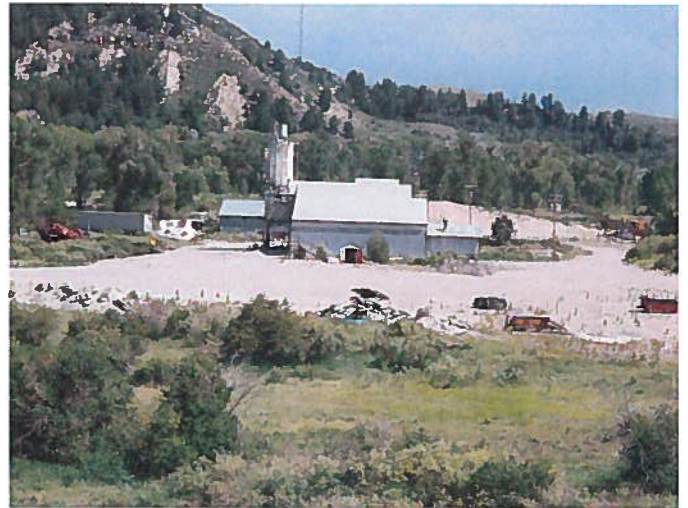
Figure 2: View of the mine from Hwy. 40.

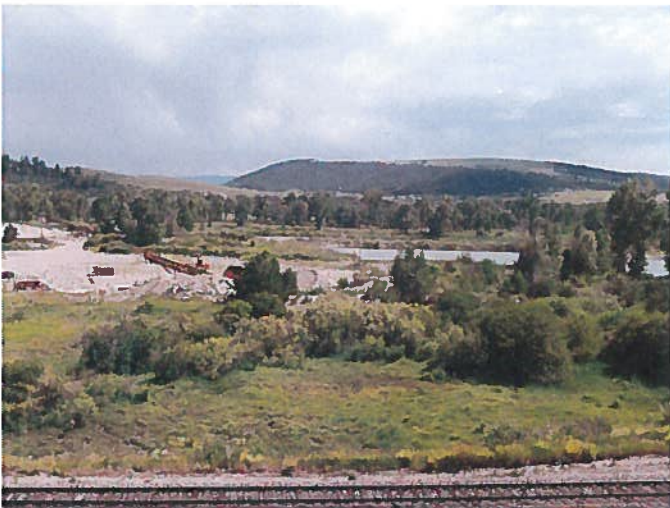
Figure 3: View of the mine from Hwy. 40.

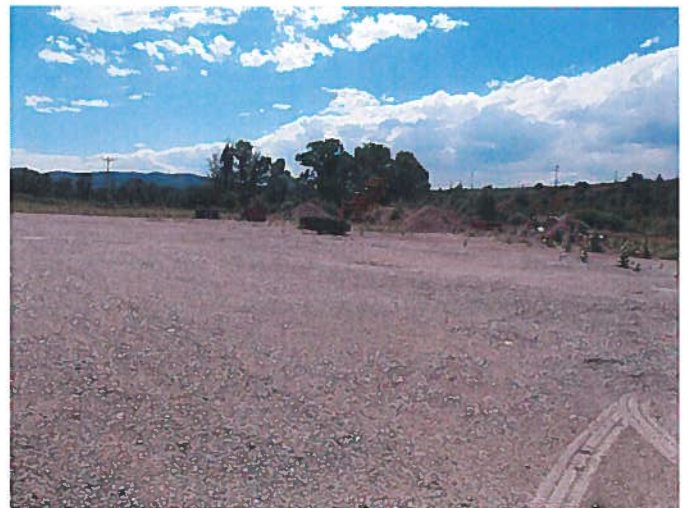
Figure 4: Stockpile area in the north part of the site.

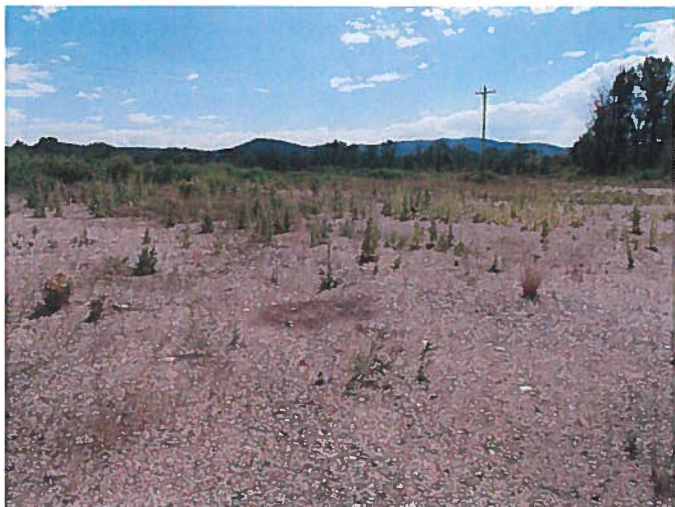
PROBLEM/POSSIBLE VIOLATION: Problem: There are state-listed noxious weeds present on site. This is a problem for failure to employ weed control methods for state listed noxious weed species within the permitted area, and to reduce the spread of weeds to nearby areas as required by Section 3.1.10 (6) of the Rules.

A significant infestation of Common mullein was observed in the stockpile area in the north part of the site. Common mullein, Bull thistle and Canada thistle were also observed in other areas throughout the site. This has been noted as a problem one page one of this report.

Figure 5: Stockpile area in the north part of the site with significant Common mullein infestation.

CORRECTIVE ACTIONS: Implement approved weed control plan and provide proof to the Division that this has been done. If a weed control plan is not already in place, the operator shall develop a weed control and management plan in accordance with Section 3.1.10 (6) of the Rules. This plan should be developed in consultation with the county extension agency, or weed control district office and should include specific control measures to be applied, a schedule for when control measures will be applied and a post-treatment monitoring plan. This weed control plan shall be submitted to the Division as a Technical Revision to the approved plan with the appropriate Technical Revision fee of \$216.00 by the corrective action date.

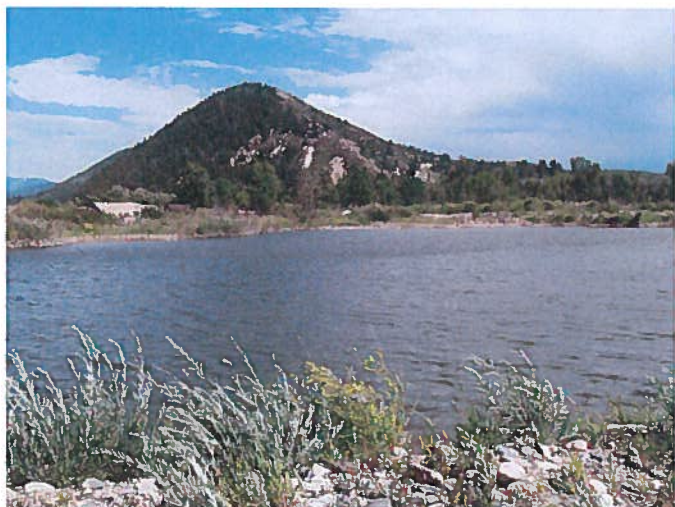
Figure 6: View facing southeast across the east pond.

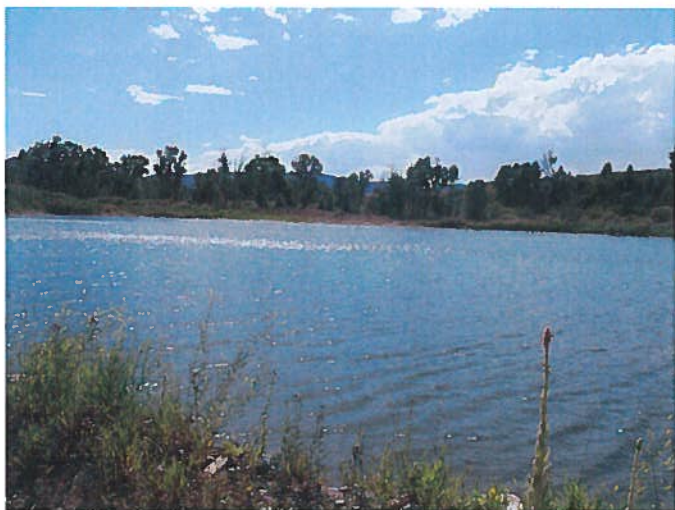
Figure 7: View facing west across the west pond.

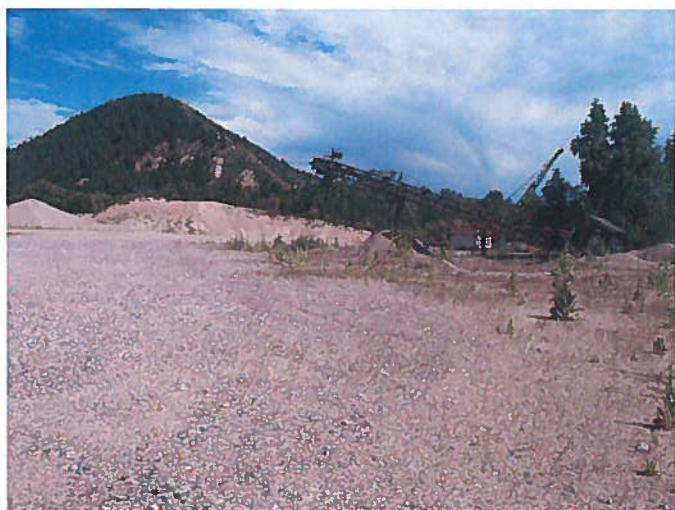
Figure 8: Processing/storage area on the south side of the buildings.
