**COLORADO DIVISION OF RECLAMATION, MINING AND SAFETY**  
**MINERALS PROGRAM INSPECTION REPORT**  
**PHONE: (303) 866-3567**

<b>MINE NAME:</b> Gardner Gravel Pit	<b>MINE/PROSPECTING ID#:</b> M-1979-034	<b>MINERAL:</b> Sand and gravel	<b>COUNTY:</b> Routt
<b>INSPECTION TYPE:</b> Monitoring	<b>INSPECTOR(S):</b> Dustin M. Czapla	<b>INSP. DATE:</b> July 10, 2013	<b>INSP. TIME:</b> 09:00
<b>OPERATOR:</b> General Operating Company	<b>OPERATOR REPRESENTATIVE:</b> Mike Gomez	<b>TYPE OF OPERATION:</b> 112c - Construction Regular Operation

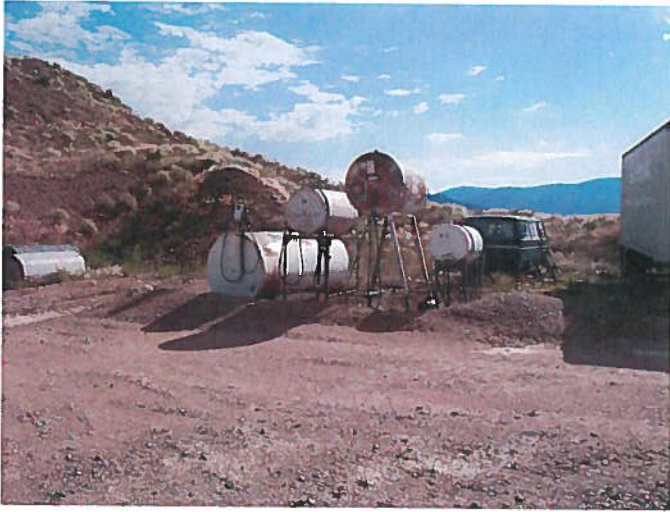
**PROBLEM/POSSIBLE VIOLATION:** Problem: Improper storage and containment of fuels and/or other hazardous materials was present on site.

Fuel tanks located in the northeast part of the mine bench lacked any secondary containment. Also, used oil containers located near the scale house have leaked a small amount of oil onto the underlying soil. The containers shall be stored in adequate containment or removed from the site. This has been noted as a problem on page one of this report.

Figure 1: Fuel containers located in the northeast part of the upper bench in a bermed, but unlined containment.

**CORRECTIVE ACTIONS:** All storage tanks, petroleum and any hazardous materials on site for any period of time shall have appropriate secondary containment. The site will also have to comply with all applicable SPCC requirements. Please supply photo documentation that any fuel or hazardous materials containers are stored properly - including applicable secondary containment structures by the corrective action date. Note that secondary containment structures shall consist of an impermeable containment which could contain all contents of the tanks and various containers (when full) plus 10% of the total capacity. The operator may also provide photo documentation that all containers have been removed from the site on or before the corrective action date.

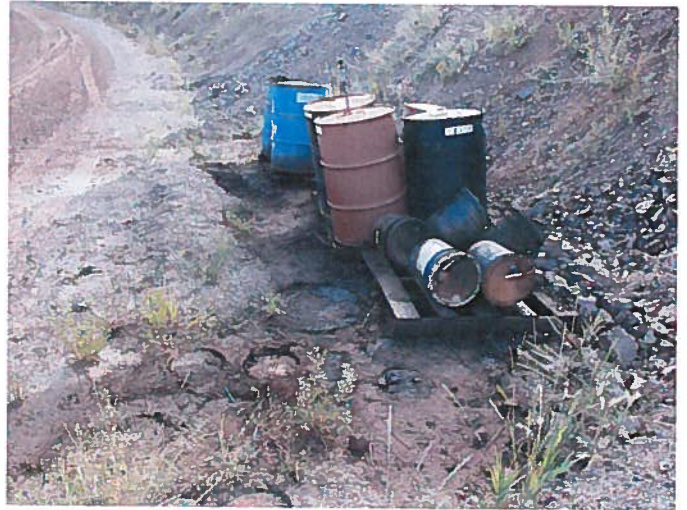
Figure 2: Oil containers located near the scale house.

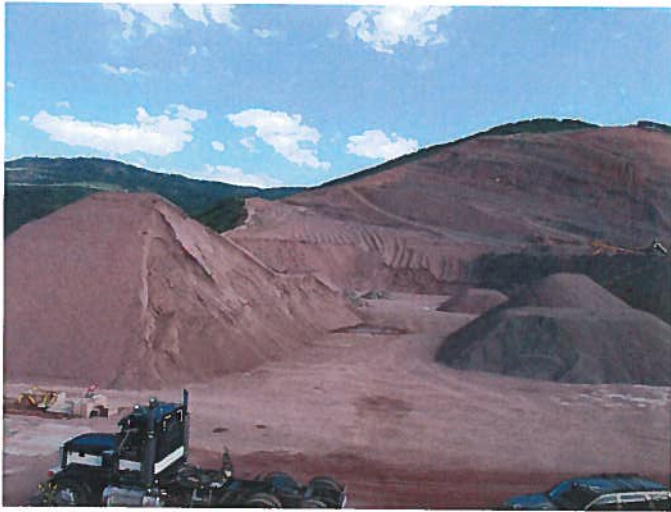
The slope of the active mine face is being maintained at approximately 1H:1V, which is consistent with the approved mine plan. Signs of instability or excessive erosion were not noted during this inspection.

Figure 3: View toward the mine face from near the scale house.

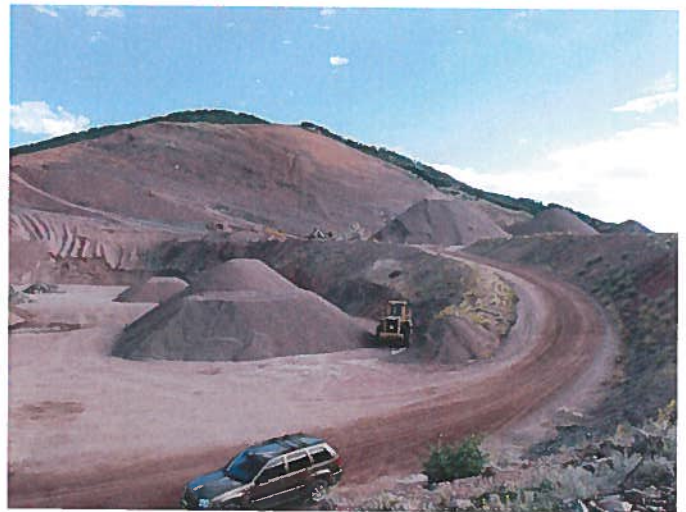
Figure 4: View toward the mine face from near the scale house.
