COLORADO DIVISION OF RECLAMATION, MINING AND SAFETY
MINERALS PROGRAM INSPECTION REPORT
PHONE: (303) 866-3567

MINE NAME: Pepper Pit	MINE/PROSPECTING ID#: M-2011-034	MINERAL: Sand & borrow matl	COUNTY: Rio Grande
INSPECTION TYPE: Monitoring	INSPECTOR(S): Bob Oswald	INSP. DATE: July 5, 2013	INSP. TIME: 13:00
OPERATOR: Cooley & Sons Excavating, Inc.	OPERATOR REPRESENTATIVE: None	TYPE OF OPERATION: 110c - Construction Limited Impact

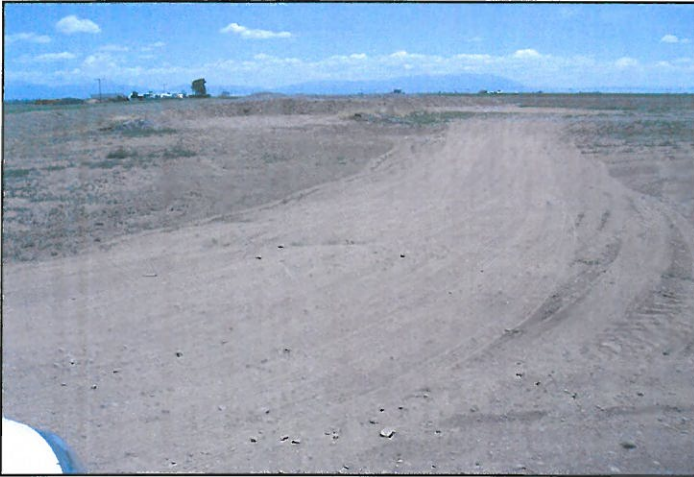
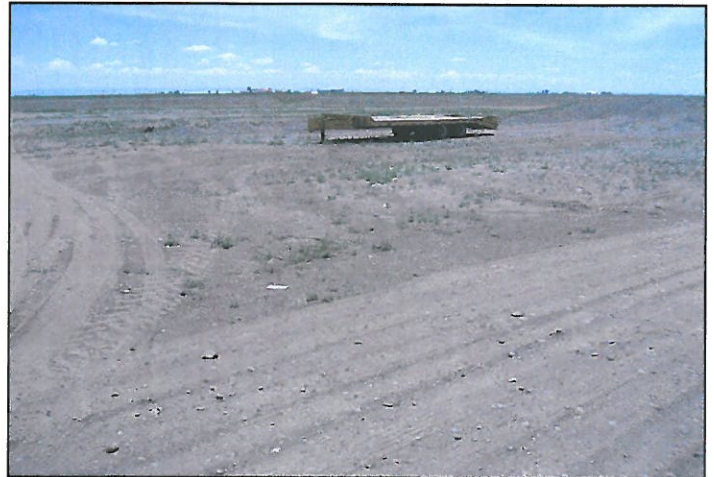
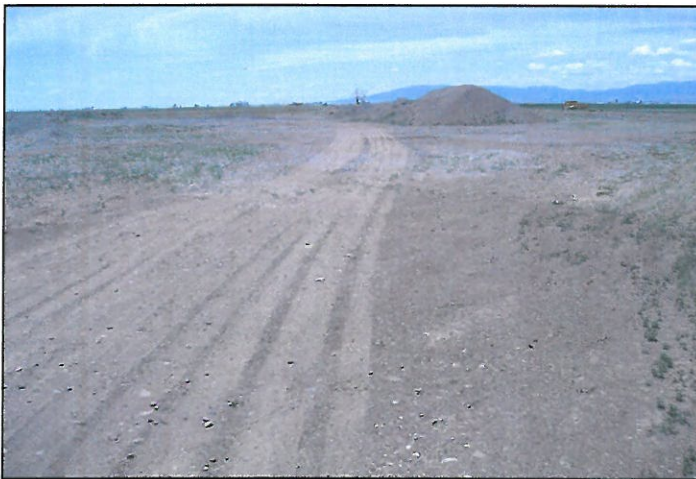
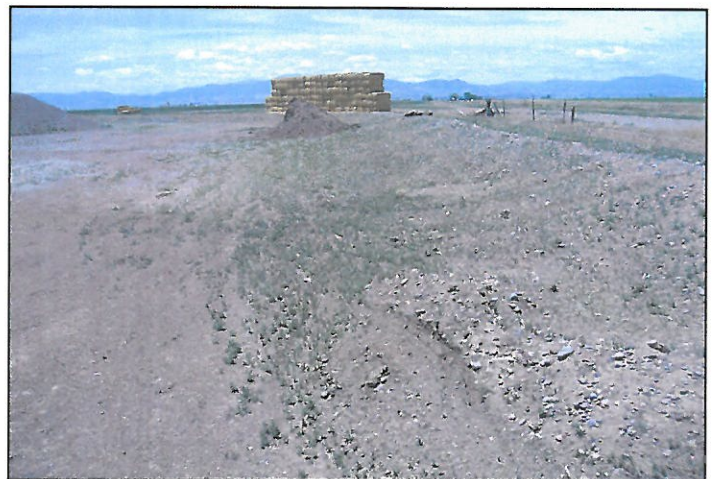
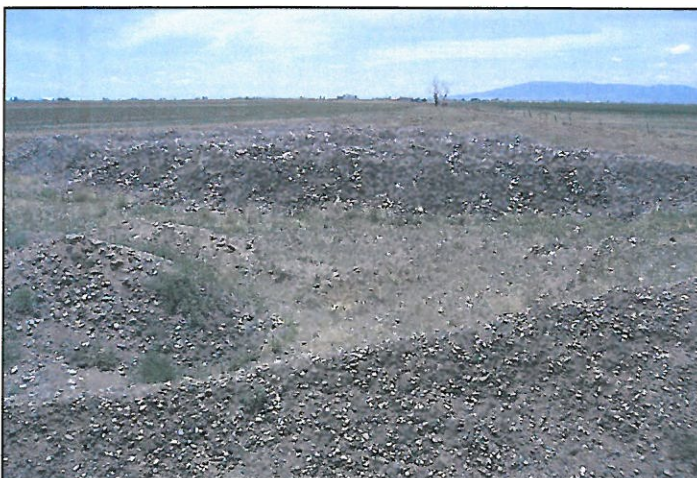
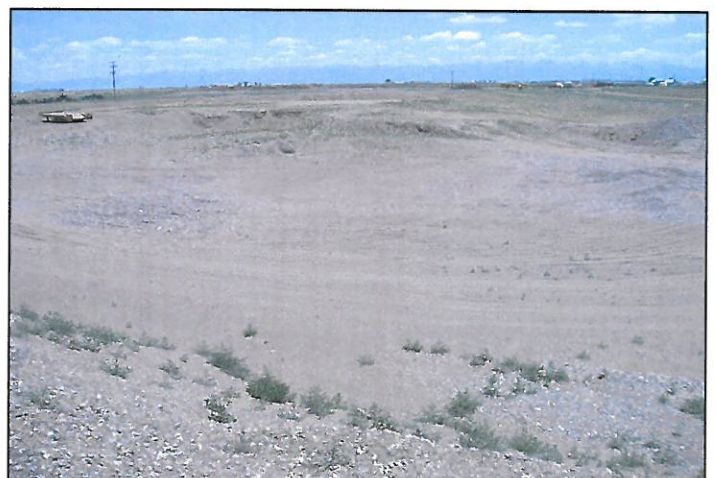
PHOTOGRAPHS

The site is being excavated to create a recharge pit for the landowner/farmer. The site occupies an unirrigated field corner adjacent to a county road. There is no entrance gate and the site was accessible. There was no equipment at the site except a 30-foot flatbed trailer. Most of the site has been excavated to a depth of about 2 to 3 feet. There was a 500-cu yd stockpile of crushed gravel, and smaller piles of pitrun, "potato rock," and soil. A smaller area on the east-central part of the site does not appear to have been excavated yet. The pit may be excavated considerably deeper if additional capacity for the pond is desired.

Topsoil was stripped from the affected area and a low-profile topsoil berm was constructed around the entire pit perimeter. The berm will function to help contain the (post-mining) recharge water that will occasionally fill the pit. The berm therefore is to remain as a permanent structure, according to the plan. It can also be considered to be the operator's method of marking the permit boundary.
