COLORADO DIVISION OF RECLAMATION, MINING AND SAFETY
MINERALS PROGRAM INSPECTION REPORT
PHONE: (303) 866-3567

MINE NAME: Taylor Pit	MINE/PROSPECTING ID#: M-2013-006	MINERAL: Limestone (general)	COUNTY: Moffat
INSPECTION TYPE: Monitoring	INSPECTOR(S): Stephanie J. Reigh	INSP. DATE: July 24, 2013	INSP. TIME: 12:00
OPERATOR: RNP Enterprises, Inc	OPERATOR REPRESENTATIVE: Rusty Taylor and Steve Baker	TYPE OF OPERATION: 110c - Construction Limited Impact

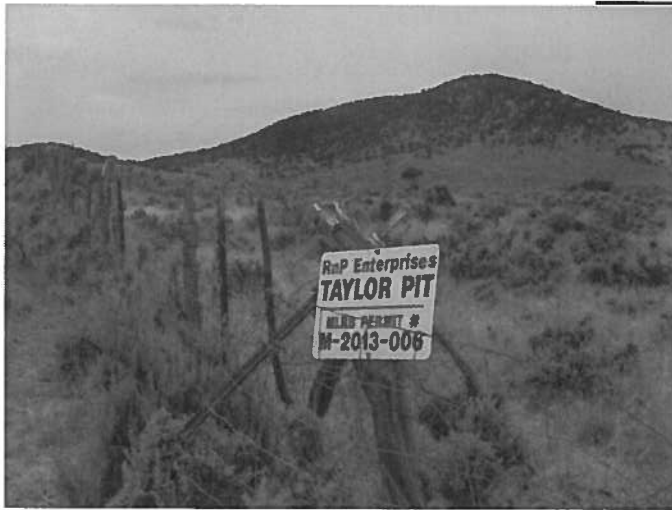
The proper mine identification sign was posted at the entrance of the mine site and the permit boundaries were marked with stakes. Equipment on site consisted of a dozer, grader, two loaders, a track hoe, grizzly screener, water truck and a screening plant. There was also a fuel tank on site. The tank had a secondary containment system, which is adequate according to the Division's rules. Silt fence was present at the site on the north and west boundaries of the permit area. On the northern boundary, the Division recommends re-installation of silt fence to be keyed in at the bottom. There were some portions of the fence that appeared to be installed incorrectly. Topsoil stockpiles were not presently seeded, as the mining operation recently started. The Division recommends topsoil stockpiles to be seeded in the fall of 2013.

Mine Identification Sign

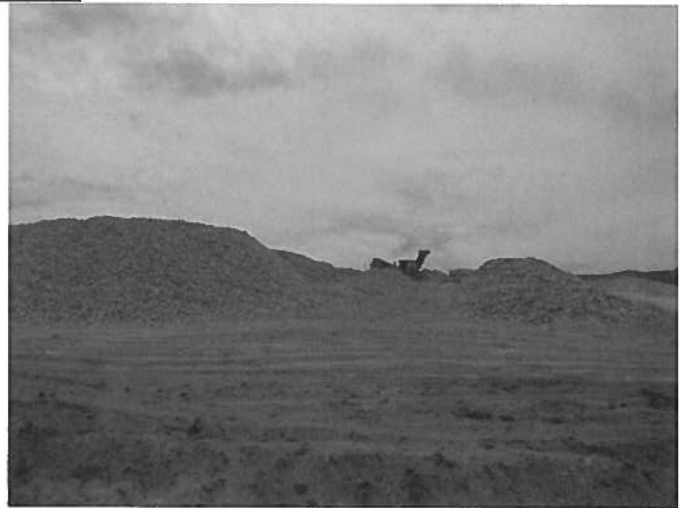
Screened Limestone Material

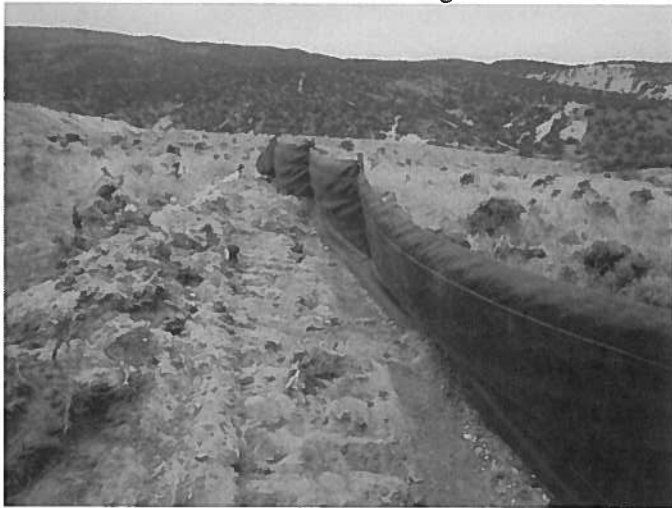
Silt Fence on Northern Boundary

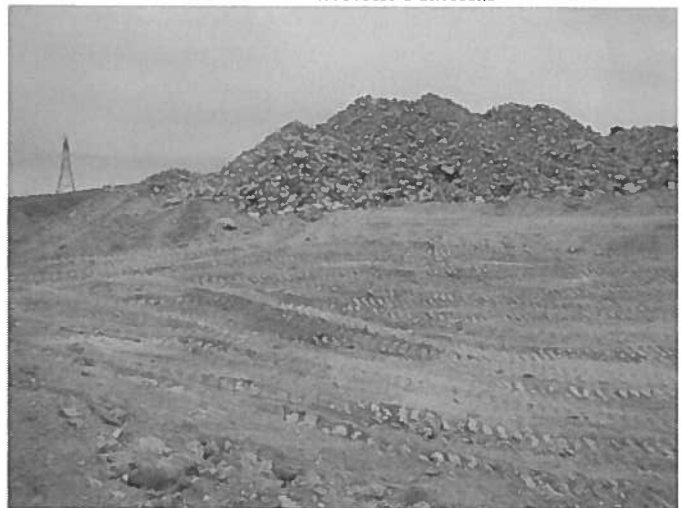
Material Sockpiles

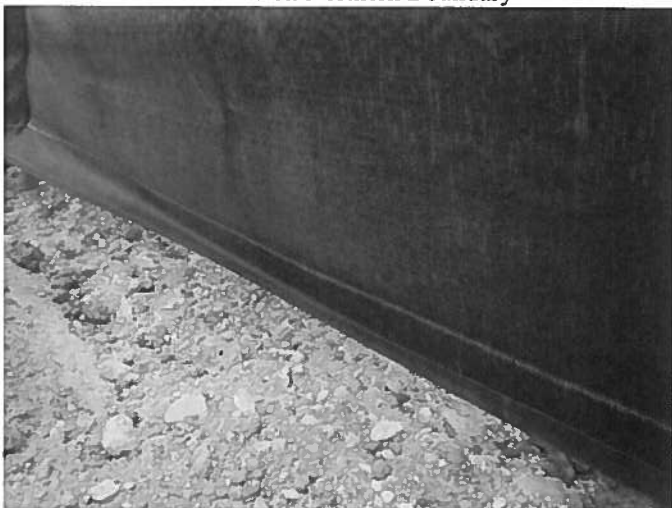
Portions of silt fence not adequately installed

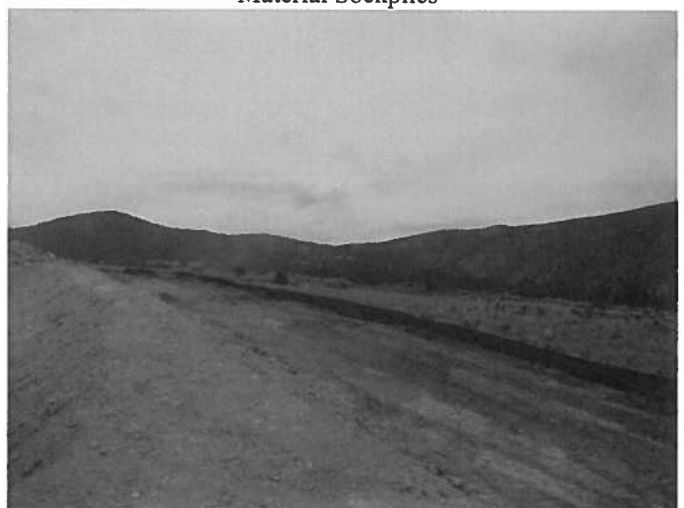
Topsoil Stockpile berm

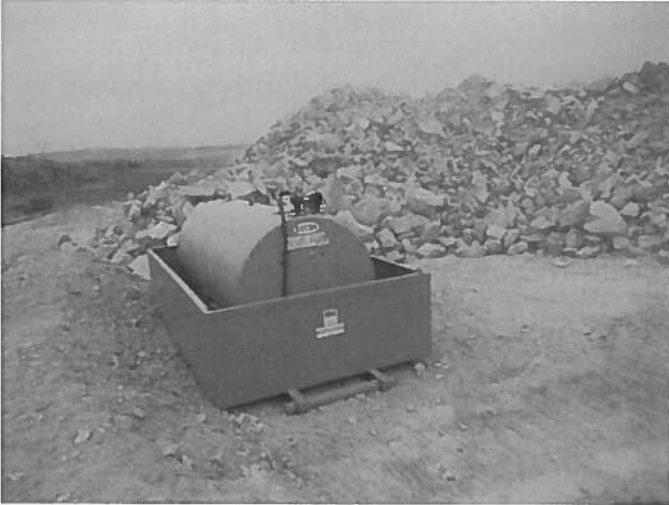
Fuel Tank on site

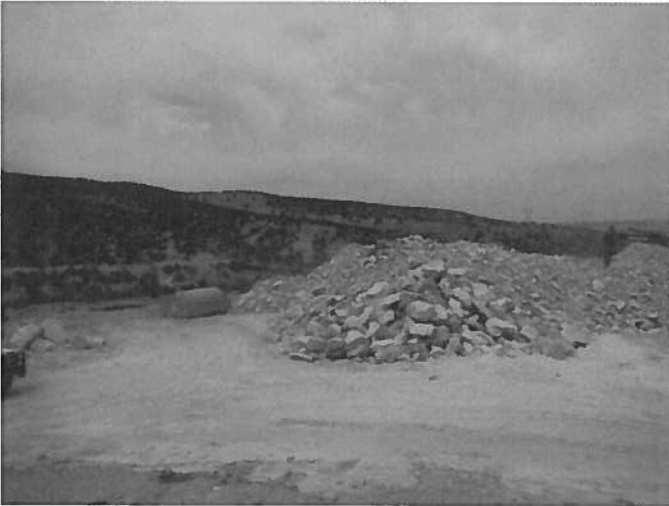
Looking at site NW
