COLORADO DIVISION OF RECLAMATION, MINING AND SAFETY COAL PROGRAM INSPECTION REPORT

Permit Number: C-1981-028 Mine Name: Keenesburg Strip Mine Operator: Coors Energy Company Operator Address: Mr Benjamin Moline P.O. Box 4030 Suite 400 Golden, CO 80401	County: Weld Operation Type: Surface Permit Status: Active Ownership: Private
	Operator Representative Present: Danny Kipp
Operator Representative Signature: (Field Issuance Only)

Inspection Start Date: July 18, 2013 Inspection Start Time: 09:45 Inspection End Date: July 18, 2013 Inspection End Time: 10:45	Inspection Type: Coal Partial Inspection Inspection Reason: Normal I&E Program Weather: Clear
Joint Inspection Agency: None	Joint Inspection Contacts:
Post Inspection Agency: None	Post Inspection Contacts:
Inspector(s): Susan L. Burgmaier	Inspector's Signature: <i>Susan Burgmaier</i> Signature Date: 7/18/2013

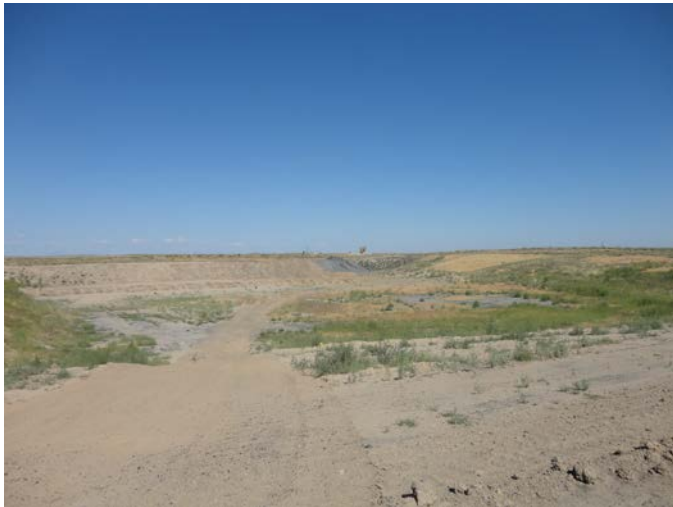
The dugout pond and sediment pond were both dry. The B-Pit floor was also dry.

Open area of B-Pit, north end

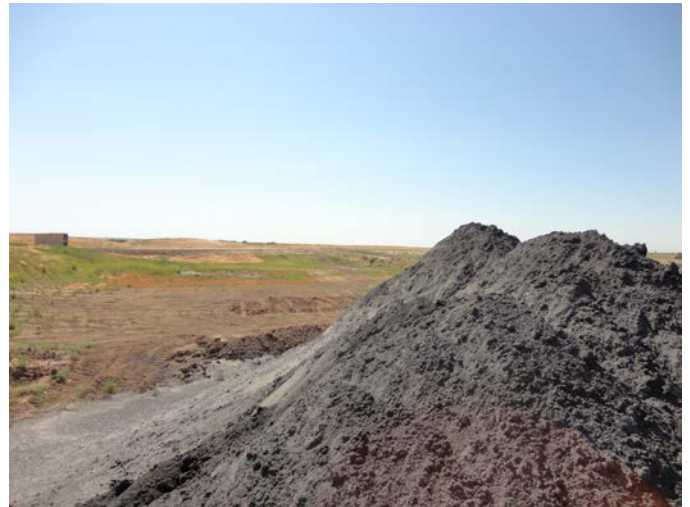
This was a partial inspection of the Keenesburg Mine conducted by Susan Burgmaier of DRMS. Danny Kipp of Coors Energy Company was present during the inspection. Weather conditions were clear and warm; ground conditions were dry. Ash disposal was underway in the B-Pit, in the lower lift of the northernmost portion of the pit.

No fugitive dust was observed during the inspection. A light breeze was blowing at the time of the inspection, but ash in the B-Pit area was not being transported due to its moisture content.

Ash disposal in B-Pit

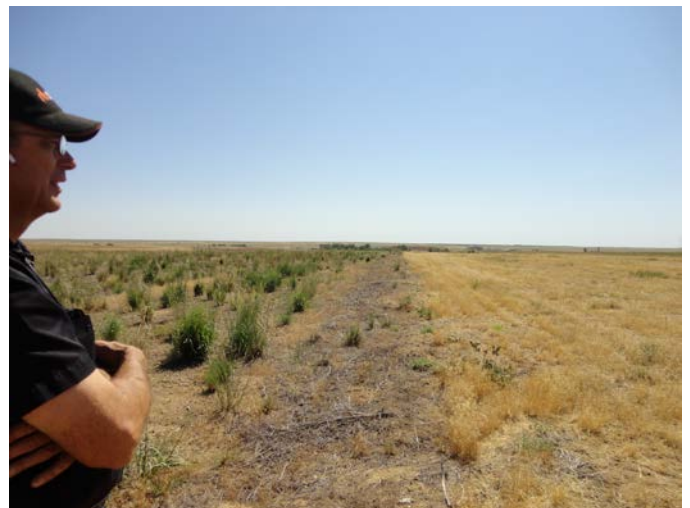
Parcel 30 was treated last fall with a pre-emergent herbicide to target cheatgrass. Parcel 30 had very little cheatgrass; there were a few strips that appeared to coincide with areas that were not overlapped when sprayed. Parcel 29 had not been sprayed, and had significant cheatgrass cover.

Parcel 30 on left, Parcel 29 on right

that have been Phase III bond released and areas that are undisturbed. Prior to spraying these areas, the operator should submit a minor revision to the permit application package to clarify plans for weed management practices on undisturbed and bond released areas within the permit area.
