COLORADO DIVISION OF RECLAMATION, MINING AND SAFETY COAL PROGRAM INSPECTION REPORT

Permit Number: C-1981-035 Mine Name: King Coal Mine Operator: GCC Energy, LLC Operator Address: Mr. Tom Bird 6473 County Road 120 Hesperus, CO 81326	County: La Plata Operation Type: Underground Permit Status: Active Ownership: Federal
	Operator Representative Present: None (Aerial Inspection)
Operator Representative Signature: (Field Issuance Only) This report was issued electronically from the Division's Durango Field Office.

Inspection Start Date: July 23, 2013 Inspection Start Time: 13:40 Inspection End Date: July 23, 2013 Inspection End Time: 13:42		Inspection Type: Aerial Inspection Inspection Reason: Normal I&E Program Weather: Cloudy	
Joint Inspection Agency: None		Joint Inspection Contacts:	
Post Inspection Agency: None		Post Inspection Contacts:	
Inspector(s): Marcia L. Talvitie, P.E.	Inspector's Signature:

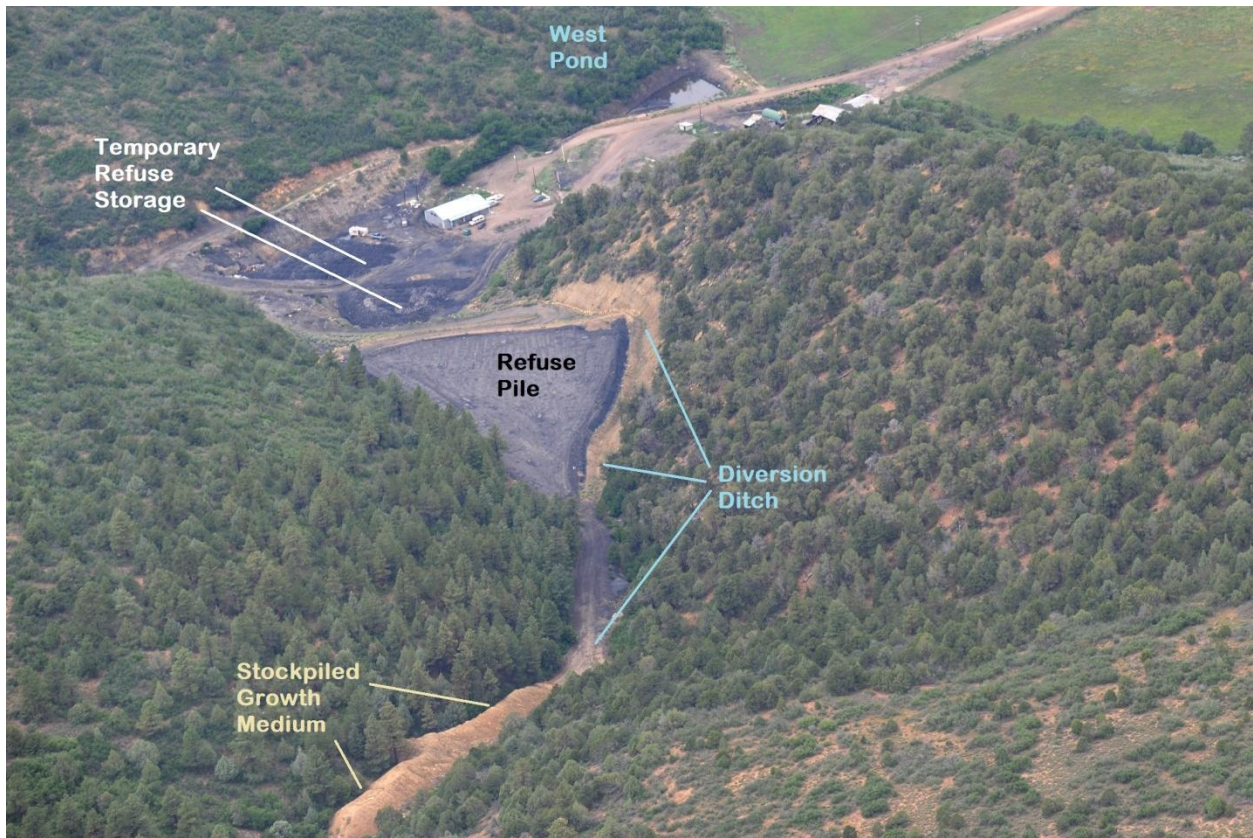
- Coal mine waste (CMW) from the King I, and now the King II mines is approved for permanent disposal in a valley fill refuse pile at the King I surface facilities.
- It appears that all of the CMW hauled to the top of the refuse pile has been distributed and compacted. A number of dumped loads of CMW could be seen in the former yard area, below.
- Soil material generated during the 2012 placement and compaction campaign was stored in the valley, up-gradient of the refuse pile.
- It appears that the clear water diversion ditch is in place, and functional

King I Refuse Pile, looking west

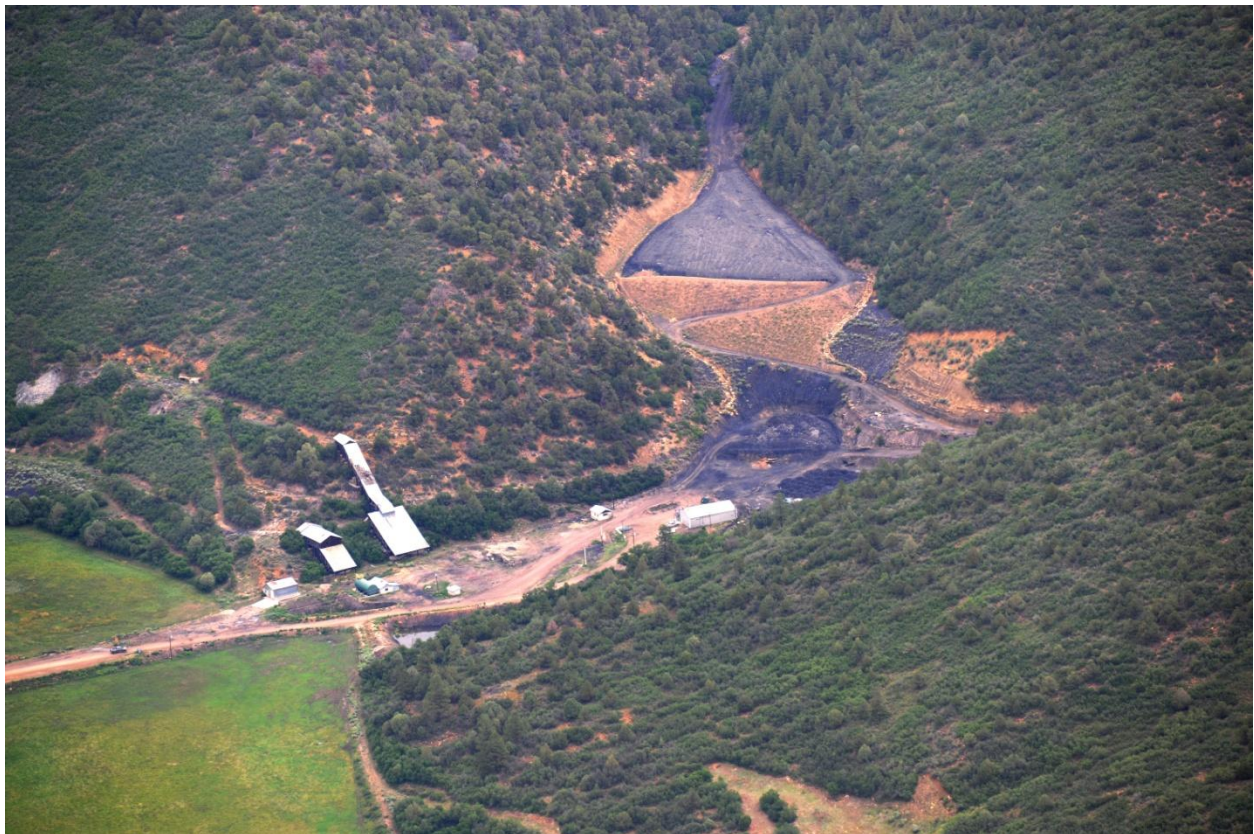
King I Refuse Pile, looking east

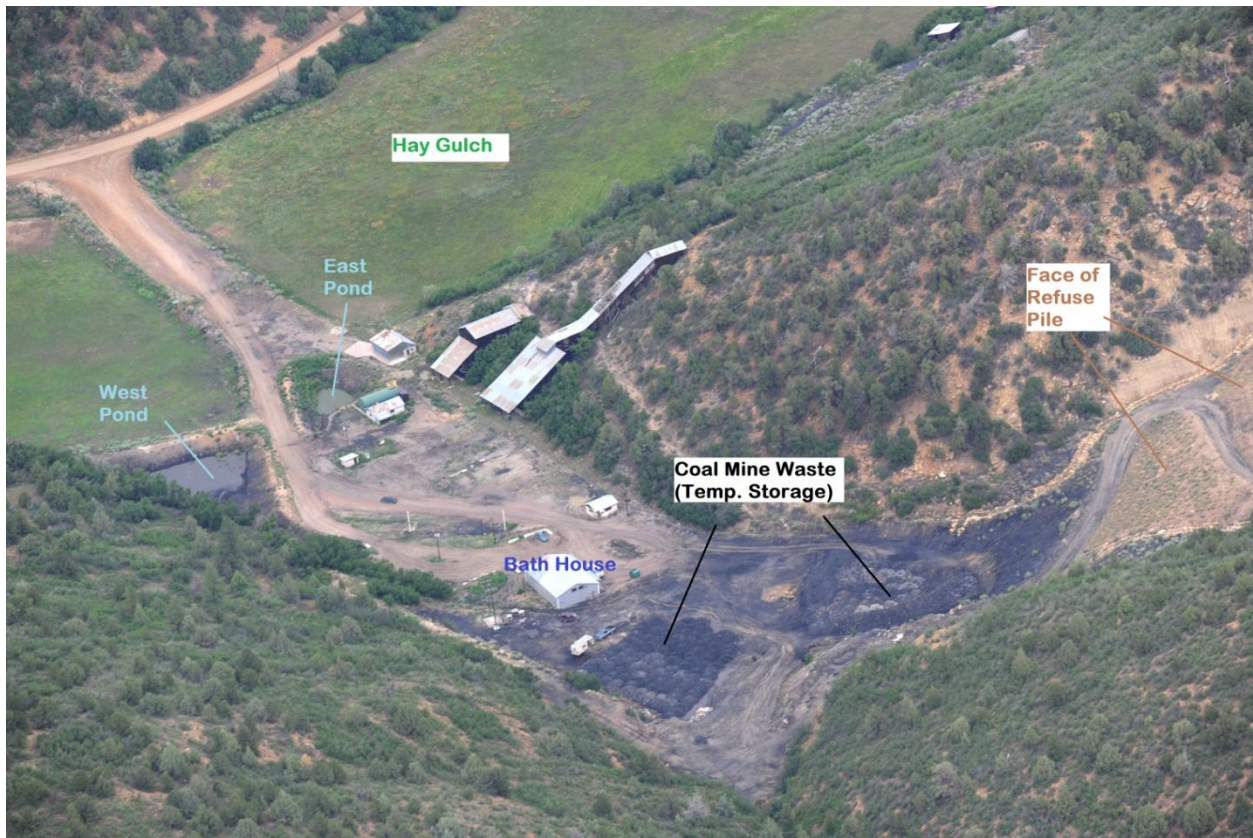
King I surface facilities

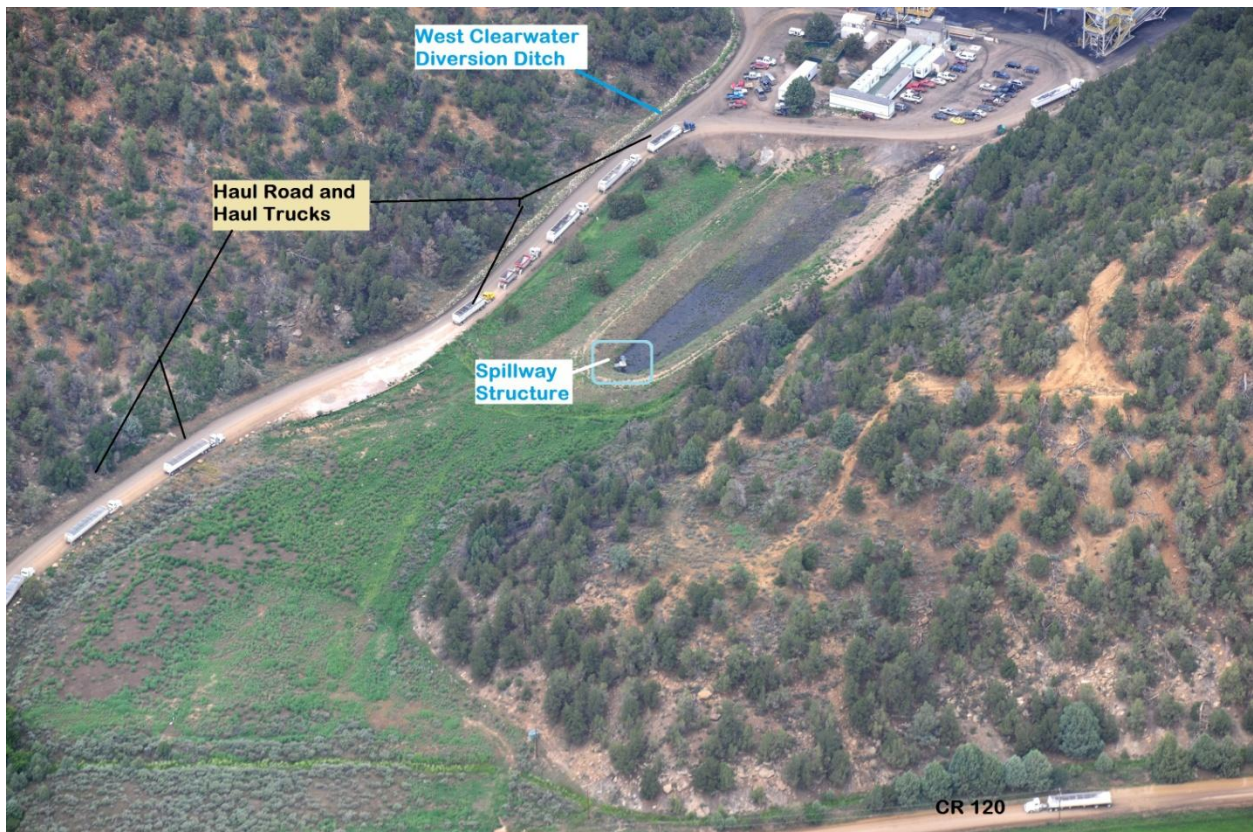
- The area appears to have been receiving some rain recently, as evidenced by the water present in the King I West and East Sedimentaion Ponds and a small amount in the King II Sedimentation Pond.

- Two topsoil stockpiles have been constructed at King II: a small pile between the sediment pond and the haul road, and a larger pile in the eastern tributary valley.

King II pond and haul road

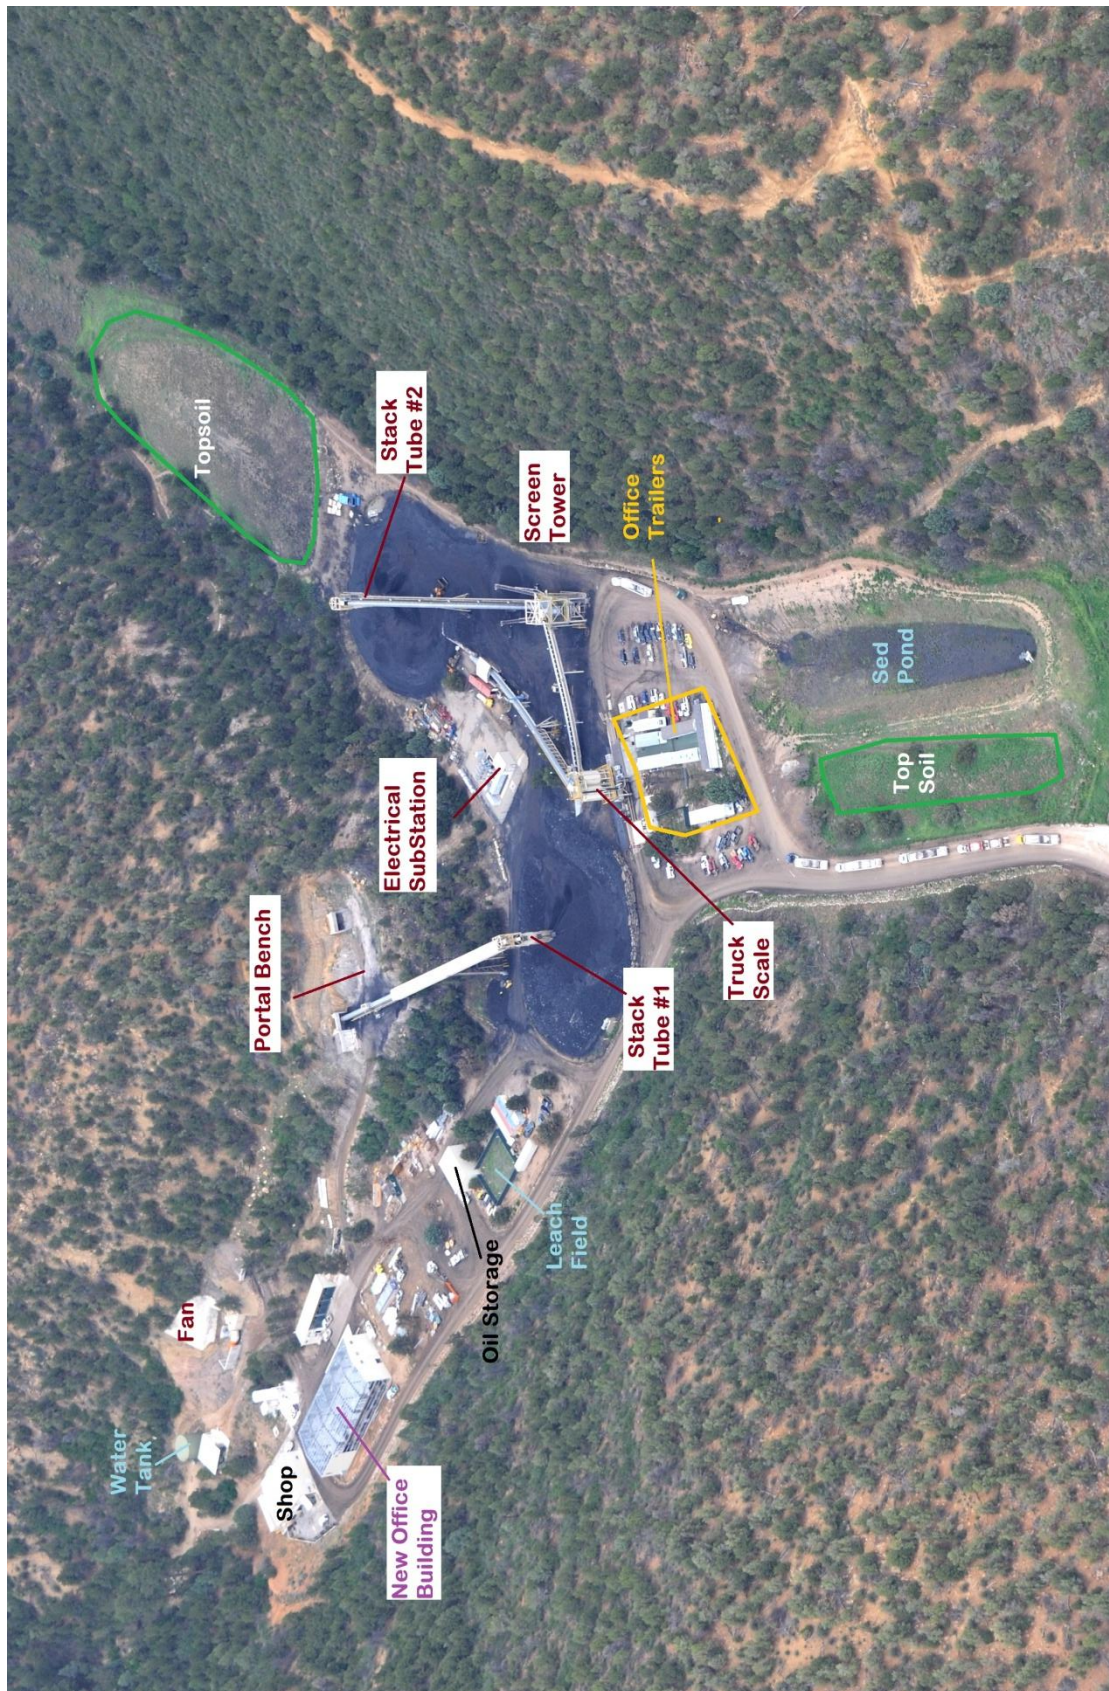
- The King II surface facilities appear neat and in order.
- Substantial progress has been made in the construction of the new office / bath house building.
- A number of highway haul trucks were lined up at King II, waiting to be loaded at the scale.

King II surface facilities, looking North
