## COLORADO DIVISION OF RECLAMATION, MINING AND SAFETY COAL PROGRAM INSPECTION REPORT

<b>Permit Number:</b> C-1996-083 <b>Mine Name:</b> Bowie No. 2 Mine <b>Operator:</b> Bowie Resources, LLC <b>Operator Address:</b> Mr William A Bear P.O. Box 483 Paonia, CO 81428	<b>County:</b> Delta <b>Operation Type:</b> Underground <b>Permit Status:</b> Active <b>Ownership:</b> Federal and Forest
	<b>Operator Representative Present:</b>  None Present - Aerial Inspection
<b>Operator Representative Signature:</b> (Field Issuance Only)

<b>Inspection Start Date:</b> July 23, 2013 <b>Inspection Start Time:</b> 11:29 <b>Inspection End Date:</b> July 23, 2013 <b>Inspection End Time:</b> 11:31	<b>Inspection Type:</b> Aerial Inspection <b>Inspection Reason:</b> Normal I&E Program <b>Weather:</b> Clear
<b>Joint Inspection Agency:</b>  None	<b>Joint Inspection Contacts:</b>
<b>Post Inspection Agency:</b>  None	<b>Post Inspection Contacts:</b>
<b>Inspector(s):</b>  Susan L. Burgmaier  Harry B. Ranney	<b>Inspector's Signature:</b>  <i>Susan Burgmaier</i>  <b>Signature Date:</b>  07/29/2013

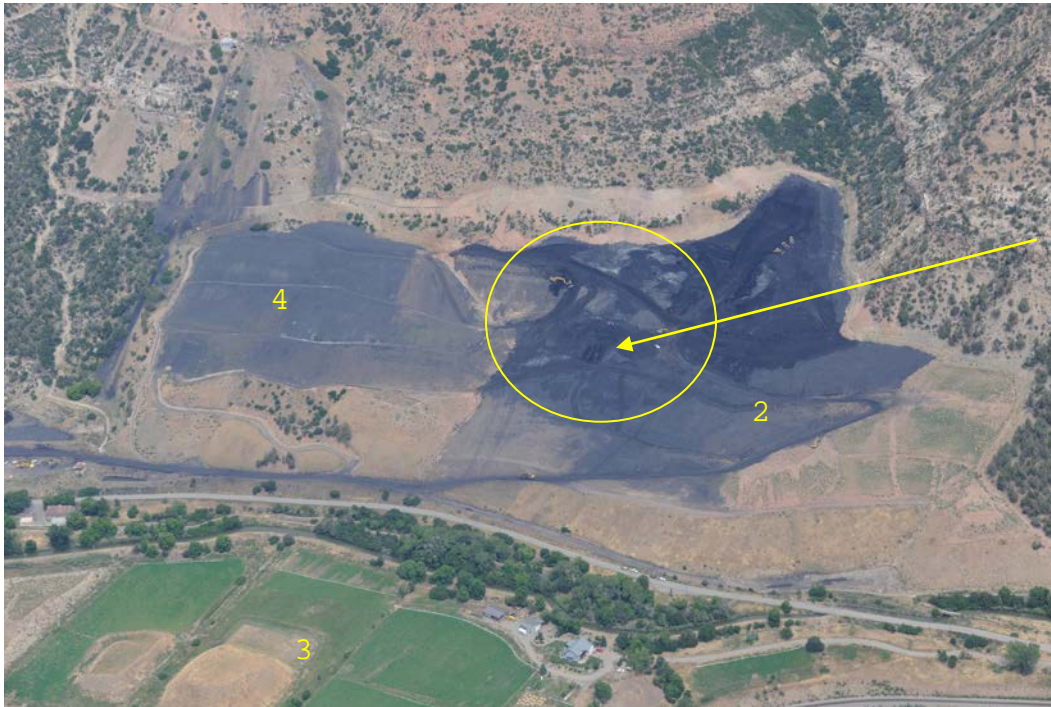
Gob Piles 2, 3,  
and 4

Gob material was being hauled to Gob Pile #2. An excavator was working the expansion area between Gob Piles #2 and #4, and compactors were working on the northeastern portion of Gob Pile #2. No standing water was observed on the refuse areas. There is still a considerable amount of material to be graded and compacted in the central area of Gob Pile #2, but the operator has made significant progress on getting the pile into compliance.

Area remaining to  
be graded and  
compacted

Abatement Description: Place and compact all existing end-dumped material on Gob Pile #2 in accordance with the Rules and approved permit application package.
