**COLORADO DIVISION OF RECLAMATION, MINING AND SAFETY  
COAL PROGRAM INSPECTION REPORT**

<b>Permit Number:</b> C-1992-080 <b>Mine Name:</b> Carbon Junction Mine <b>Operator:</b> Oakridge Energy, Inc. <b>Operator Address:</b> Mr. Michael S Savage 4610 Haystack Drive Windsor, CO 80550	<b>County:</b> La Plata <b>Operation Type:</b> Surface <b>Permit Status:</b> Inactive <b>Ownership:</b> Private
<b>Operator Representative Present:</b>  None (Aerial Inspection)	
<b>Operator Representative Signature: (Field Issuance Only)</b>  This report was issued electronically from the Division's Durango Field Office.

<b>Inspection Start Date:</b> July 23, 2013 <b>Inspection Start Time:</b> 13:49 <b>Inspection End Date:</b> July 23, 2013 <b>Inspection End Time:</b> 13:50	<b>Inspection Type:</b> Aerial Inspection <b>Inspection Reason:</b> Normal I&E Program <b>Weather:</b> Cloudy	
<b>Joint Inspection Agency:</b>  None	<b>Joint Inspection Contacts:</b>	
<b>Post Inspection Agency:</b>  None	<b>Post Inspection Contacts:</b>	
<b>Inspector(s):</b>  Marcia L. Talvitie, P.E.	<b>Inspector's Signature:</b>

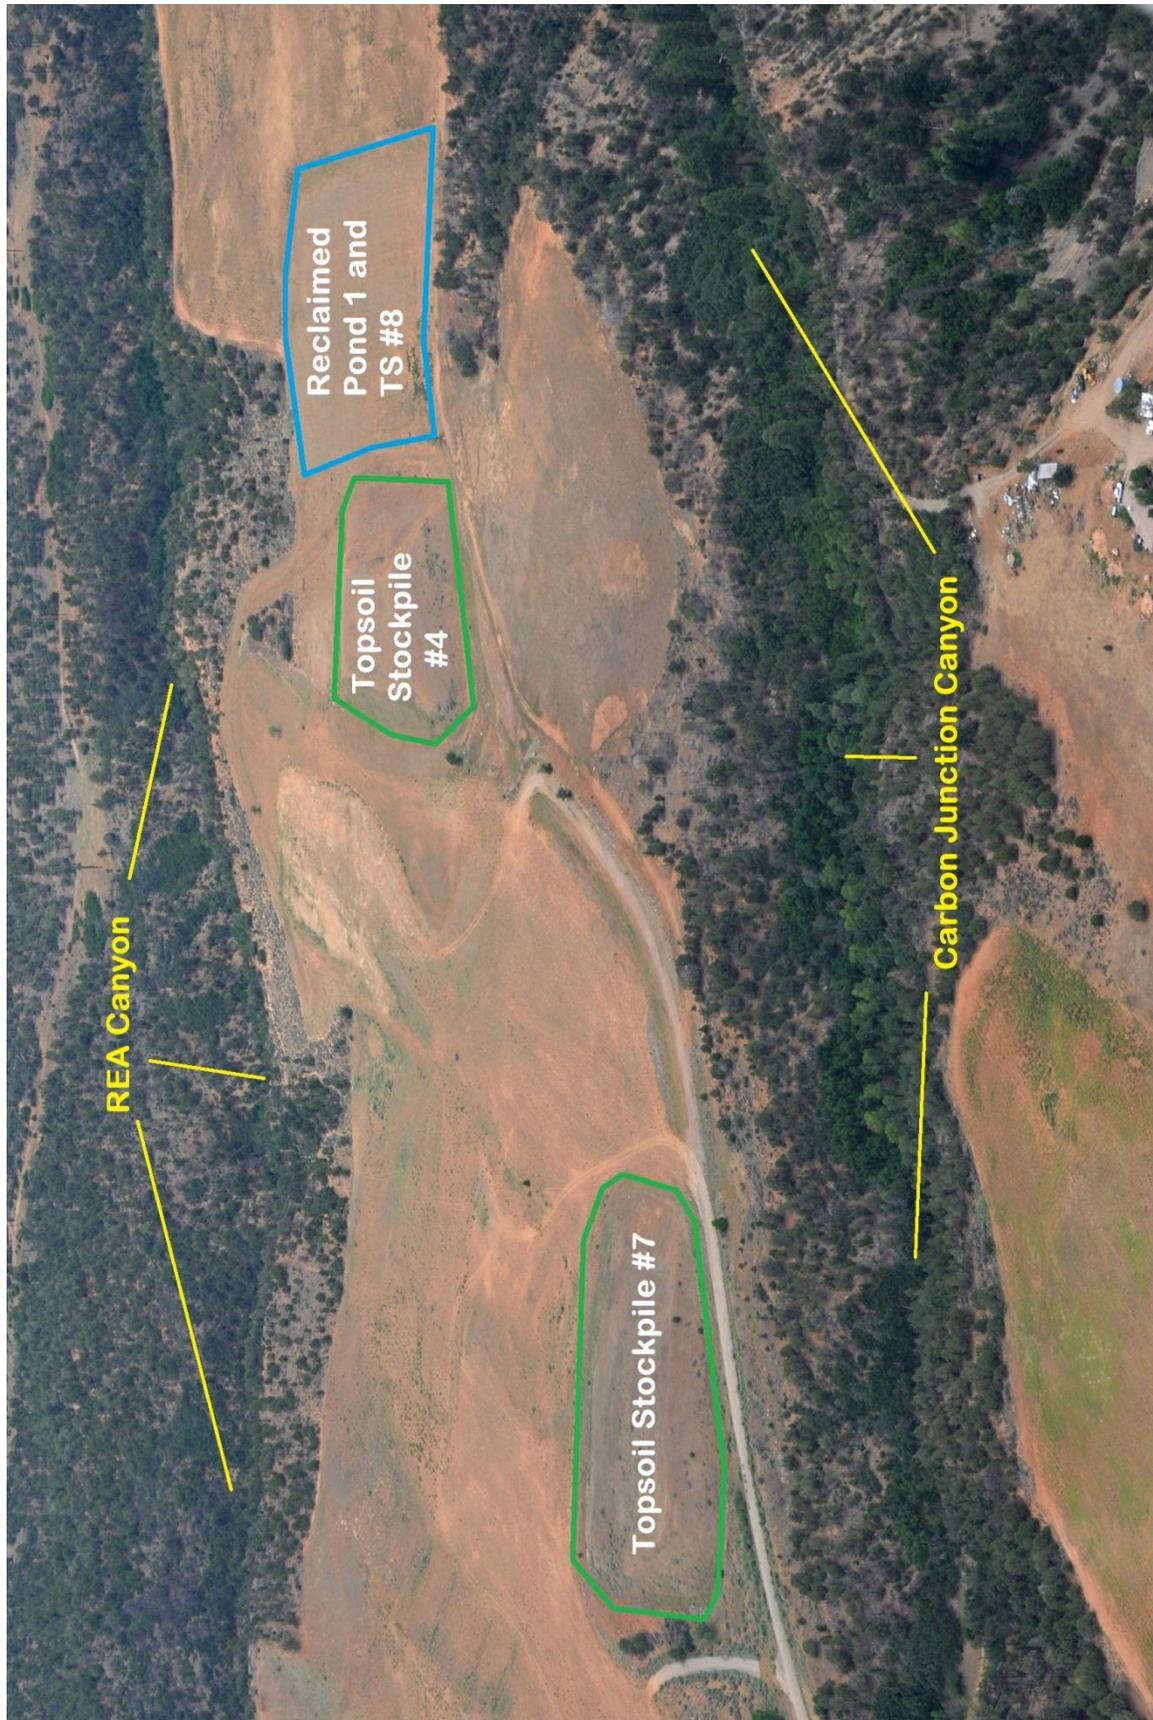
Looking South across the southern end of the permit area

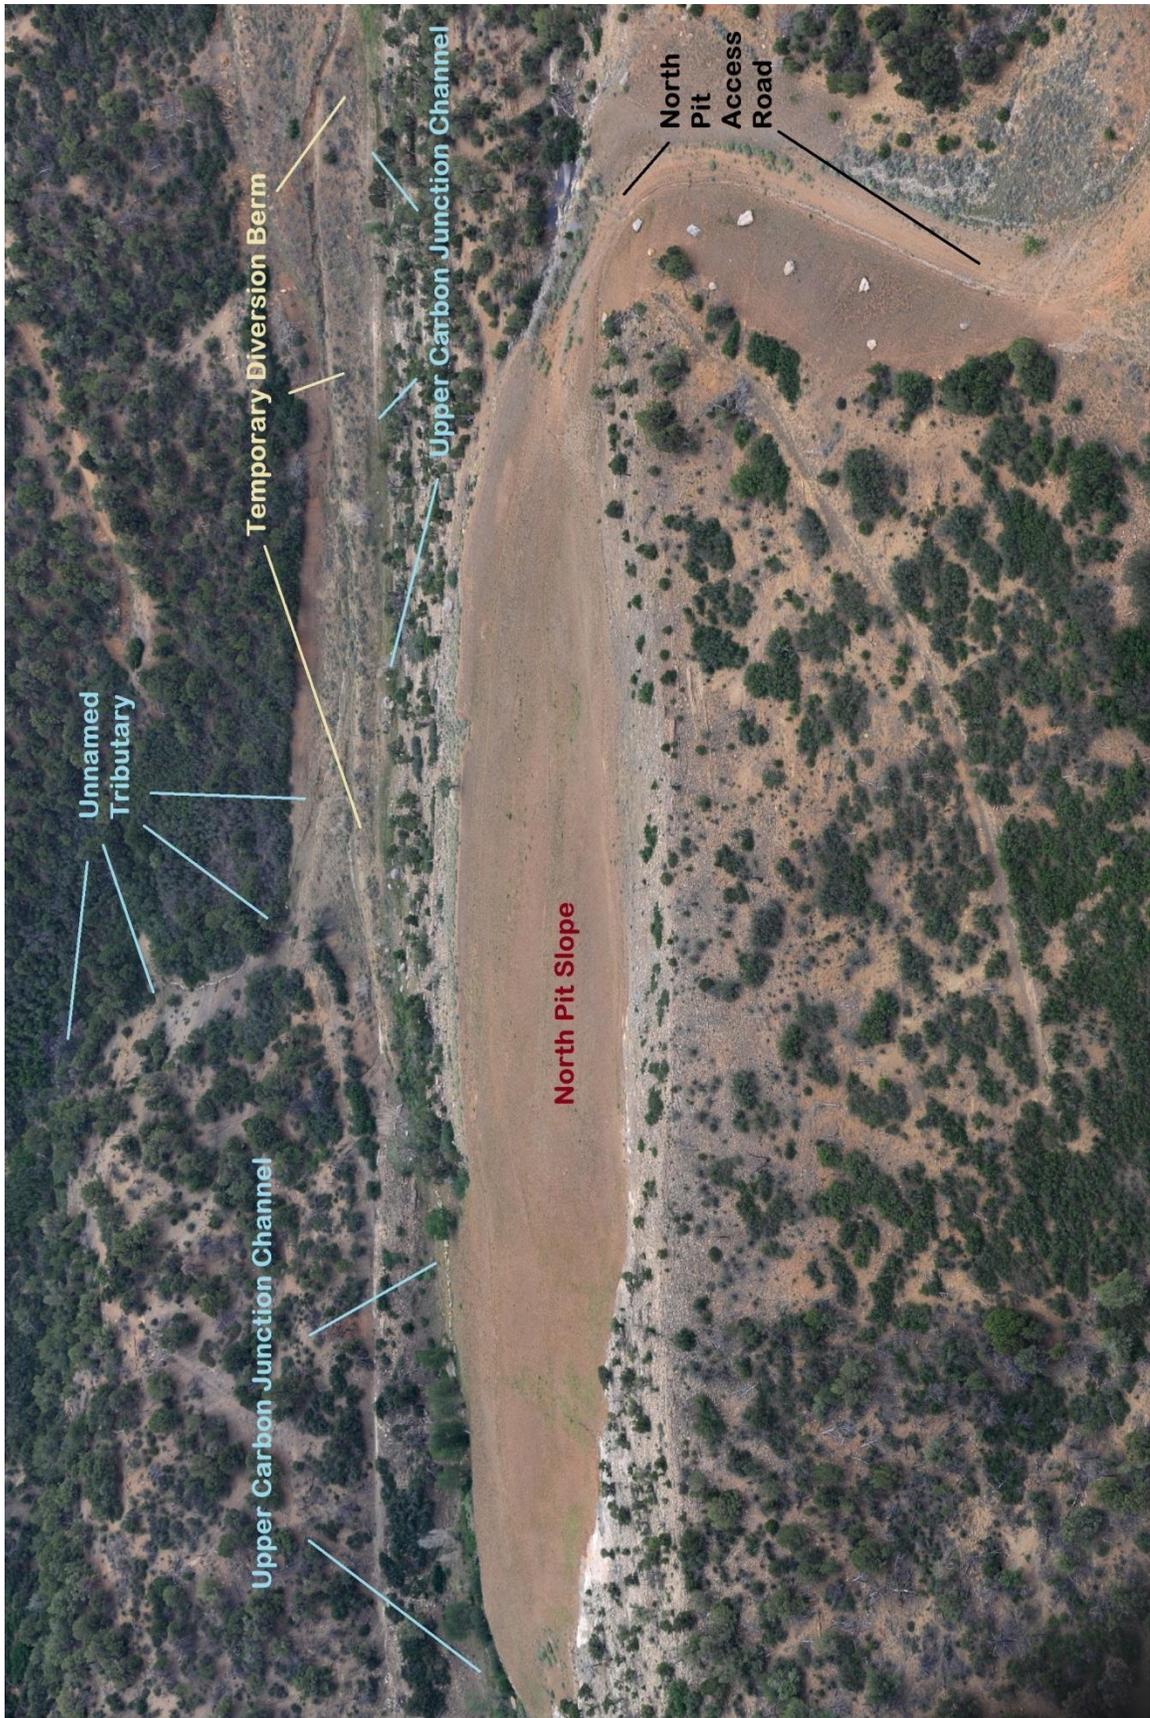
Looking South, down the face of the reclaimed North Pit

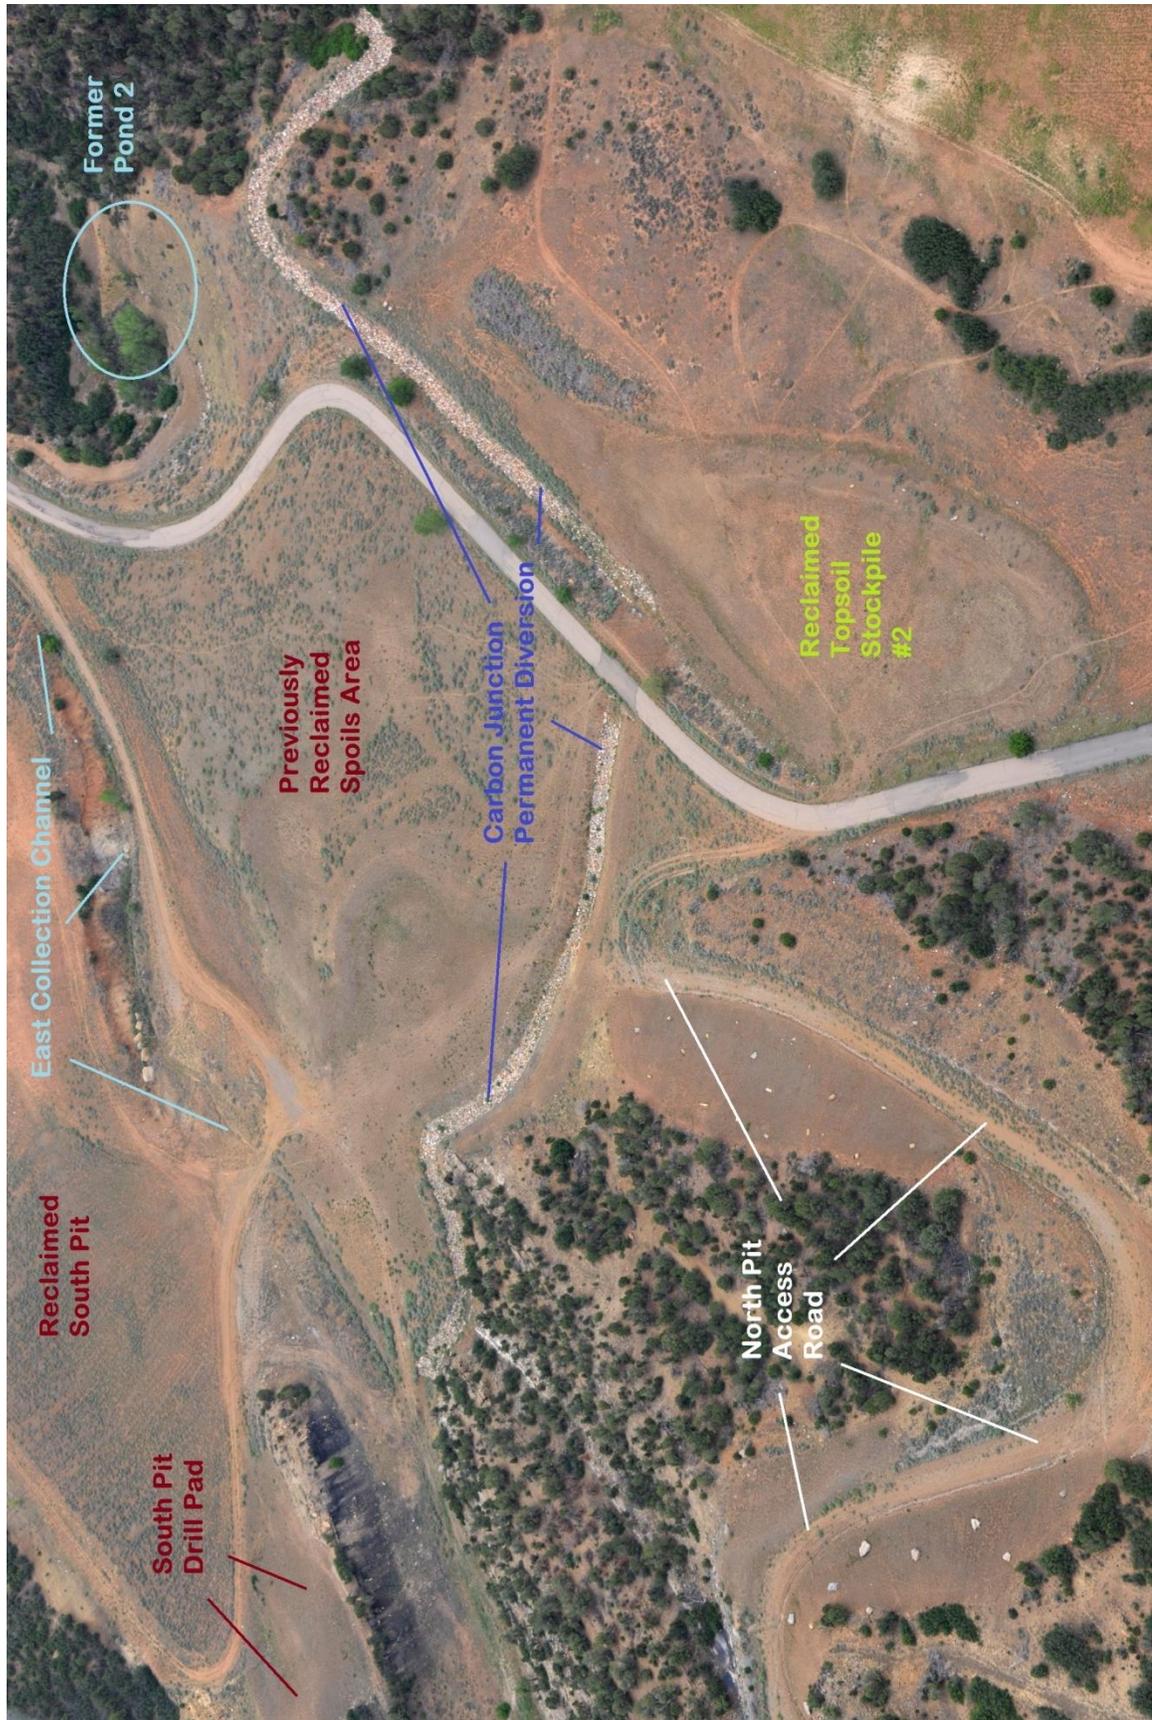
Central permit area, looking South

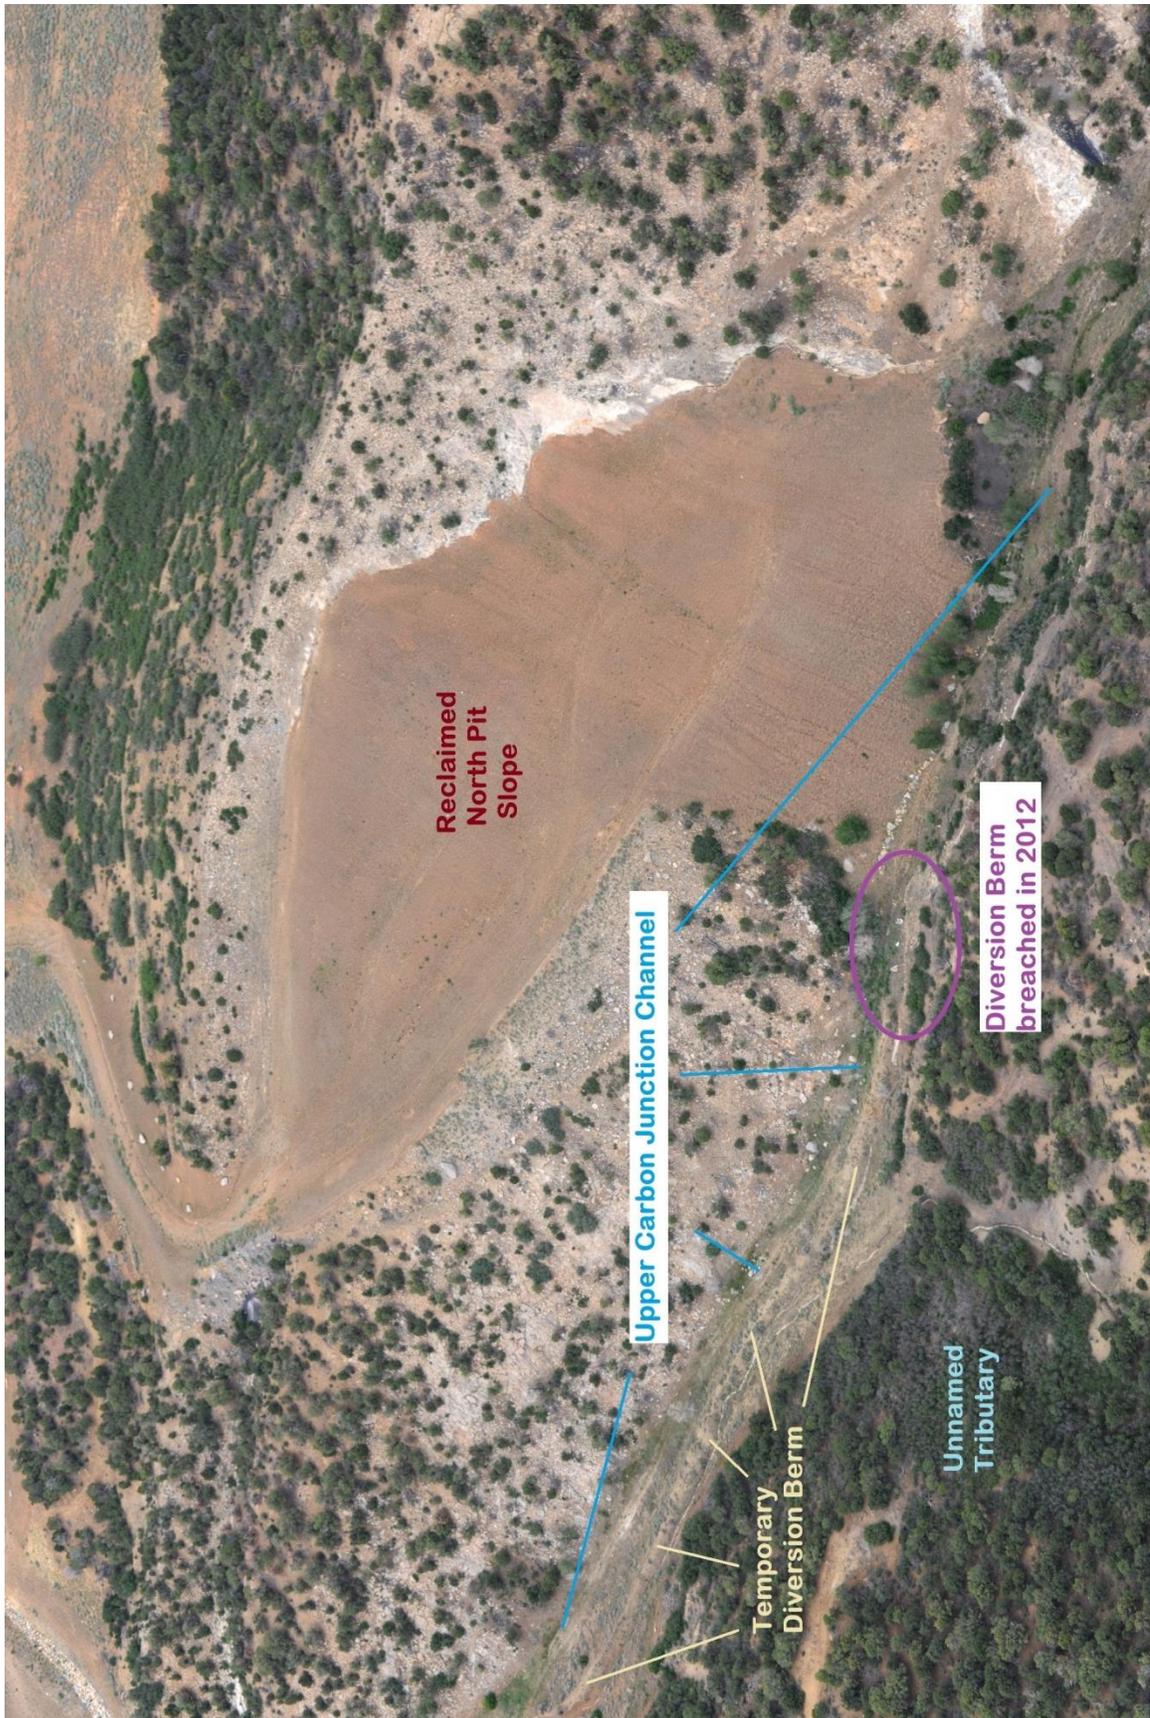
Looking North at the reclaimed North Pit slope

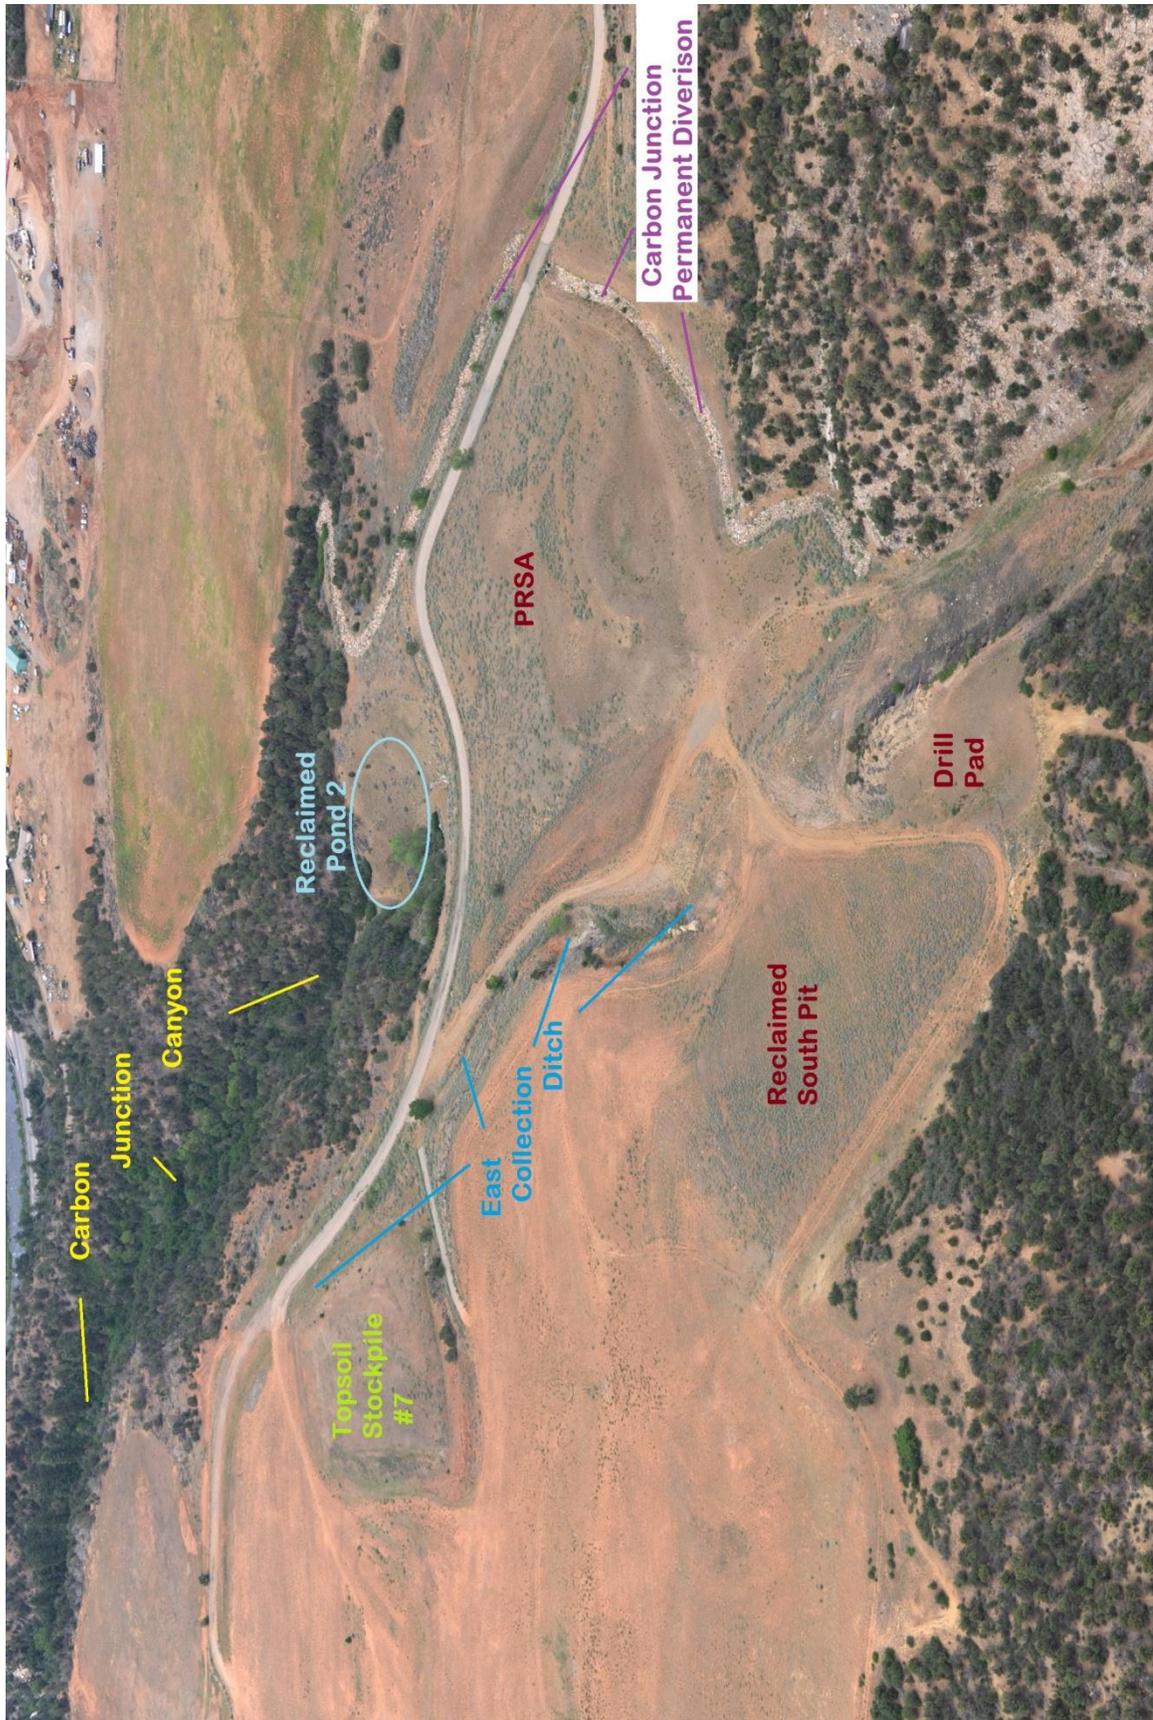
Looking SW down Carbon Junction Canyon
