**Re: Union Carbide Gravel Pit , Permit No. M-1982-010, Financial Warranty Release Denial,
Revision No. SL-01**

COLORADO DIVISION OF RECLAMATION, MINING AND SAFETY
MINERALS PROGRAM INSPECTION REPORT
PHONE: (303) 866-3567

MINE NAME: Union Carbide Gravel Pit	MINE/PROSPECTING ID#: M-1982-010	MINERAL: Sand and gravel	COUNTY: Garfield
INSPECTION TYPE: Surety Release Inspection	INSPECTOR(S): Stephanie J. Mitchell	INSP. DATE: June 4, 2013	INSP. TIME: 09:00
OPERATOR: Roaring Fork Resources, Inc.	OPERATOR REPRESENTATIVE: Sandy Lowell	TYPE OF OPERATION: 112c - Construction Regular Operation

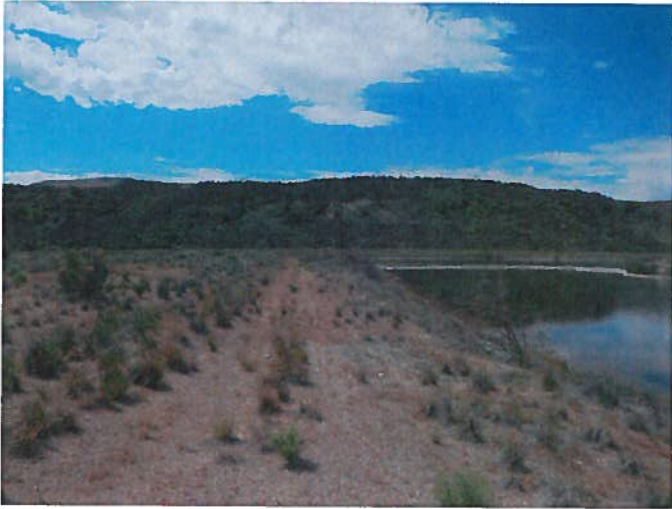
Looking South

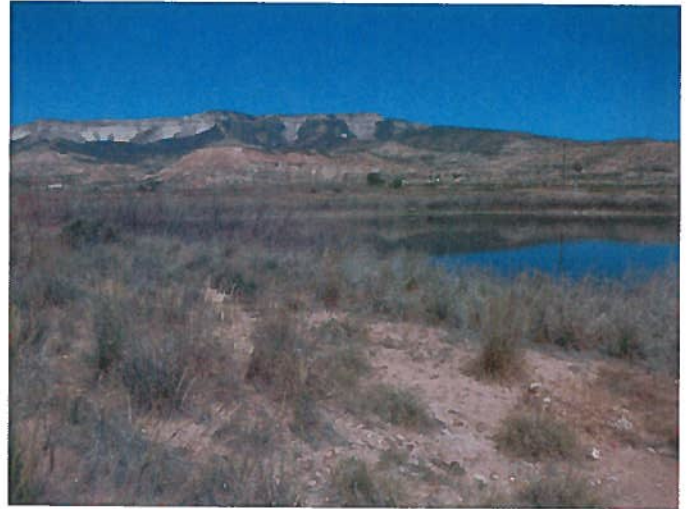
Looking North

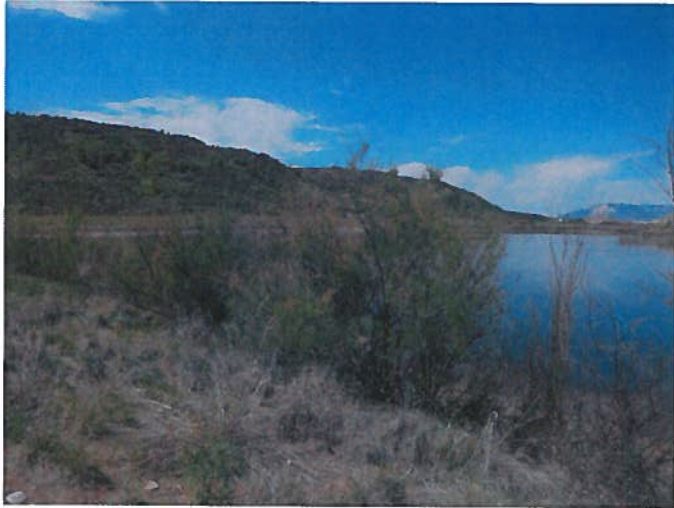
Looking West

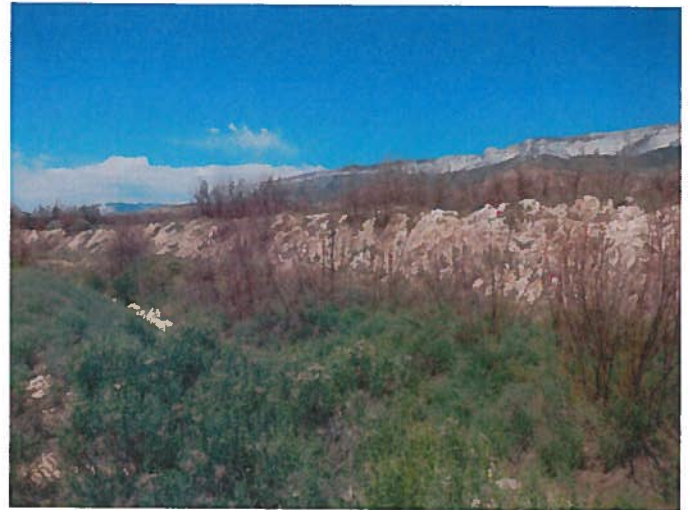
Approved berm on west side of site. Tamarisk not living

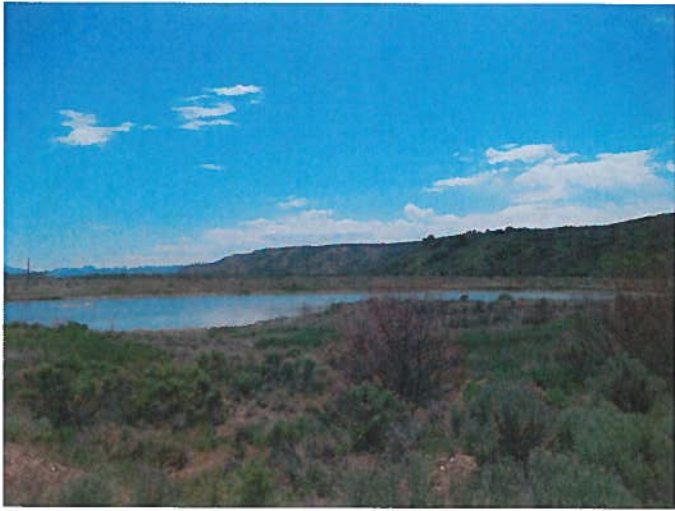
Overall Site, looking East
