**COLORADO DIVISION OF RECLAMATION, MINING AND SAFETY  
MINERALS PROGRAM INSPECTION REPORT  
PHONE: (303) 866-3567**

<b>MINE NAME:</b> Camilletti Milner Pit #2	<b>MINE/PROSPECTING ID#:</b> M-2001-023	<b>MINERAL:</b> Sand and gravel	<b>COUNTY:</b> Routt
<b>INSPECTION TYPE:</b> Monitoring	<b>INSPECTOR(S):</b> Dustin M. Czapla	<b>INSP. DATE:</b> July 9, 2013	<b>INSP. TIME:</b> 15:00
<b>OPERATOR:</b> Precision Excavating, Inc.	<b>OPERATOR REPRESENTATIVE:</b> Bob Hayes	<b>TYPE OF OPERATION:</b> 112c - Construction Regular Operation

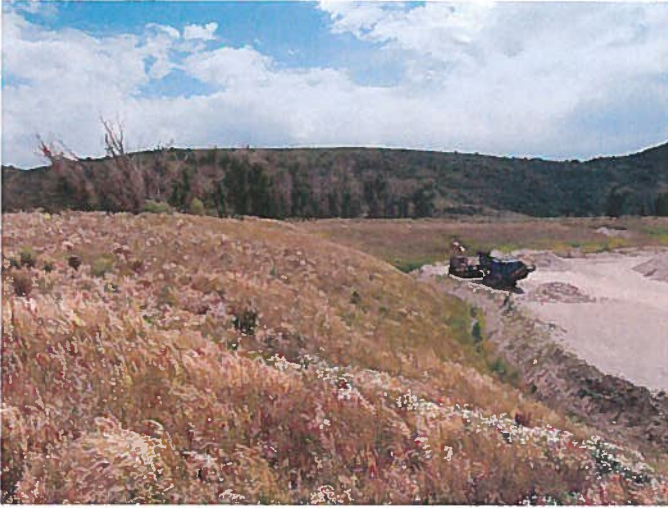
Figure 1: View from the northeast side of the original pit area, facing south.

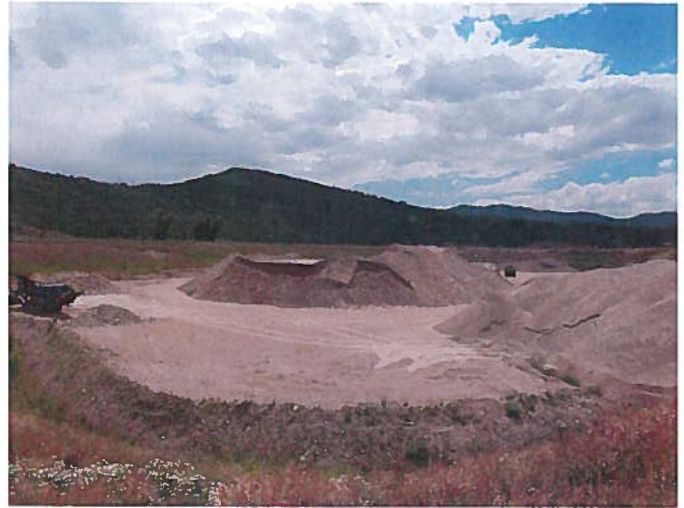
Figure 2: View from the northeast side of the original pit area, facing southwest.

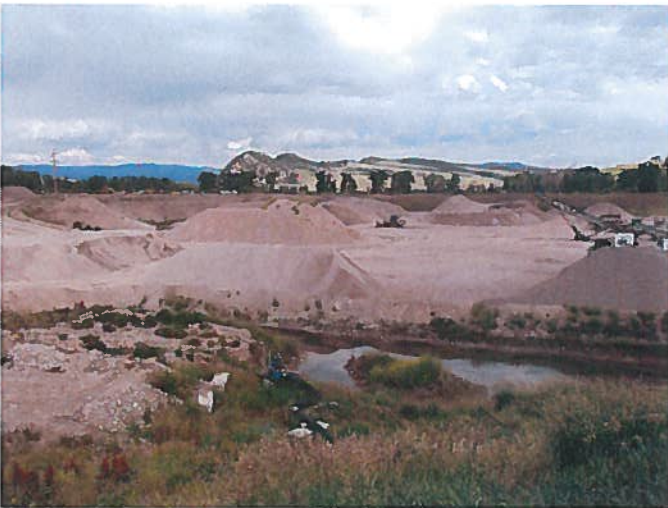
Figure 3: View from the west side of the original pit area, facing east.

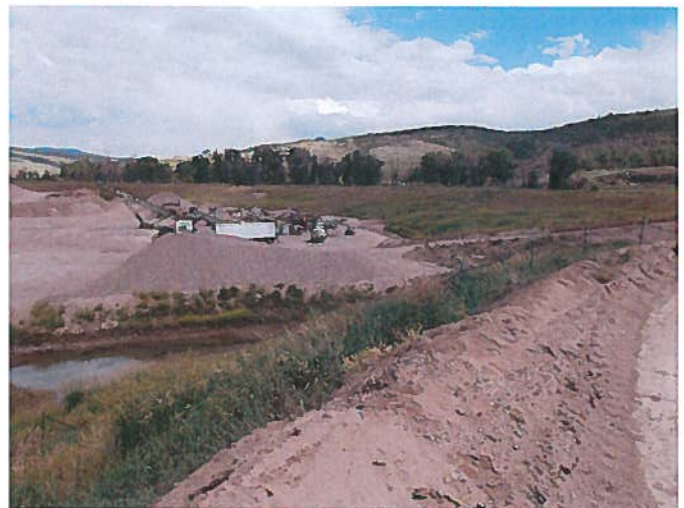
Figure 4: View from the west side of the original pit area, facing east.

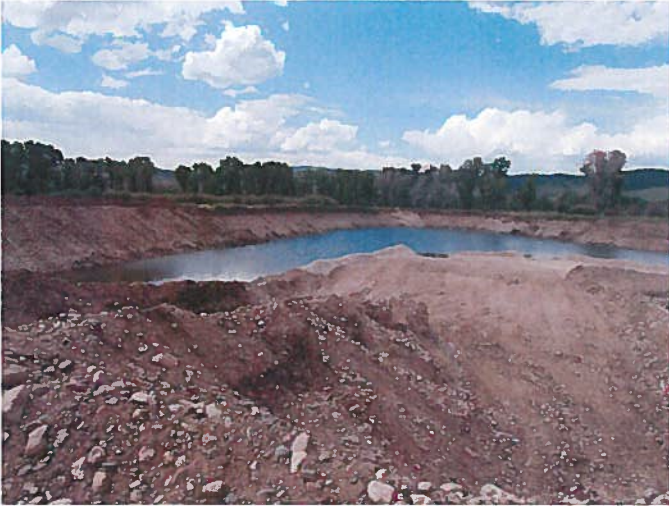
Figure 5: View from the south side of the pit in the expansion area, facing north.

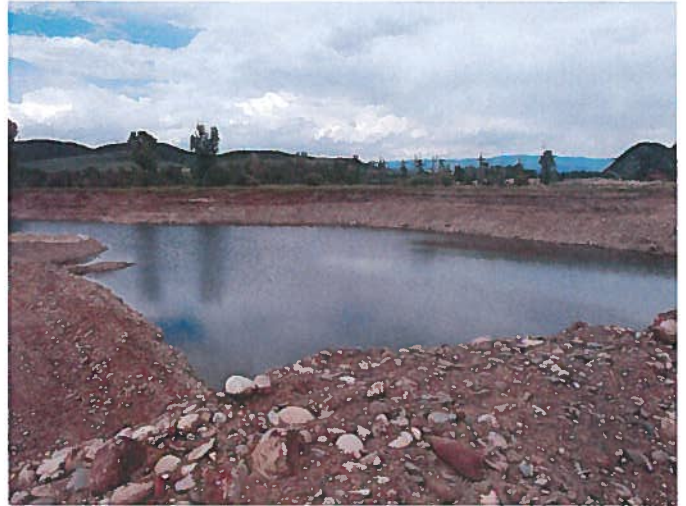
Figure 6: View from the south side of the pit in the expansion area, facing north.
