COLORADO DIVISION OF RECLAMATION, MINING AND SAFETY COAL PROGRAM INSPECTION REPORT

Permit Number: C-1981-008 Mine Name: New Horizon Mine Operator: Western Fuels-Colorado, LLC Operator Address: Mr. Ross L Gubka P.O. Box 628 Nucla, CO 81424	County: Montrose Operation Type: Surface Permit Status: Active Ownership: Private
	Operator Representative Present: None (Aerial Inspection)
Operator Representative Signature: (Field Issuance Only) This report was issued electronically from the Division's Durango Field Office.

Inspection Start Date: July 23, 2013 Inspection Start Time: 12:57 Inspection End Date: July 23, 2013 Inspection End Time: 13:01		Inspection Type: Aerial Inspection Inspection Reason: Normal I&E Program Weather: Cloudy	
Joint Inspection Agency: None		Joint Inspection Contacts:	
Post Inspection Agency: None		Post Inspection Contacts:	
Inspector(s): Marcia L. Talvitie, P.E.	Inspector's Signature:

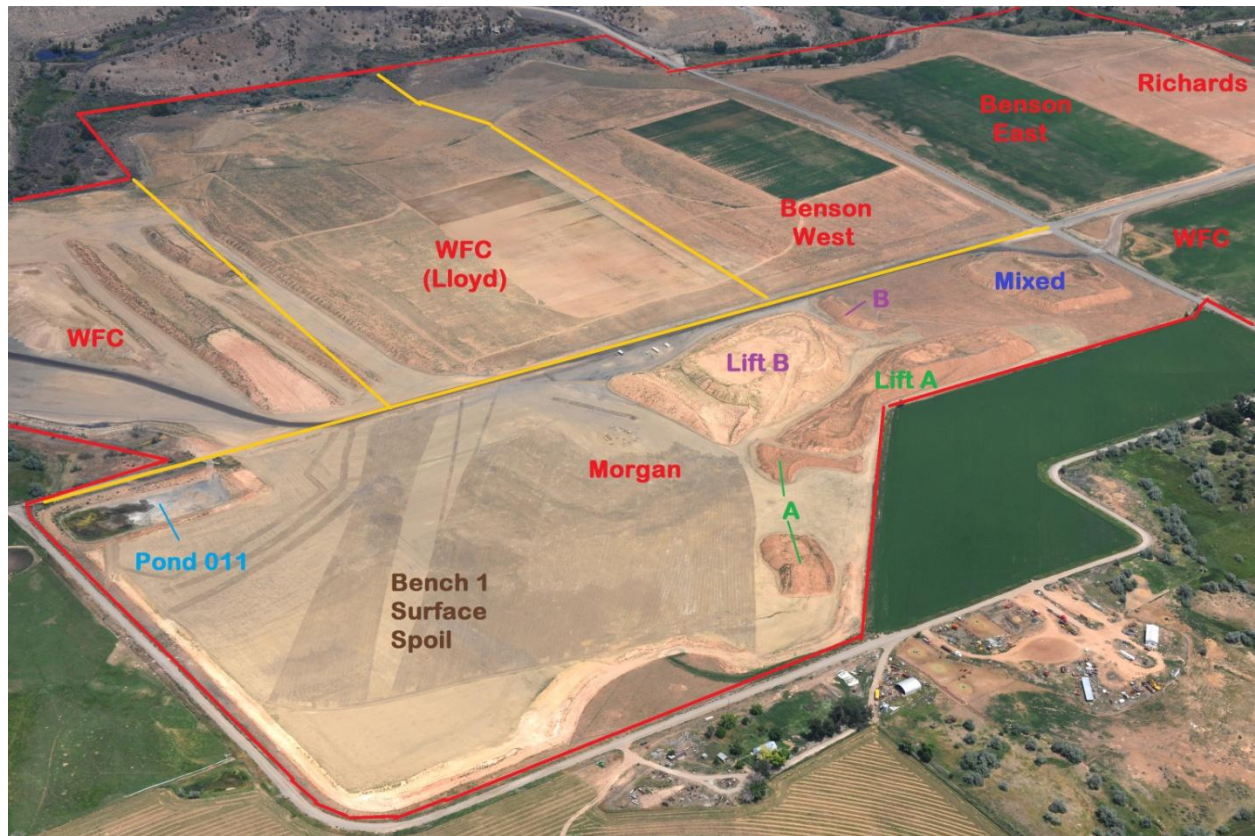
Permit area west of 2700 Road, looking NE

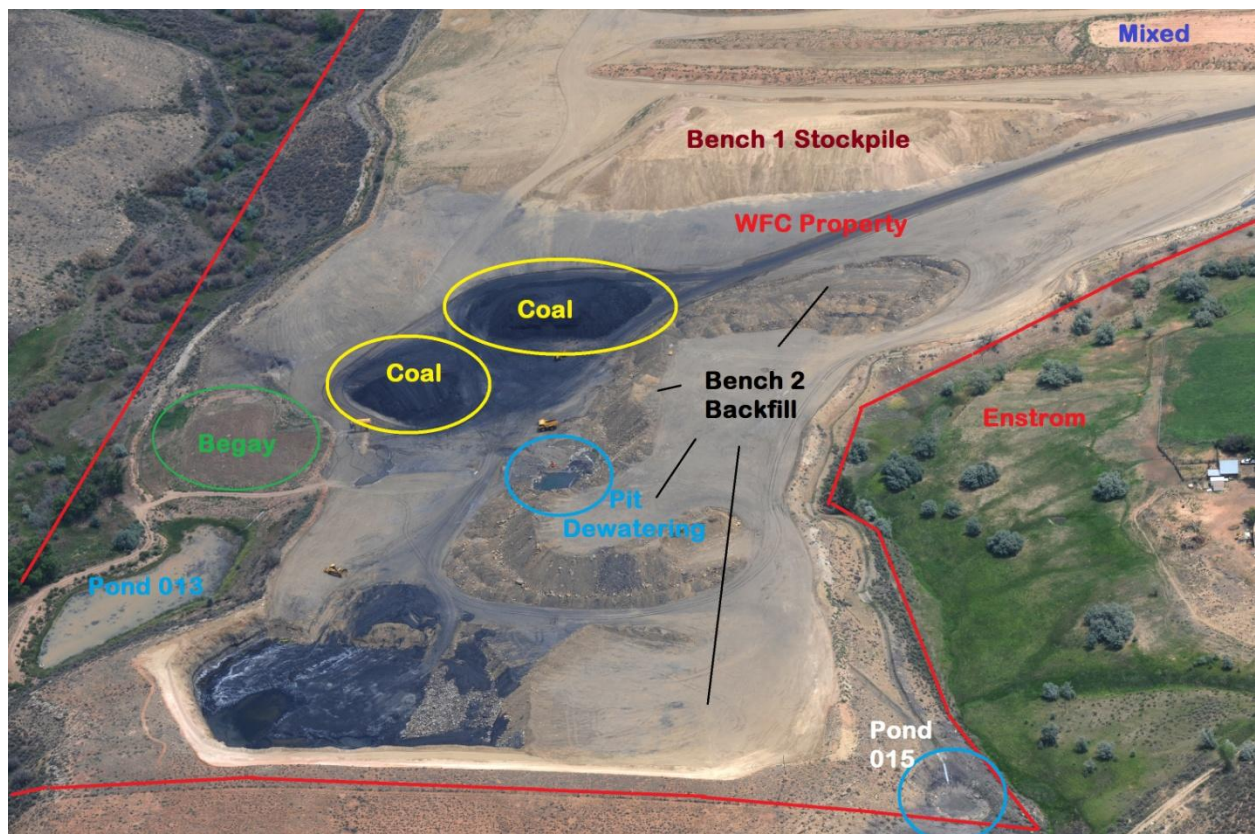
- All backfilling of the pit has been completed, with the exception of the NW corner of the WFC property, the last area to be mined.
- Material for backfilling the final cut will need to come from the boxcut spoil pile located near the southeastern corner of the permit.

WFC parcel, awaiting final backfill and transport of mined coal resource (looking East)

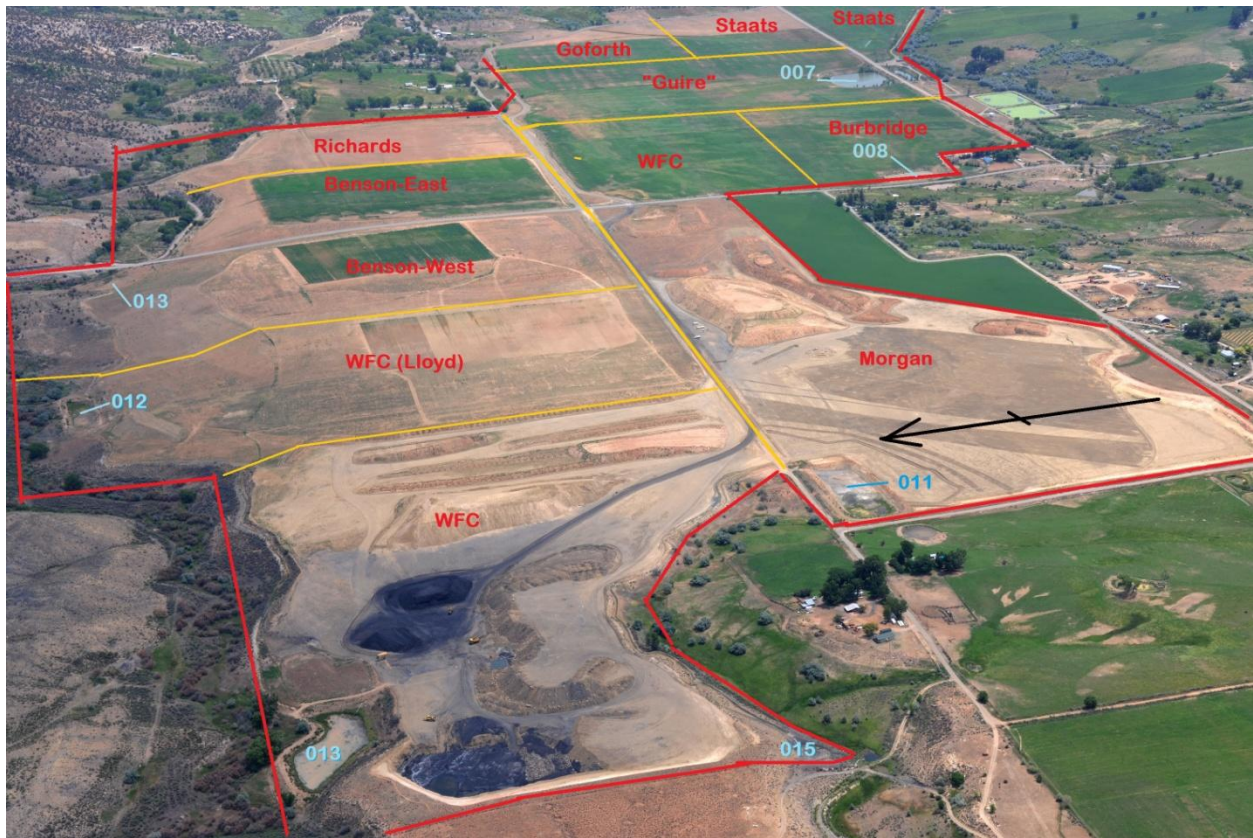
Western end of permit area, looking East

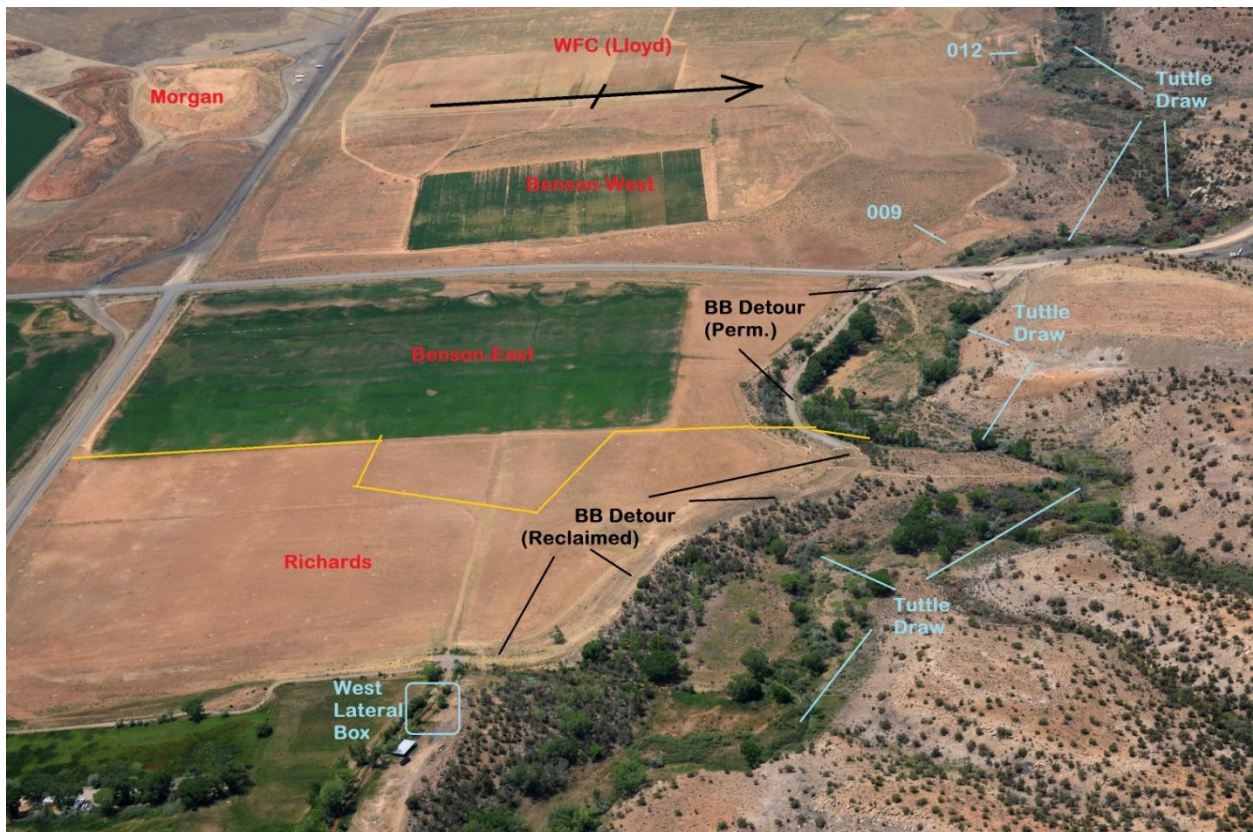
Northern side of permit area, looking West

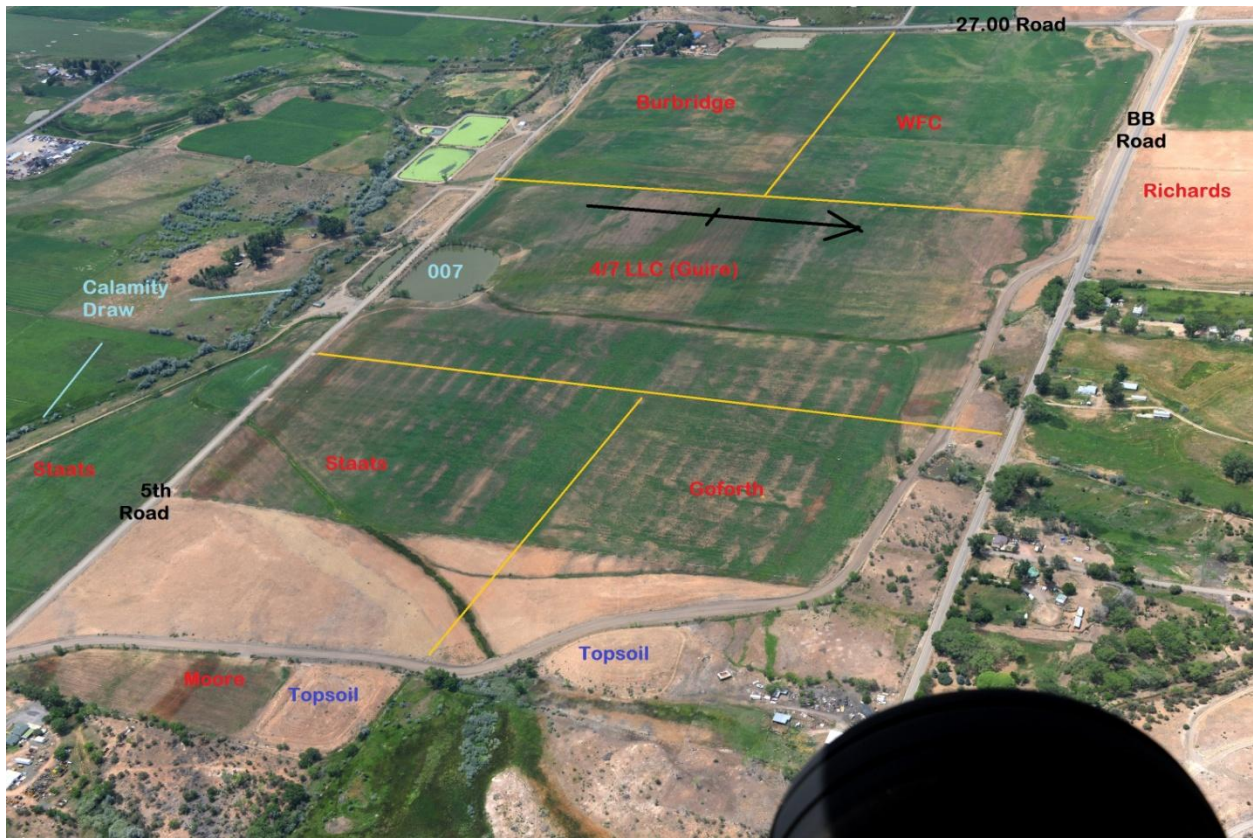
Eastern portion of permit area, looking West

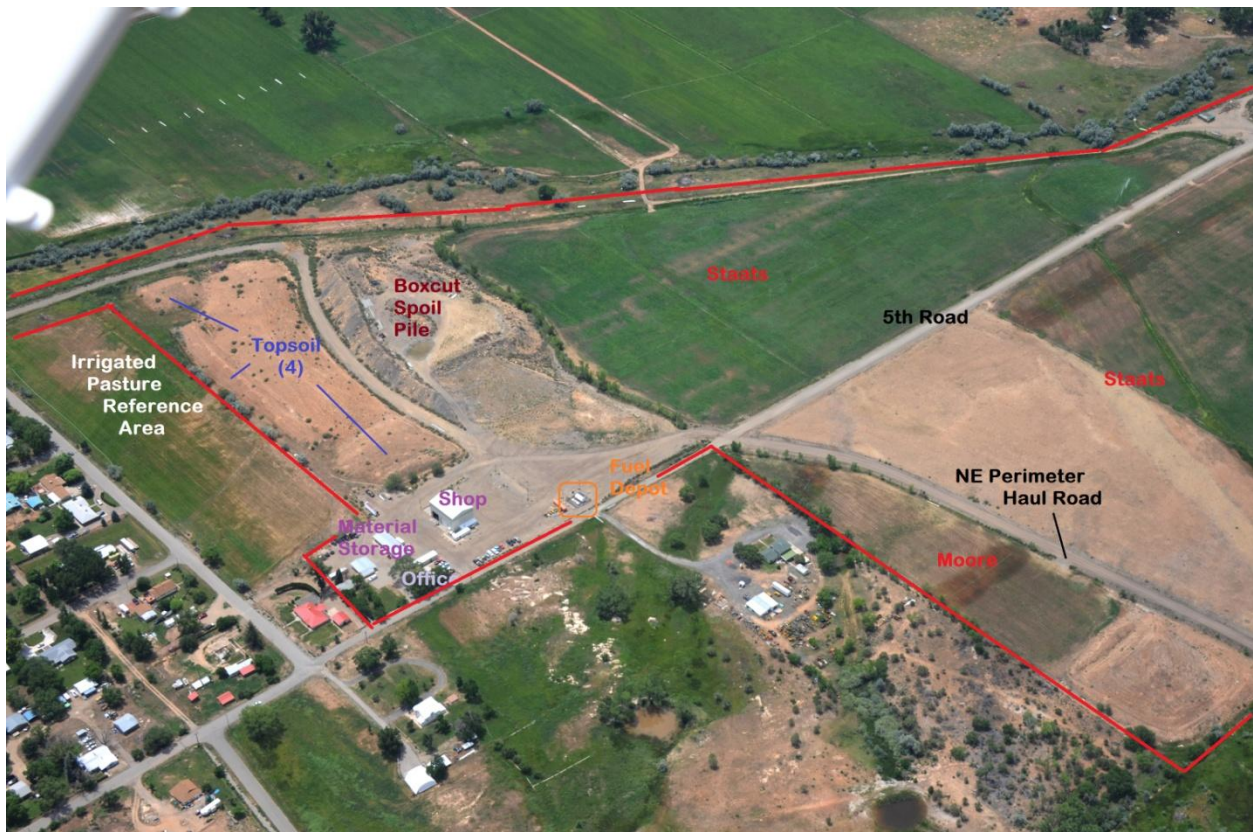
- Fields with a postmining land use of Dryland Pasture were extremely dry in appearance. Due to the condition (and thus relative invisibility) of the grasses, it was impossible to determine the success of revegetation efforts for those parcels.
- The Irrigated Pasture reference area appeared to be receiving irrigation, especially the lower portion. There did not appear to be any livestock grazing the reference area.

Surface facilities, IP Reference Area, SE corner of permit area (looking SW)
