COLORADO DIVISION OF RECLAMATION, MINING AND SAFETY
MINERALS PROGRAM INSPECTION REPORT
PHONE: (303) 866-3567

MINE NAME: Bulldog Project	MINE/PROSPECTING ID#: P-2010-014	MINERAL: Silver, zinc, lead and	COUNTY: Mineral
INSPECTION TYPE: Mineral Prospect Inspection	INSPECTOR(S): Bob Oswald	INSP. DATE: July 11, 2013	INSP. TIME: 14:00
OPERATOR: Rio Grande Silver, Inc.	OPERATOR REPRESENTATIVE: Randy McClure, Cassidy Harraden	TYPE OF OPERATION: MP - Mineral Prospecting

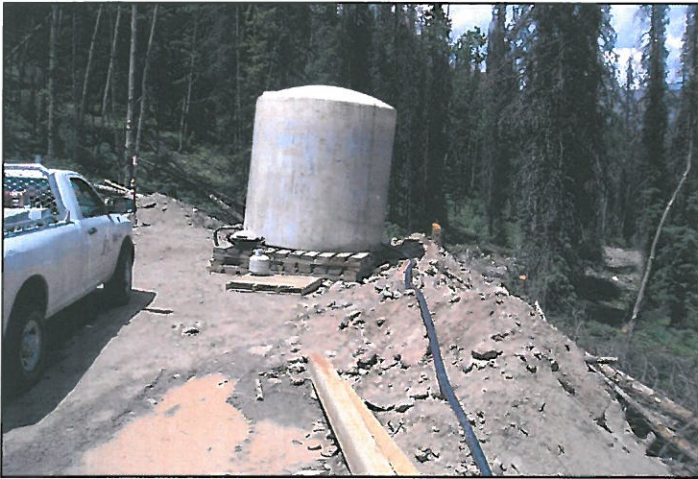
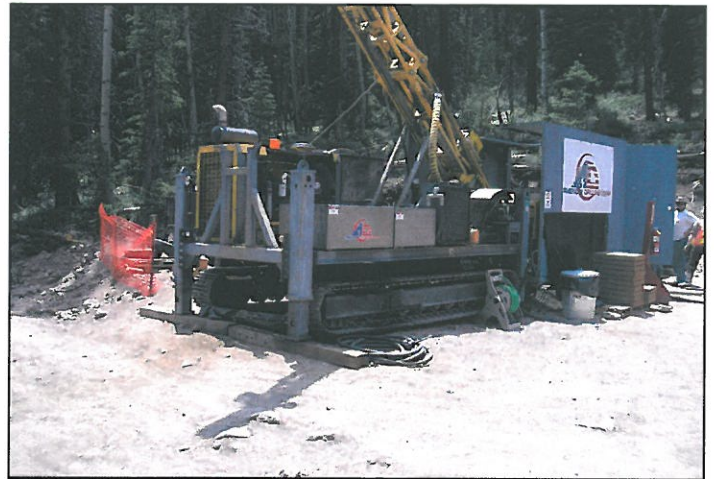
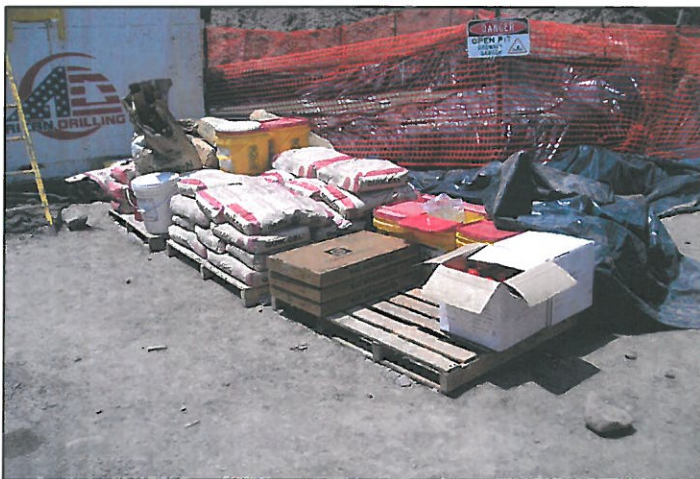
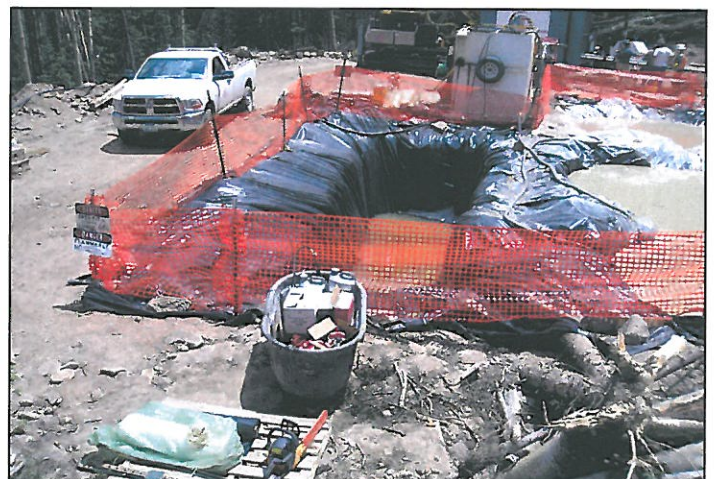
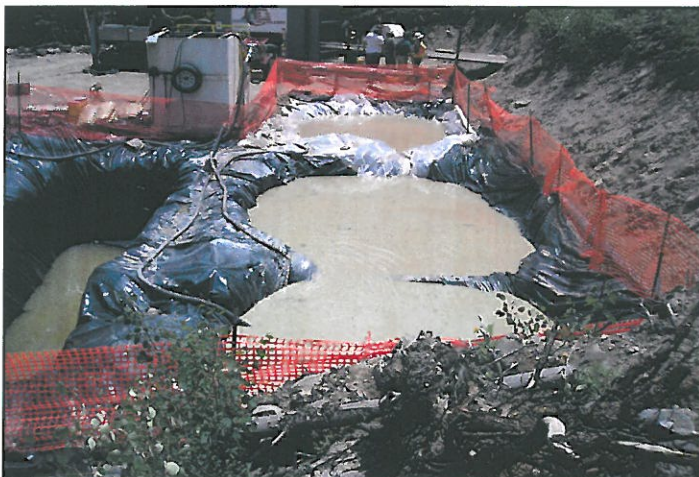
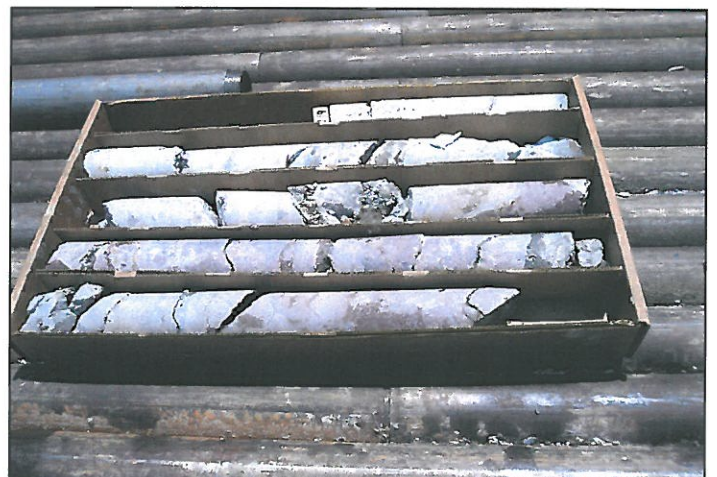
There was drilling activity at the time of the inspection at drill pad BD-7. A tracked drill was set up and core drilling was ongoing. Drill water was being supplied by portable water tanks that were set up on drill site BD-6, and piped up to holding tanks on the BD-7 pad. Drill additives in bags and sealed buckets were arranged on pallets, and hydrocarbons were stored in barrels and tanks with adequate secondary containment. Drill mud sumps (3 cells) that were excavated into the pad and lined with heavy plastic membrane, were also utilized. All fluids and materials were well contained.

The disturbed area was marked, and all disturbance was within the markers. The pad had been cut into the hill slope, with attention given to salvaging the topsoil, berms to contain stormwater on the pad, and sediment controls at the toe of the fill slope to control sediment. There was no debris or uncontained contaminants on the site. All observed activity was in conformance with the approved plan.
