**RE: GROUNDWATER MONITORING RESULTS
MONTROSE 552-ACRE RANCH
MONTROSE COUNTY, COLORADO**

MONTROSE 552-ACRE RANCH

MONTROSE COUNTY, COLORADO

**GEOLOGIC REPORT
LOAN EAGLE LAND BROKERAGE
MONTROSE 552-ACRE RANCH
T ROAD
MONTROSE COUNTY, COLORADO**

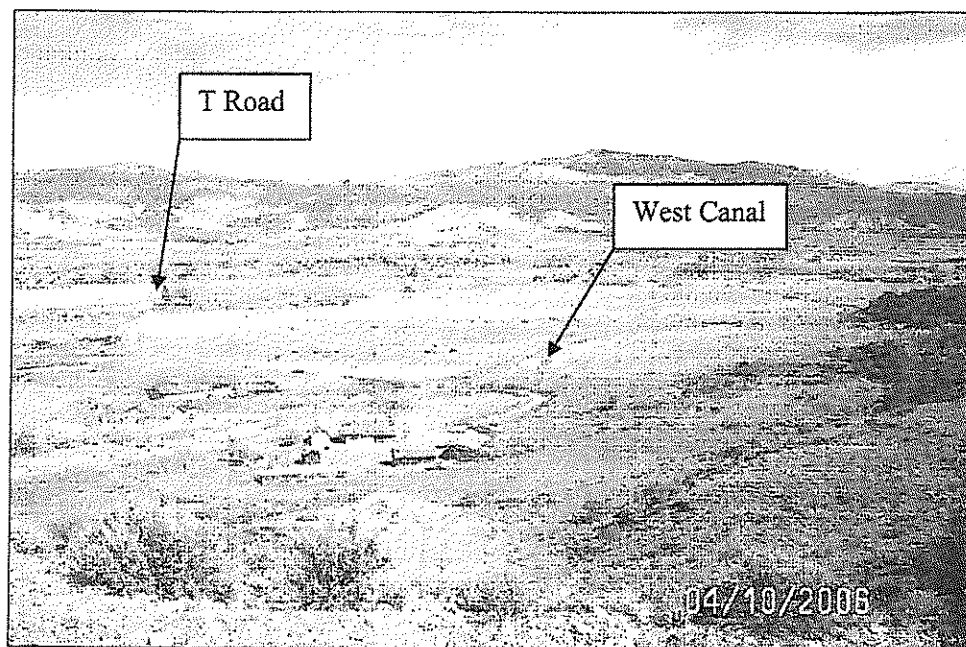
Looking south from on top of the escarpment, majority of the lower agricultural fields is pictured. T Road is to the left of the photograph, while the West canal is running through the center of the photo.

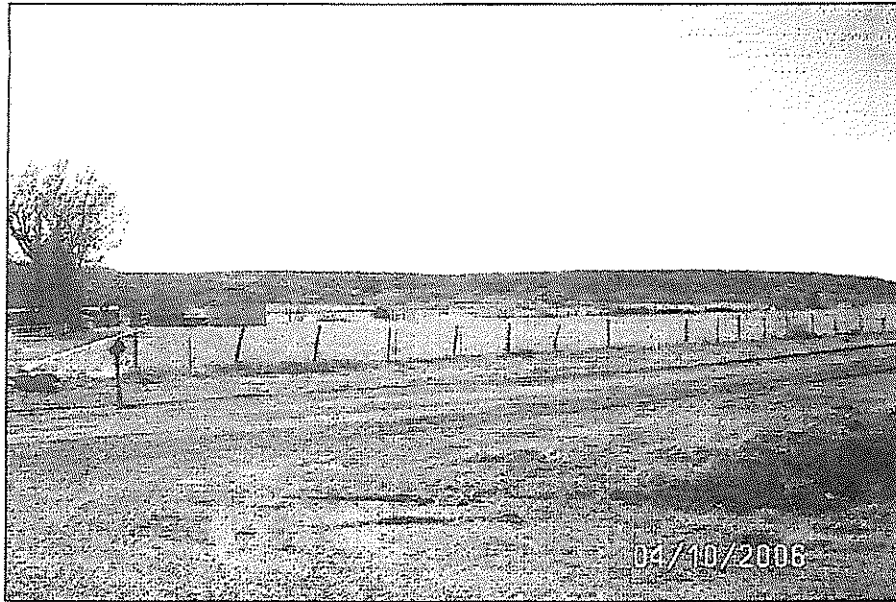
Looking west, the escarpment and the eastern most agricultural field can be seen. The frontage road for Highway 550 is pictured in the immediate foreground.

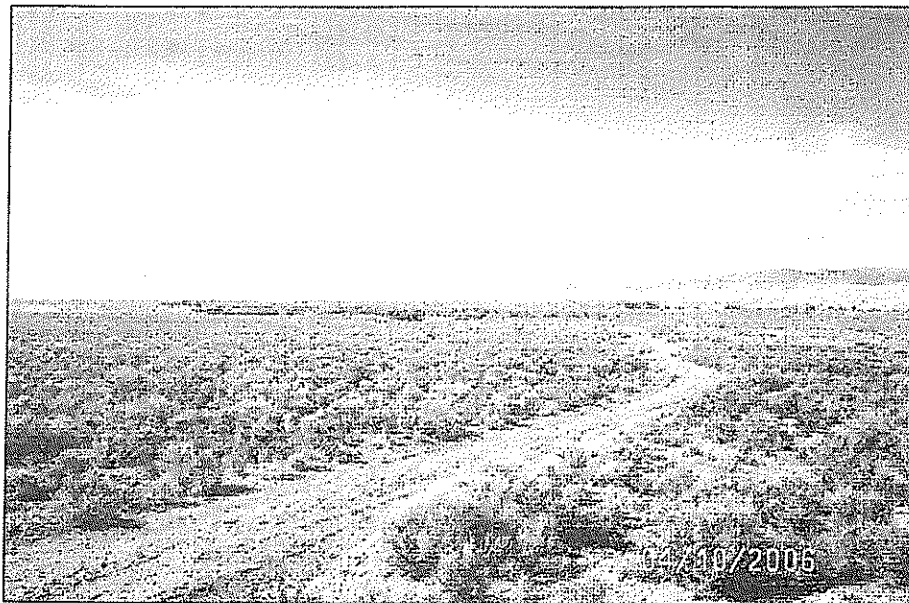
Looking north, the mesa top is pictured. BLM land borders the south and west. The escarpment is to the right of the photographer.

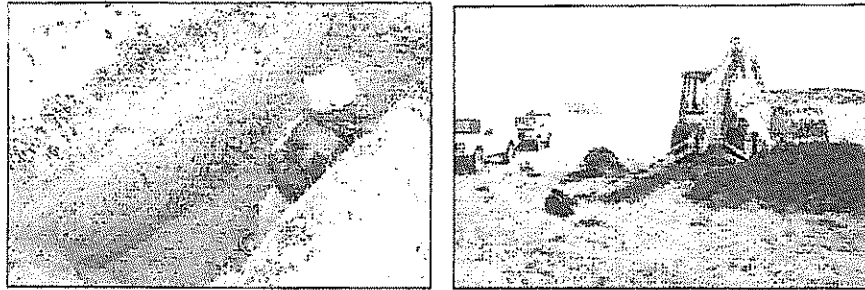
TP#2, TP#3, TP#4, TP#5, TP#6, TP#7, TP#9, TP#12, and TP#13 were excavated in the agricultural fields. These pits generally consisted of approximately 1-foot of damp, organic, silt and clay topsoil underlain by stiff silt and clay with varying amounts of sand and gravel. TP#6 and TP#7, which were located furthest east, revealed deep gravel and cobbles underlying the silt and clay at depths of 2 and 7.5 feet. Atterberg Limits tests performed on the clayey soils revealed Plasticity Indices (PI) ranging from 19 to 32, indicating that the soil typically has a moderate to high shrink/swell potential with moisture changes. Gradation Analyses performed on the clayey samples indicate that these subsoils are typically composed of 61.6 to 95.3% fines (silt and clay), 2 to 37.7% sand, and 0.0 to 20.1% gravel. A sample of the underlying gravel and cobbles in TP#6 revealed to be Non-Plastic (NP) and composed of 3.2% fines, 27.7% sand, and 69.1% gravel. Drive samples were taken in these soils and subjected to swell/consolidation tests. Under a confining pressure of 2000 pounds per square foot (psf) and left at their in-situ moisture contents ranging from 14.7 to 24.3%, the samples generated estimated swelling pressures ranging from 190 to 950 psf, considered low to moderate (see Summary of Laboratory Test Results, respectively). These excavations were terminated at an approximate depth of 8 feet, with no groundwater being encountered. Samples tested revealed moderately high levels of sulfates.

Soils at TP#3 and TP#4. The photograph on the left shows the typical soil profile revealed in out test pits throughout the lower agricultural fields, while the photo on the right shows a test hole during excavation.

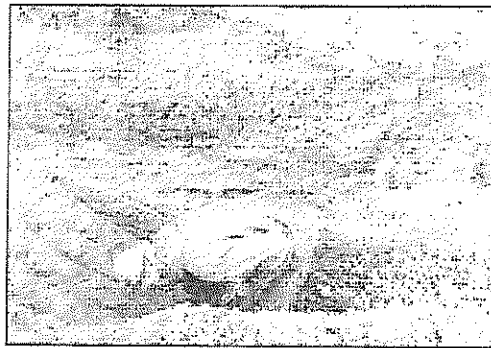
TP#1, TP#8, TP#10, TP#11, TP#14, TP#15, and TP#16 were located within the escarpment. The soil and rock ranged from shale to sand and gravel. Atterberg Limits tests performed on the variety of material found revealed PI's ranging from 22 to 26, indicating that the soils typically have a moderate shrink/swell potential. Gradation analysis were performed on the various samples indicate that these subsoils (not including shale) are typically composed of 50 to 83.7% fines, 16.3 to 31.2% sand and 0 to 29.3% gravel. Drive samples were taken in these soils and subjected to swell/consolidation tests. Under confining pressures ranging from 2000 to 8000 psf and left in their in-situ moisture contents ranging from 11.6 to 12.5% the samples generated swelling pressures ranging from 650 to 2570 psf, considered low to high (see Summary of Laboratory Test Results). These excavations were terminated at an approximate depth of 8 feet, with no groundwater being encountered. A sample of soil from the escarpment area was found to contain a high level of sulfate.

Soils at TP#16. The photograph shows the typical soil profile revealed in out test pits within the escarpment. Note the upper granular material overlying the fractured shale.

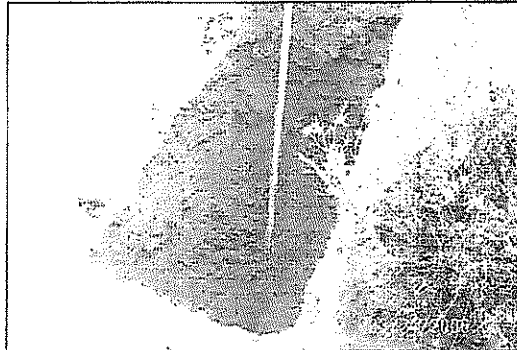
TP#17 through TP#20, as well as BH04-1 through BH04-4, were excavated/drilled on top of the mesa. These test pits and borings generally revealed clayey sand and gravel overlying sandy gravel and cobbles, which is underlain by shale at depths ranging from 15 to 35 feet. Atterberg Limits tests performed on the gravelly soils revealed Plasticity Indices (PI) ranging from Non-Plastic (NP) to 19, indicating that the soil typically has a low to moderate shrink/swell potential with moisture changes. Gradation Analyses performed on the sand and gravelly samples indicate

that these subsoils are typically composed of 1.2 to 40.7% fines (silt and clay), 6.2 to 54.6% sand, and 16.1 to 92.8% gravel. Drive samples were taken in these soils and subjected to swell/consolidation tests. Under confining pressures ranging from 2000 to 4000 psf and left in their in-situ moisture contents ranging from 6.7 to 9.8% the samples generated swelling pressures ranging from 360 to 1610 psf, considered low to moderate (see Summary of Laboratory Test Results).

Soils at TP#18. The picture shows the typical test pit on top of the mesa.
