COLORADO DIVISION OF RECLAMATION, MINING AND SAFETY
MINERALS PROGRAM INSPECTION REPORT
PHONE: (303) 866-3567

MINE NAME: Smuggler Mine	MINE/PROSPECTING ID#: M-1995-097	MINERAL: Silver	COUNTY: Pitkin
INSPECTION TYPE: Monitoring	INSPECTOR(S): Dustin M. Czapla	INSP. DATE: August 23, 2013	INSP. TIME: 12:00
OPERATOR: New Smuggler Mine Company	OPERATOR REPRESENTATIVE: Roger Messler	TYPE OF OPERATION: 110(2) - Hard Rock Limited Impact

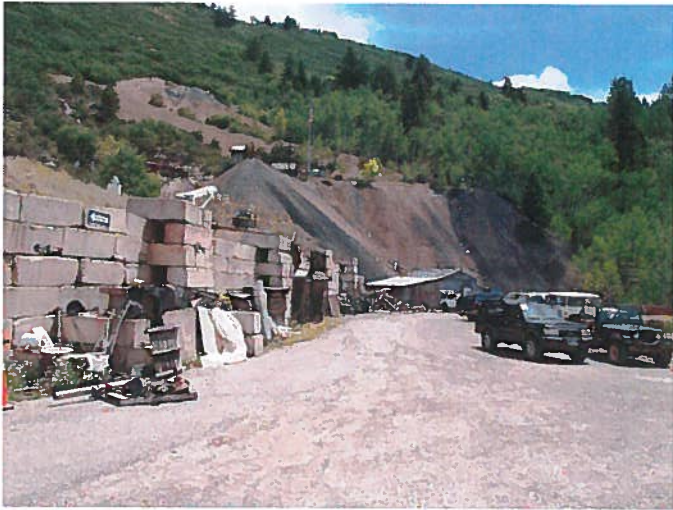
Figure 1: View toward the No. 2 Dump from the from the main mine pad

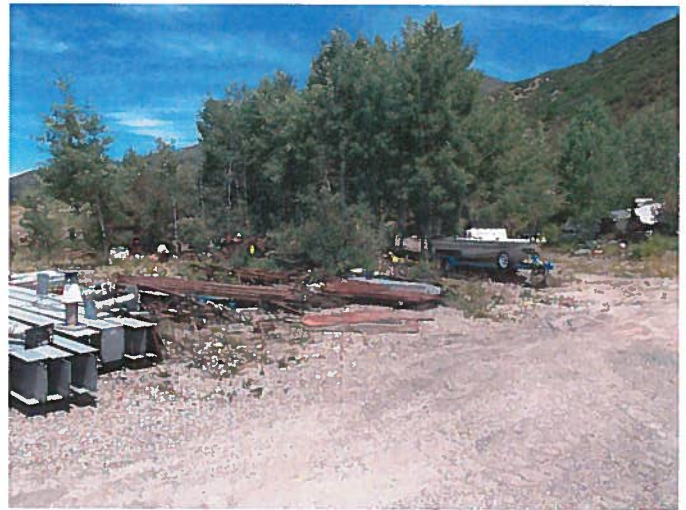
A large amount of various scrap material and equipment, much of which is unrelated to the mining operation, is still located in various areas throughout the site.

Figure 2: Various equipment, material and debris stored throughout the site

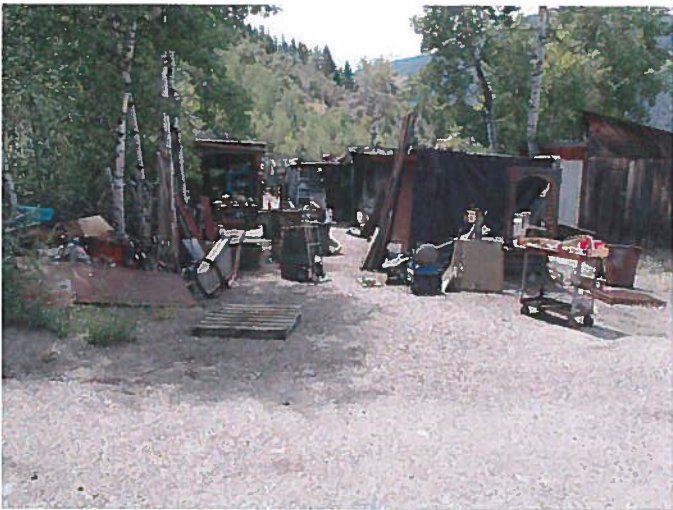
Figure 3: Various equipment, material and debris stored throughout the site

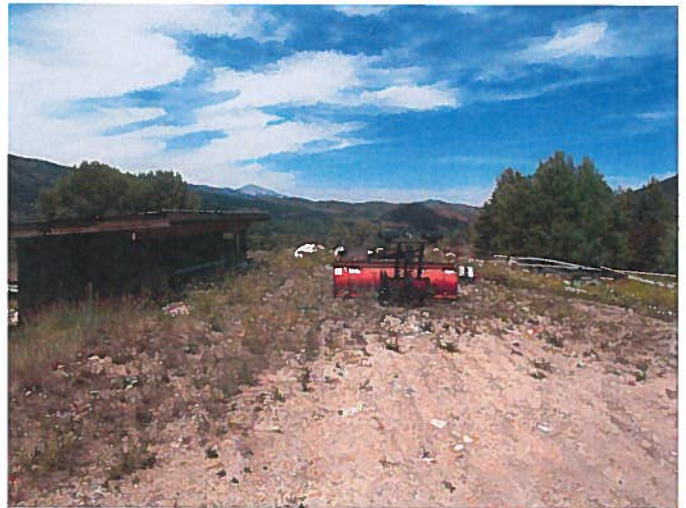
Fuel stored on site was placed in an adequate containment structure.

Figure 4: Fuel containment structure is shown on the left side of the photo

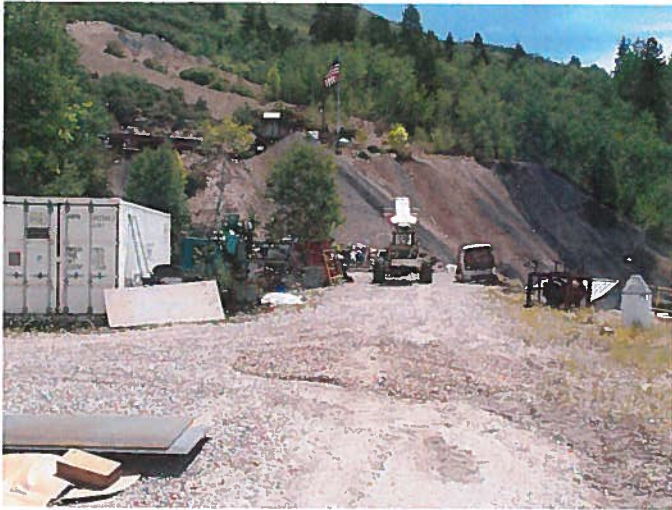
Figure 5: Various equipment, material and debris stored throughout the site

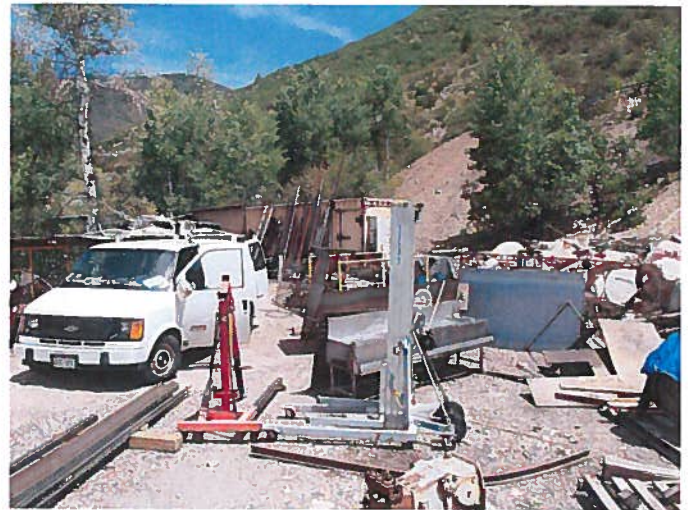
Figure 6: Various equipment, material and debris stored throughout the site

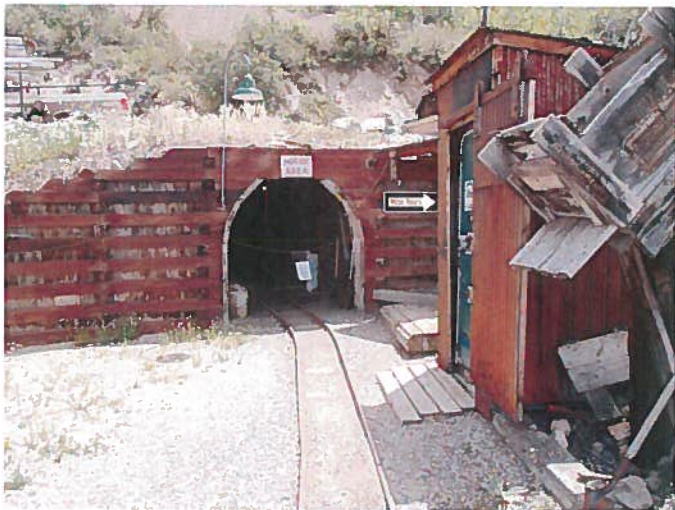
Figure 7: Clark Tunnel

Tunnel No. 1A and the Smuggler Shaft, located on the Main Mine Pad level, were locked securely. The Clark Tunnel and Tunnel No. 2, which are utilized by the tours, were open. A tour was taking place during this inspection. Tunnel No. 3 has been covered with the adjacent dump material.

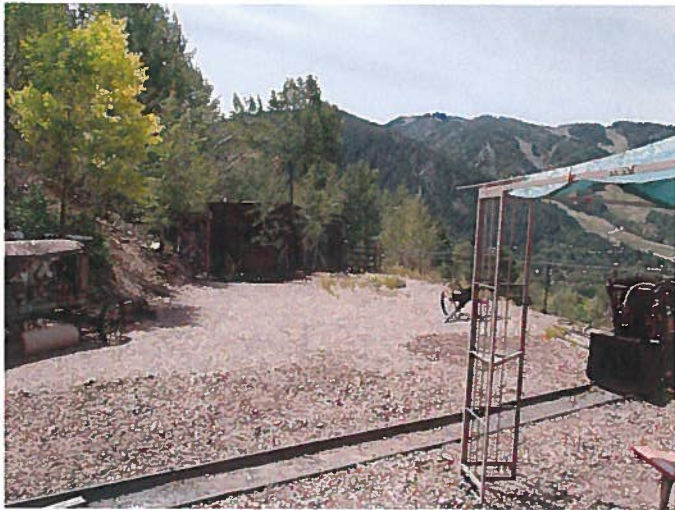
Figure 9: View toward the watchman quarters located on the south side of Tunnel No. 2

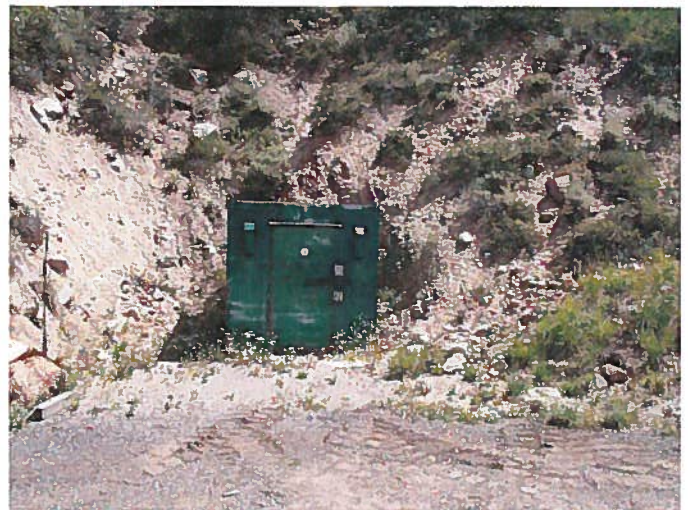
Figure 10: Unused ordinance locker located on the north side of the Clark Tunnel
