**COLORADO DIVISION OF RECLAMATION, MINING AND SAFETY
MINERALS PROGRAM INSPECTION REPORT
PHONE: (303) 866-3567**

MINE NAME: White Banks Mine	MINE/PROSPECTING ID#: M-1999-042	MINERAL: Alabaster, marble, quartz	COUNTY: Pitkin
INSPECTION TYPE: Monitoring	INSPECTOR(S): Dustin M. Czapla	INSP. DATE: July 23, 2013	INSP. TIME: 09:30
OPERATOR: Avalanche Creek Marble & Alabaster LLC	OPERATOR REPRESENTATIVE: None	TYPE OF OPERATION: 110c - Construction Limited Impact

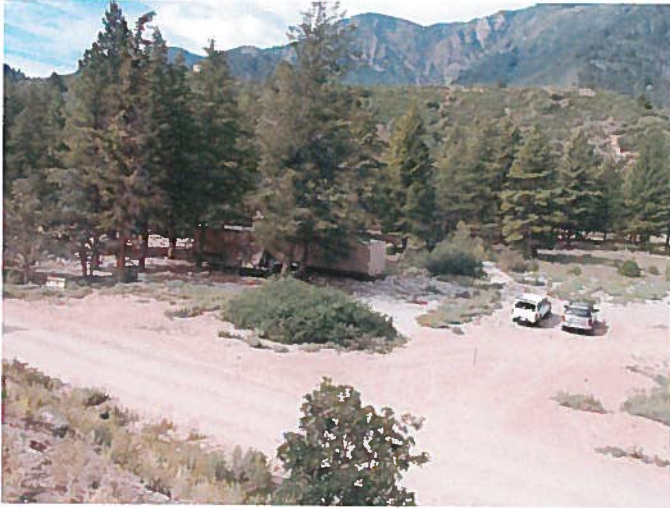
Figure 1: View of the bathhouse and parking area on the south side of FR 310

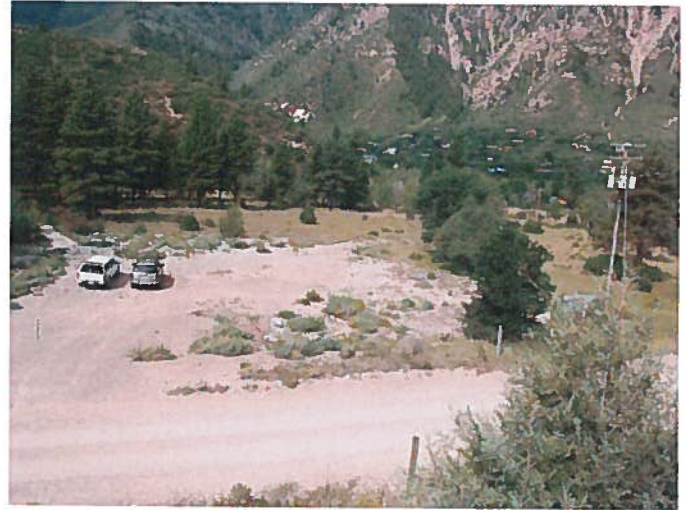
Figure 2: View of the parking and work/storage area on the south side of FR 310

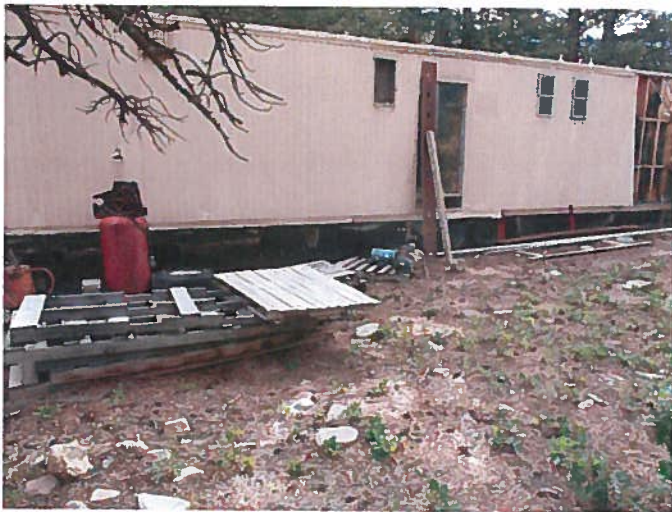
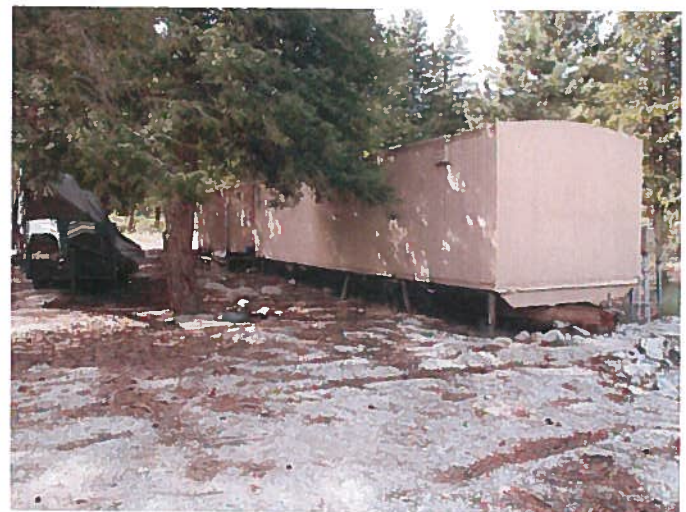
A "bathhouse" was located in the conifer grove on the south side of the parking area. The structure appeared to be in a dilapidated condition. Various refuse and debris was located outside the structure. A flat-bed gooseneck trailer was located on the east side of the bathhouse. This piece of equipment appeared to be operational. The "temporary" stockpile of material, which was addressed through TR-2 in 2004, was still located in the southeast part of the conifer grove.

Figure 3: Bathhouse

Figure 4: Bathhouse

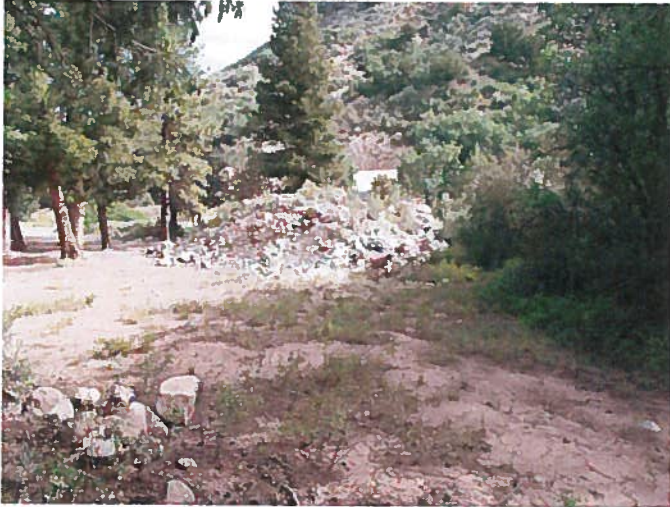
Figure 5: TR-2 material stockpiled in southeast part of conifer grove

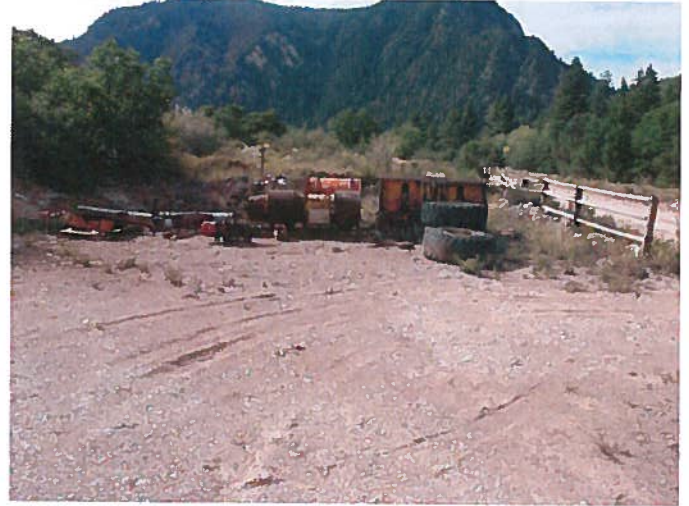
Miscellaneous pieces of equipment were located in the south part of this area. Although much of the equipment appeared to be nonfunctional, it was stored in an orderly manner. The main cabin structure appeared to be structurally sound and in decent condition. Stability of the structures that have been attached to the cabin however, such as the deck on the east side, the awning on the west side and the entry stairs on the south side, was questionable. The portal entrance was securely locked during this inspection.

Figure 6: Equipment stored in south part of mine yard on north side of FR310

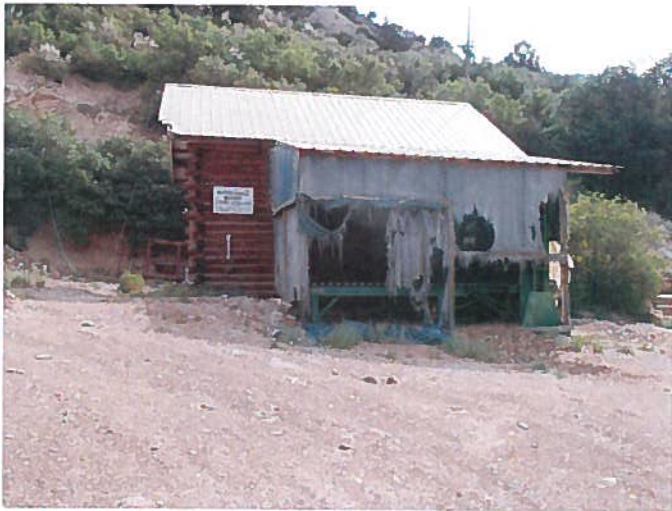
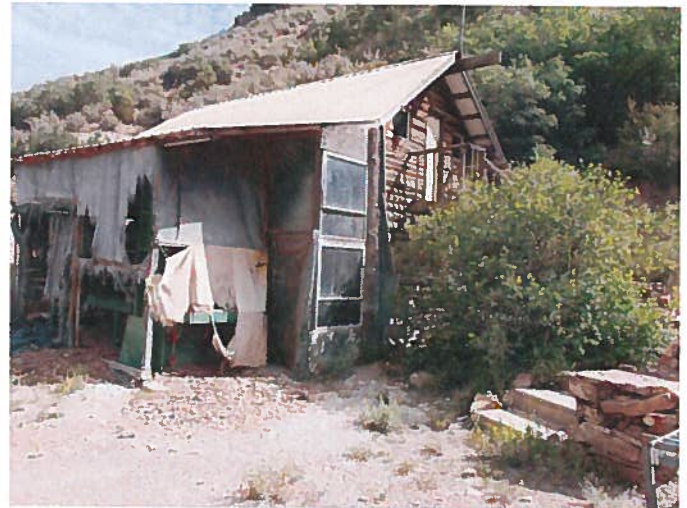
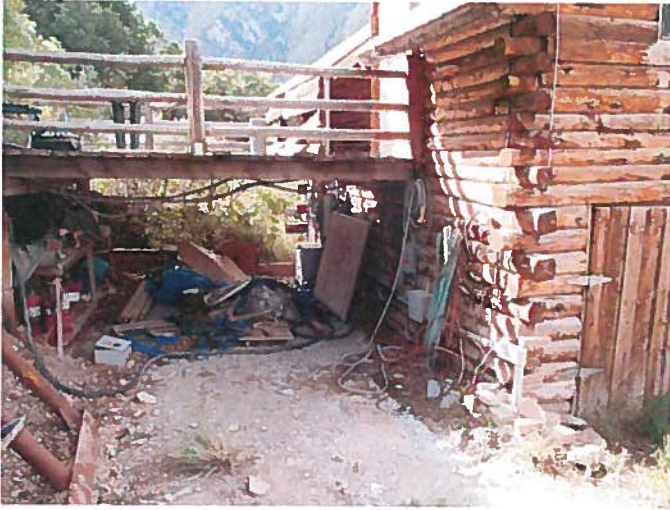
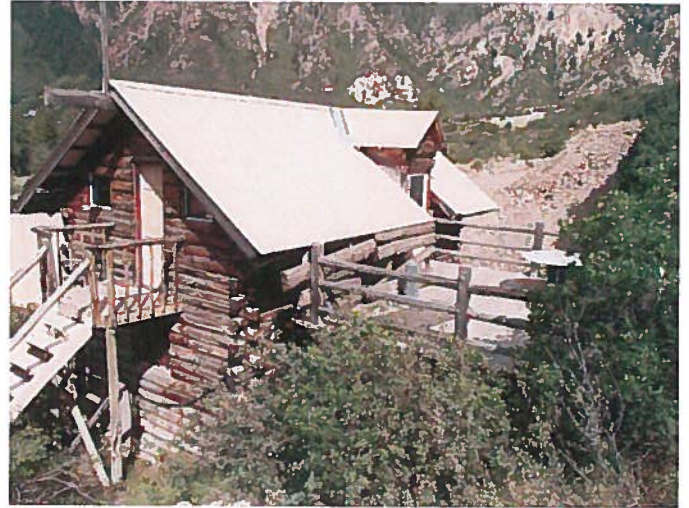
Figure 7: Cabin located on north side of FR 310

Figure 8: Cabin located on north side of FR 310

Figure 9: Cabin located on north side of FR 310

Figure 10: Cabin located on north side of FR 310

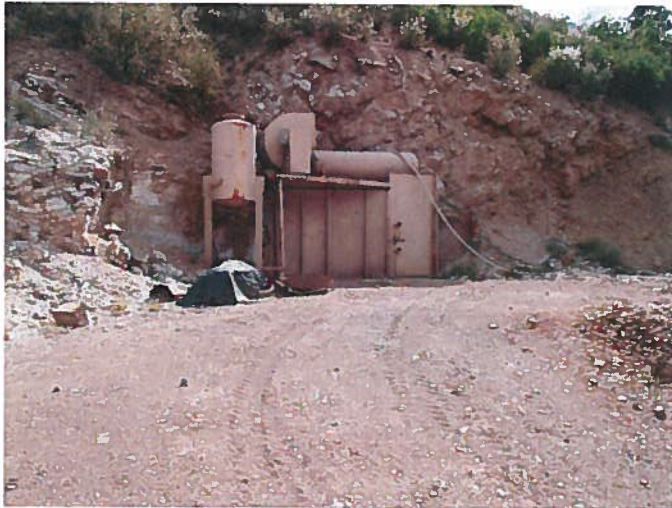
Figure 11: Portal entrance

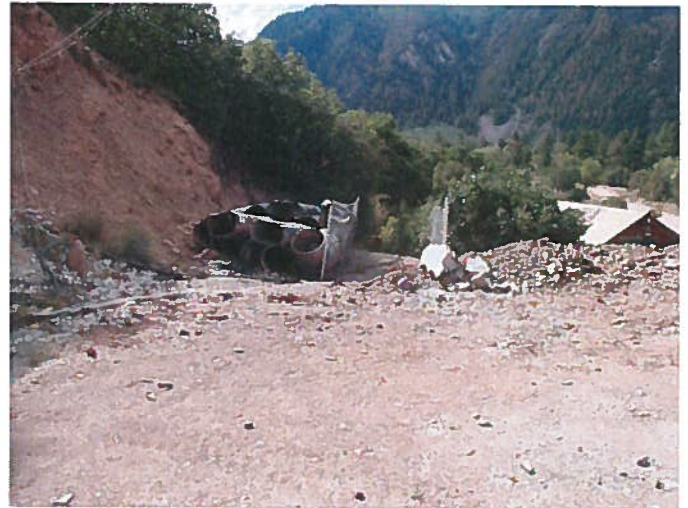
Figure 12: Vent pipe stored near portal entrance
