**COLORADO DIVISION OF RECLAMATION, MINING AND SAFETY
COAL PROGRAM INSPECTION REPORT**

Permit Number: C-1981-018 Mine Name: Deserado Mine Operator: Blue Mountain Energy, Inc Operator Address: Mr Scott Wanstedt 3607 County Road 65 Rangely, CO 81648	County: Rio Blanco Operation Type: Underground Permit Status: Active Ownership: Federal
	Operator Representative Present: Scott Wanstedt
Operator Representative Signature: (Field Issuance Only)

Inspection Start Date: July 30, 2013 Inspection Start Time: 08:00 Inspection End Date: July 30, 2013 Inspection End Time: 12:00	Inspection Type: Coal Partial Inspection Inspection Reason: Normal I&E Program Weather: Clear
Joint Inspection Agency: None	Joint Inspection Contacts: None
Post Inspection Agency: None	Post Inspection Contacts: None
Inspector(s): Zach T. Trujillo	Inspector's Signature:

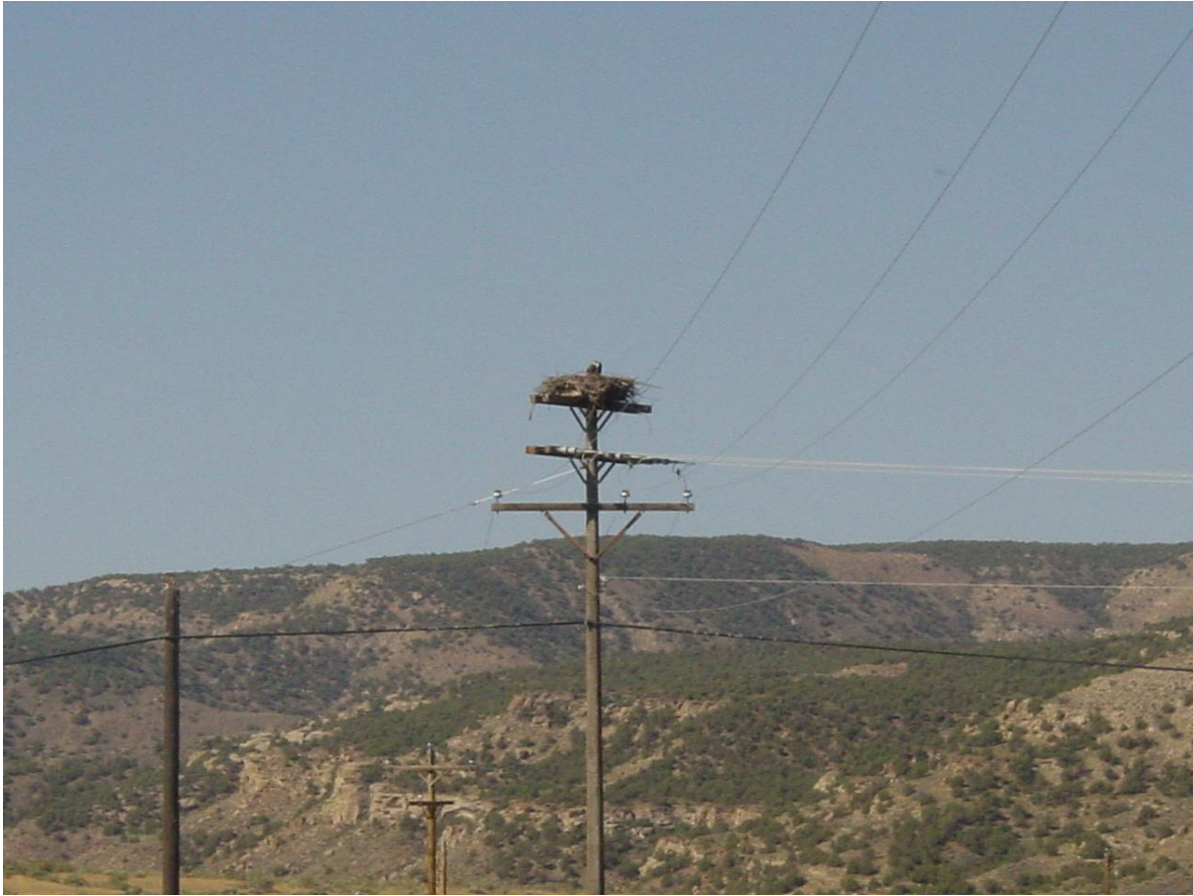
Three resident ospreys were observed along the Raw Water Lagoon. Osprey nest was observed to be on the perch above the power line pole.

Osprey and nest above the Raw Water Lagoon.

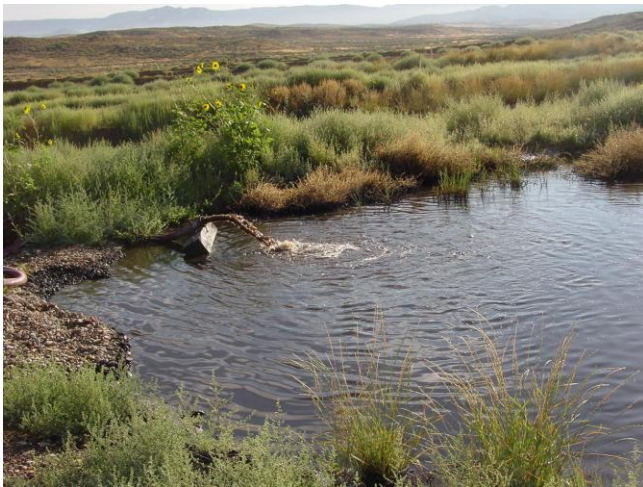
The B-seam Dewatering Pond was running for a short time during the time of the inspection. Issues with coagulant entering and mixing with the water properly was noted as the reason for the pumping to be stopped. Previous pumping has filled water up to the 5th pond where water was then being pumped into the artificial wetland to help flush and establish the area. Water has reached up to the 7th cell of the artificial wetlands. The Finishing Pond was dry and to the date of this inspection, no water has been discharged from the B-Seam Dewatering Pond system.

B-Seam Dewatering Pump.

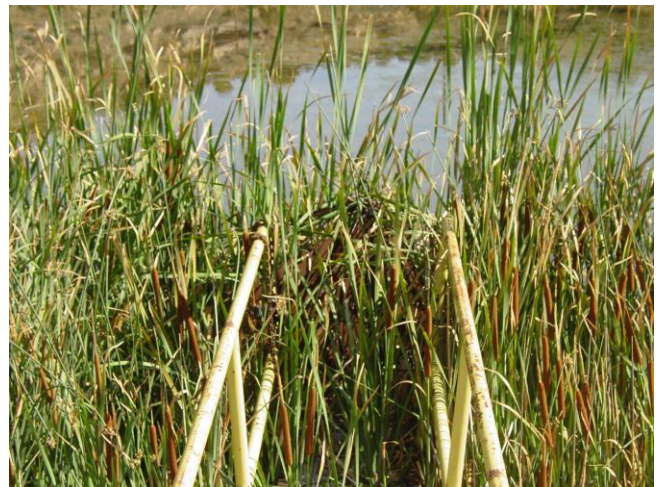
Pond DP-1 held water with no discharge during the time of the inspection. Large quantities of cat tails have grown within the pond and along the embankment. Cattails have formed around the primary spillway possibly impeding any flow that would occur during discharge and are in need of being removed from the inlet of the pipe.

Pond DP-1 primary spillway.

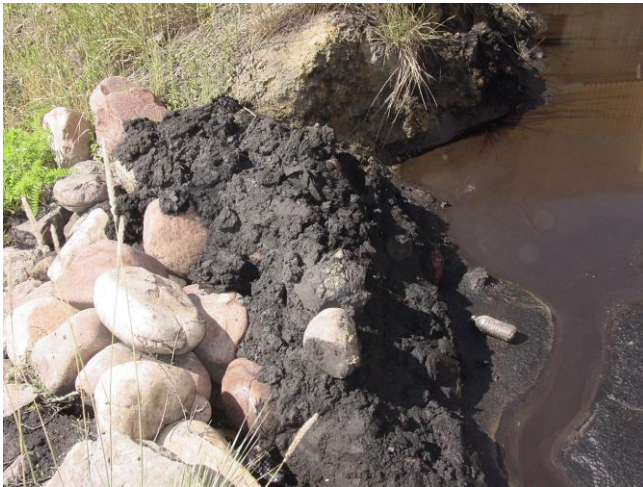
The rock check dam for the secondary channel into Pond DP-1 below the rotary breaker has sediment build around it and is need of being cleaned.

Rock check dam for secondary channel into DP-1.

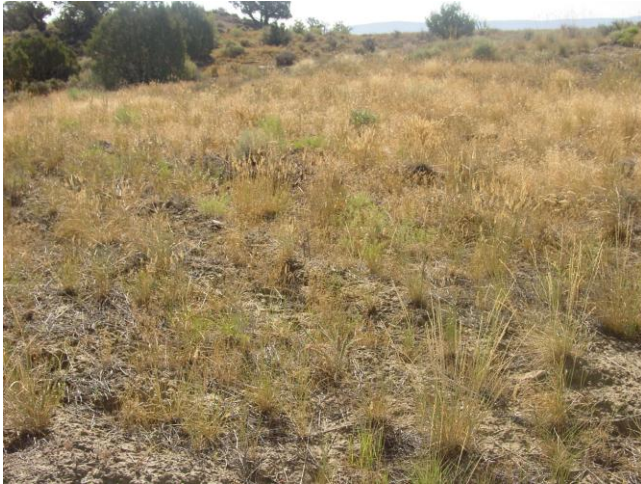
Multiple reclaimed degas and nitrogen injection bore holes and their related pads were inspected for reclamation success. The pads were reclaimed approximately 1 to 5 years ago. Vegetative growth was good and stable in all pads with no observations of noxious weeds. No erosion was noted on any of the sites.

Reclaimed degas/nitrogen injection bore hole pad.
