**COLORADO DIVISION OF RECLAMATION, MINING AND SAFETY  
COAL PROGRAM INSPECTION REPORT**

<b>Permit Number:</b> C-1981-010 <b>Mine Name:</b> Trapper Mine <b>Operator:</b> Trapper Mining, Inc. <b>Operator Address:</b> Mr. Forrest V Luke P.O. Box 187 Craig, CO 81626	<b>County:</b> Moffat <b>Operation Type:</b> Surface <b>Permit Status:</b> Active <b>Ownership:</b> Federal
<b>Operator Representative Present:</b>  Graham Roberts	
<b>Operator Representative Signature:</b> (Field Issuance Only)

<b>Inspection Start Date:</b> July 31, 2013 <b>Inspection Start Time:</b> 08:30 <b>Inspection End Date:</b> July 31, 2013 <b>Inspection End Time:</b> 11:15		<b>Inspection Type:</b> Coal Partial Inspection <b>Inspection Reason:</b> Normal I&E Program <b>Weather:</b> Clear	
<b>Joint Inspection Agency:</b>  None		<b>Joint Inspection Contacts:</b>	
<b>Post Inspection Agency:</b>  None		<b>Post Inspection Contacts:</b>	
<b>Inspector(s):</b>  Michael P. Boulay	<b>Inspector's Signature:</b>  <i>Michael P. Boulay</i>		<b>Signature Date:</b>  August 6, 2013

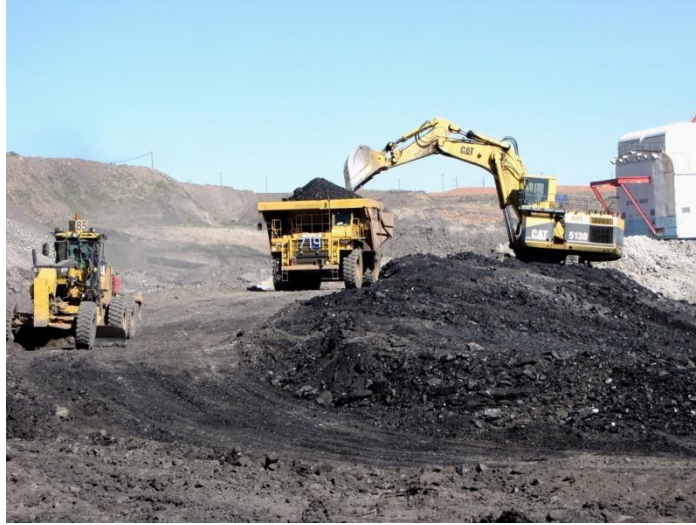
The K and L Pits were observed. Coal was being loaded and hauled from the K-Pit to the Power Plant. Overburden from the K-Pit was also being hauled and stockpiled. The Molly Brown dragline located at the L-Pit was not actively working at the time of the inspection. Backfill and grading operations and topsoil redistribution was also observed during this inspection.

Coal haul from K-Pit

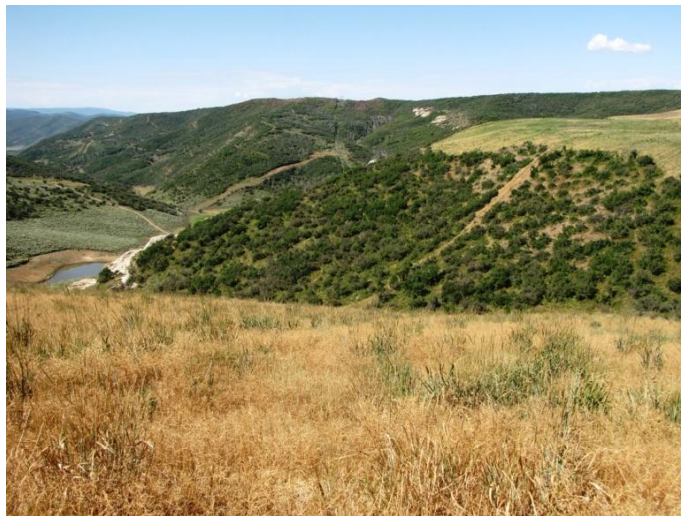
Several large drainage areas and ponds were viewed including Oak Gulch, Flume Gulch and Horse Gulch. Graham Roberts provided me with a general overview of the site including Trapper Mine's drainage reconstruction techniques. We inspected a new stock pond and newly constructed drainage channel at the Z-Pit. We also viewed the Phase III released A Pit drainage area and ponds.

All of the ponds inspected were retaining water. Pond inlets and discharge structures appeared stable with no problems identified.

Horse Gulch

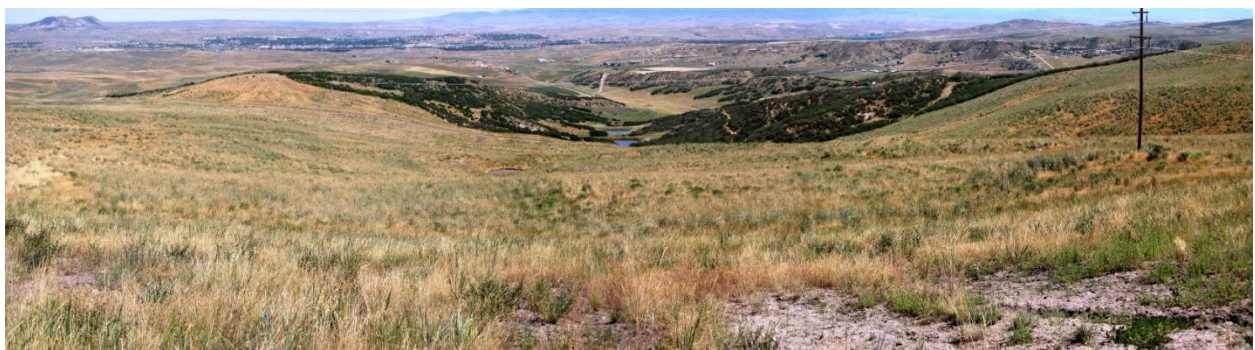
Oak Drainage

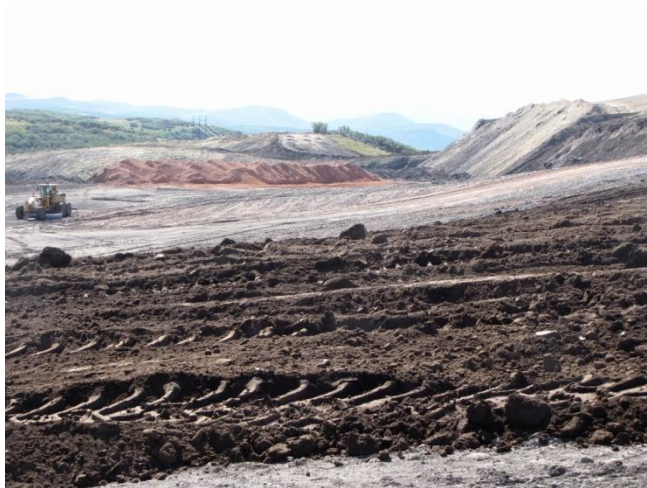
Topsoil replacement above K-Pit

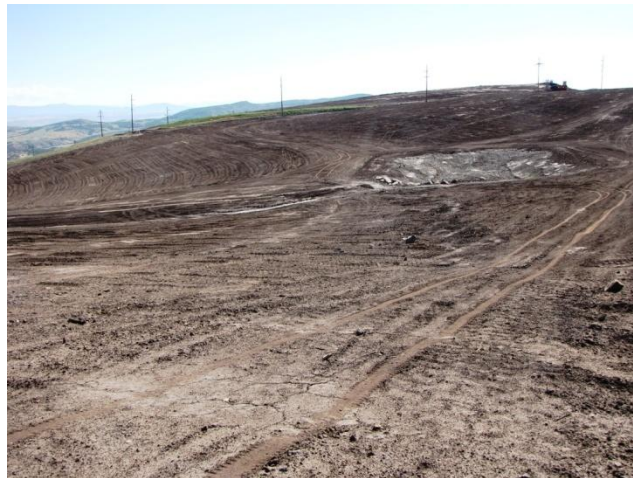
Newly constructed stock pond and drainage in Z-Pit

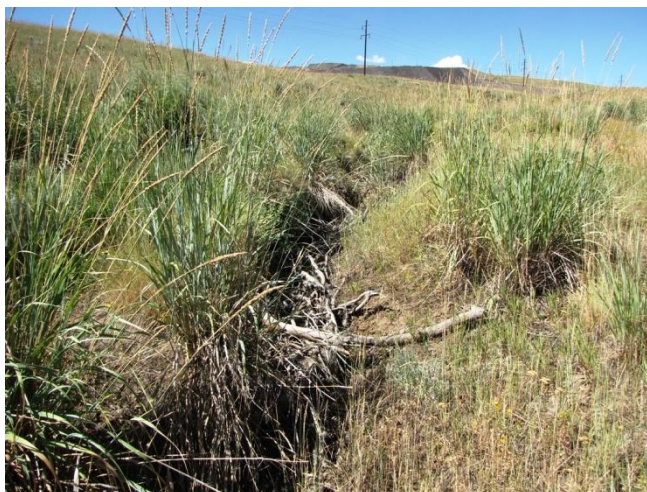
A-Pit drainage channel
