## COLORADO DIVISION OF RECLAMATION, MINING AND SAFETY COAL PROGRAM INSPECTION REPORT

<b>Permit Number:</b> C-1981-025 <b>Mine Name:</b> North Thompson Creek Mine <b>Operator:</b> MINREC, Inc. <b>Operator Address:</b> Mr. James E Stover 2352 N 7th St, Ste B Grand Junction, CO 81501	<b>County:</b> Garfield <b>Operation Type:</b> Underground <b>Permit Status:</b> Inactive <b>Ownership:</b> Federal
<b>Operator Representative Present:</b>  Stan Muhr	
<b>Operator Representative Signature: (Field Issuance Only)</b>

<b>Inspection Start Date:</b> July 8, 2013 <b>Inspection Start Time:</b> 12:00 <b>Inspection End Date:</b> July 8, 2013 <b>Inspection End Time:</b> 15:00	<b>Inspection Type:</b> Coal Complete Inspection <b>Inspection Reason:</b> Normal I&E Program <b>Weather:</b> Clear
<b>Joint Inspection Agency:</b>  None	<b>Joint Inspection Contacts:</b>  
<b>Post Inspection Agency:</b>  None	<b>Post Inspection Contacts:</b>  
<b>Inspector(s):</b>  Brock F. Bowles  David A. Berry	<b>Inspector's Signature:</b>

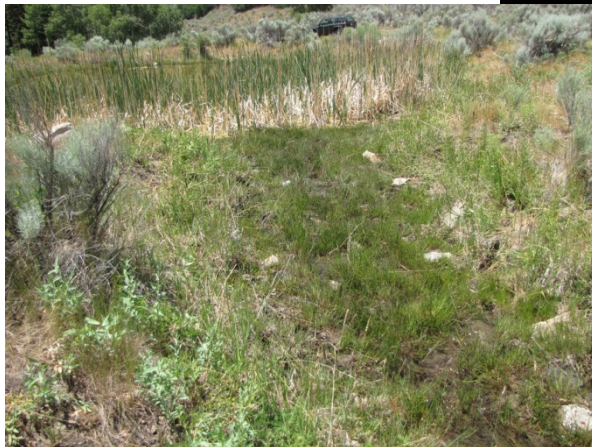
Both the #1 and #3 portals were discharging into the long pond and the water was clear. The long pond berm was well vegetated and appeared to be stable. Water was flowing into the T1 pond from the long pond. The open ditch between the T1 and T2 ponds was well vegetated and appeared to be stable (photo 1). The water was directed from T2 to the P9 pond (photo 2) which contained water but was not discharging. The pipes that were in the open ditch between Pond T2 and Outfall 001 during the last inspection had been removed (photo 3). The discharge pipe leading from Outfall 001, which was obstructed during the last inspection, had been cleaned.

Photo 1 – Open Ditch Between Ponds T1 and T2

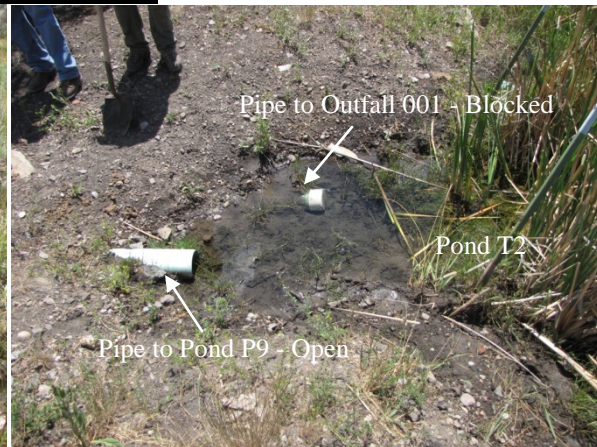
Photo 2 – Diversion Structure at Pond T2 Outlet

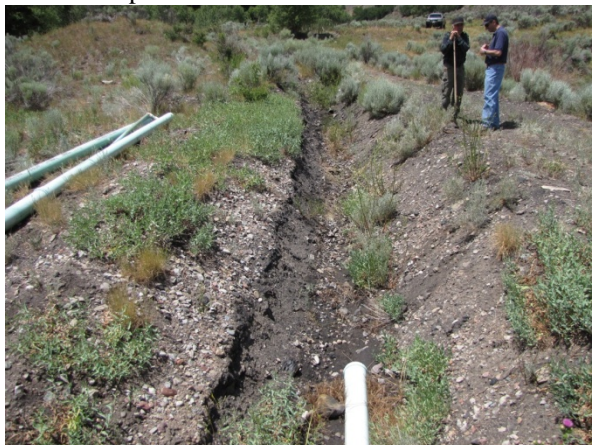
Photo 3 – Pipes Removed From Ditch

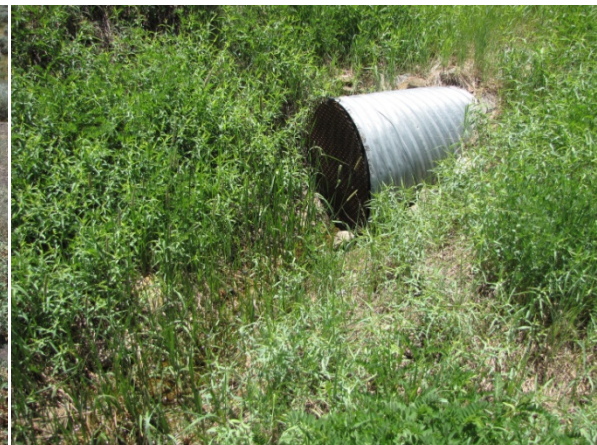
Water was noted seeping from the 36-inch air shaft access culvert (photo 4). This culvert is located on the south side of North Thompson Creek by Portal #1. Standing water was in the ditch leading from the culvert to North Thompson Creek. The culvert has a locked grate to prevent access. The Division recommends that the water seeping out of the culvert be tested to determine if treatment is necessary. The water should be tested for the parameters outlined in the current NPDES permit.

Photo 4 – Fan Shaft Access Culvert is Seeping Water
