**COLORADO DIVISION OF RECLAMATION, MINING AND SAFETY
COAL PROGRAM INSPECTION REPORT**

Permit Number: C-1994-082 Mine Name: Yoast Mine Operator: Seneca Coal Company, LLC Operator Address: Mr. Roy Karo 37796 Routt County Road 53 P.O. Box 670 Hayden, CO 81639	County: Routt Operation Type: Surface Permit Status: Permanent Cessation Ownership: Federal
Operator Representative Present:	
Operator Representative Signature: (Field Issuance Only)

Inspection Start Date: July 30, 2013 Inspection Start Time: 11:45 Inspection End Date: July 30, 2013 Inspection End Time: 13:20	Inspection Type: Coal Partial Inspection Inspection Reason: Normal I&E Program Weather: Clear
Joint Inspection Agency: None	Joint Inspection Contacts:
Post Inspection Agency: None	Post Inspection Contacts:
Inspector(s): Michael P. Boulay	Inspector's Signature: <i>Michael P. Boulay</i> Signature Date: August 7, 2013

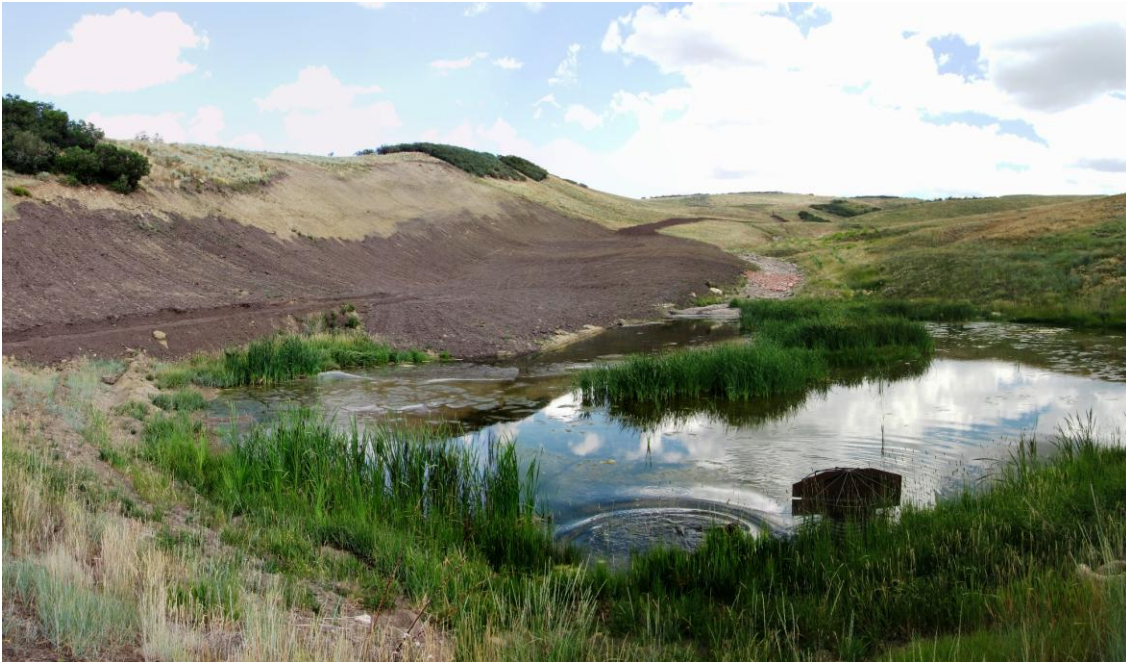
Pond 012 has been significantly impacted by the slide damaged area immediately north of the pond (see attached Photograph No. 1). Substantial slide repair work has been completed over several years at this location and it now appears that the area is stabilizing. There was no indication of additional slumping or cracking noted during this inspection.

Photo No. 1 - Pond 012

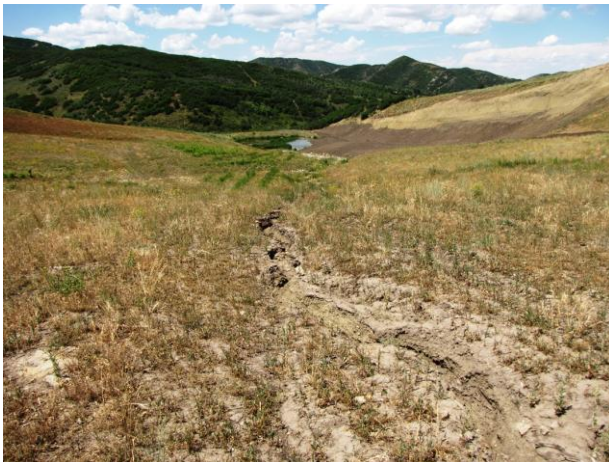
Formation of a significant rill was noted in the Pond 012 watershed uphill of Pond 012 (see Photo No. 2). This rill should be filled and regarded to prevent further erosion and damage to the vegetation in this area. This small area should be seeded this fall after the erosion has been repaired.

Photo No. 2 - Rill forming above pond 012

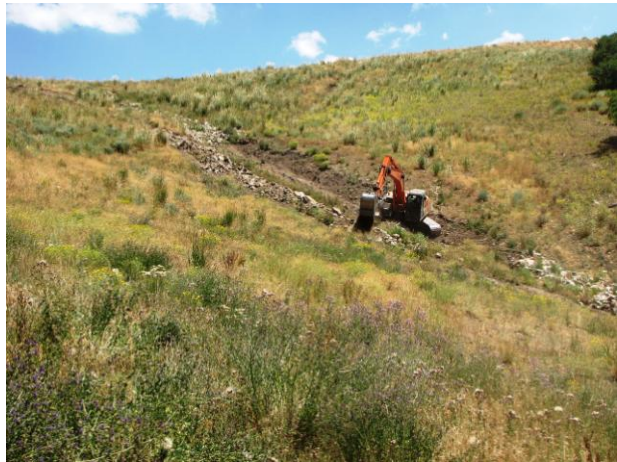
A portion of Post Mine Channel YPM-7 has been damaged from recent rainstorms. The location is below the former Haul Road. A trackhoe was working to repair the drainage at the time of this inspection (Photo No. 3).

Photo No. 3 - Trackhoe repairing YPM-7

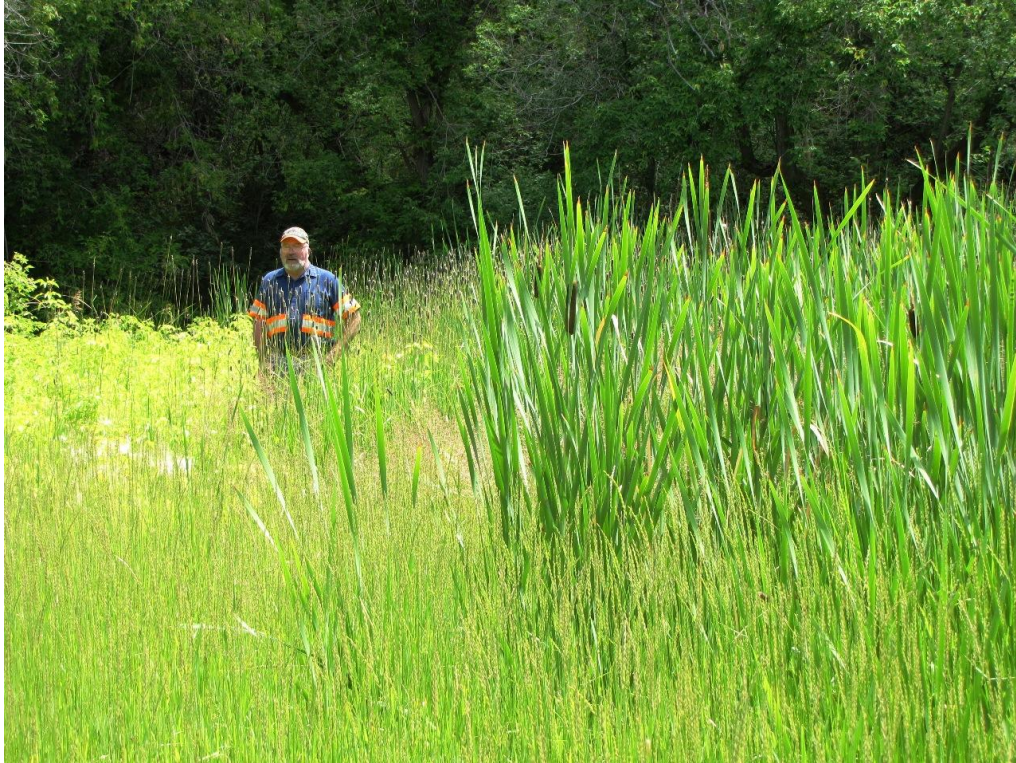
The lower Annand Draw drainage was inspected. The rock check dams that were constructed here have performed well. The check dams have filled in with sediment allowing thick vegetation to grow in the channel

bottom (Photo No. 4). The significant erosion that had occurred in this stretch of the lower Annand Draw has healed and the sediment control structures worked as designed by controlling the erosion and preventing further damage to the channel.

Photo No. 4 – Lower Annand Draw

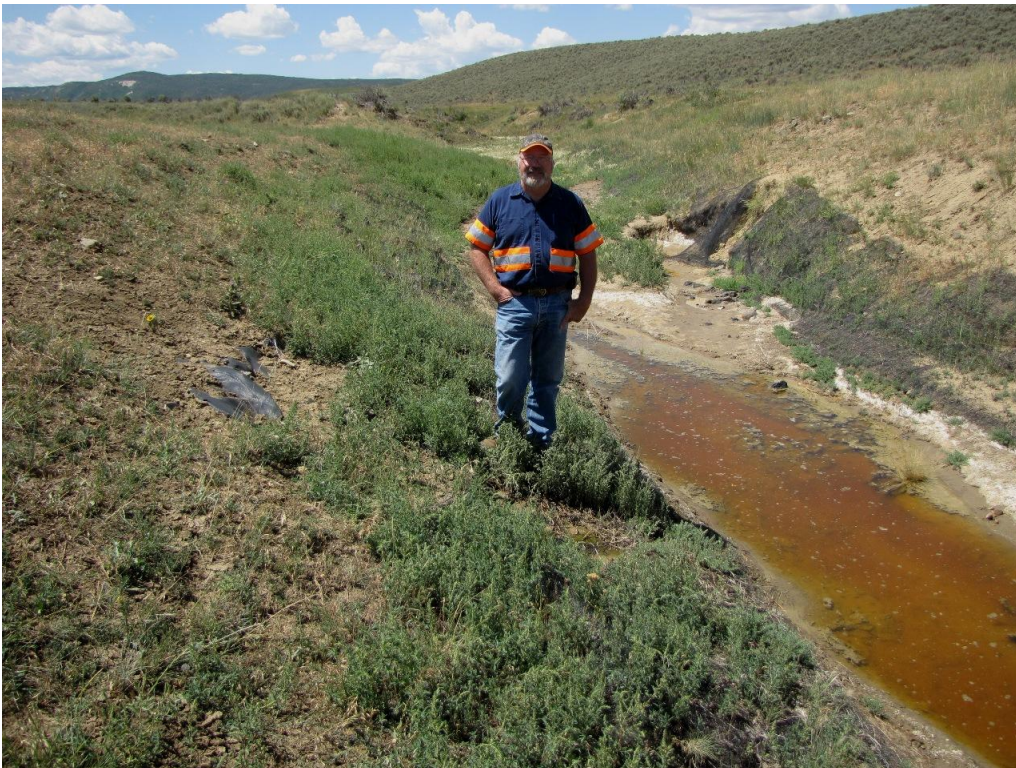
The deadhead route where the 650 dragline was walked across a portion of Mr. John Maneotis's property in 1996 was inspected. The location is to the west of former Haul Road A. It was necessary to access Mr. Maneotis's property in 1996 in order to clear the 650 dragline beneath the PSCo/WAPA power lines that crossed Haul Road A. The deadhead route to walk under the power lines was reclaimed shortly after it was utilized and this included a reclaimed drainage channel design. In 2007 the channel was redesigned and reconstructed to provide a steeper gradient due to water backing up in the channel and to repair a hillside seep that had formed above and adjacent to the channel. The reconstructed channel has held up well and is functioning as intended. The seep was repaired by installing a French drain which diverts the flow to the drainage channel below. The seep repair is also functioning properly. The constructed channel on the Maneotis property and the former deadhead route location is shown in Photo No. 5.

Photo No. 5 - Former deadhead route on Maneotis property.
