**COLORADO DIVISION OF RECLAMATION, MINING AND SAFETY
COAL PROGRAM INSPECTION REPORT**

Permit Number: C-1982-057 Mine Name: Seneca II-W Mine Operator: Seneca Coal Company, LLC Operator Address: Mr. Roy Karo 37796 Routt County Road 53 P.O. Box 670 Hayden, CO 81639	County: Routt Operation Type: Surface Permit Status: Permanent Cessation Ownership: Federal
	Operator Representative Present: Roy Karo
Operator Representative Signature: (Field Issuance Only)

Inspection Start Date: July 30, 2013 Inspection Start Time: 08:30 Inspection End Date: July 30, 2013 Inspection End Time: 11:30		Inspection Type: Coal Partial Inspection Inspection Reason: Normal I&E Program Weather: Clear	
Joint Inspection Agency: None		Joint Inspection Contacts:	
Post Inspection Agency: None		Post Inspection Contacts:	
Inspector(s): Michael P. Boulay	Inspector's Signature: <i>Michael P. Boulay</i>		Signature Date: August 7, 2013

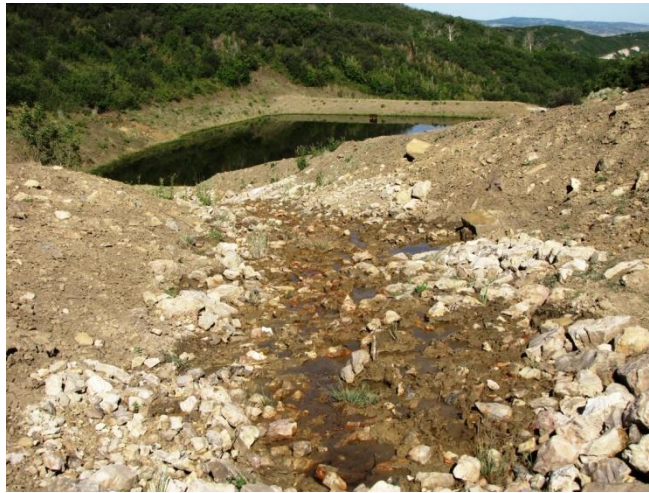
The groundwater seep that resulted from the damaged and subsequently abandoned monitoring wells at the inlet of Pond 016 was inspected. It continues to flow at a low rate and is routed by a French drain to Pond 016. The location of the seep is well armored with riprap and remains stable.

Groundwater seep at Pond 016

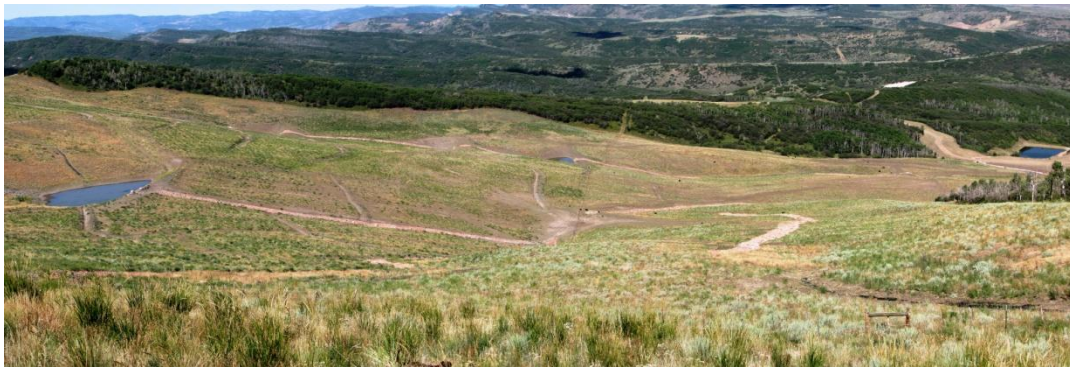
Cattle were grazing in the Pond 016 watershed in the vicinity of Stock Ponds 27 and 28. These stock ponds were retaining significant amounts of water.

Stock ponds in Pond 016 watershed

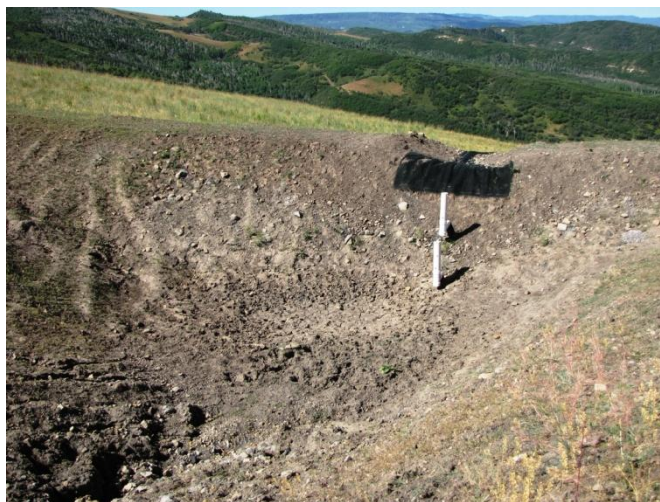
Several surge ponds were viewed and they appear to be in good condition and functional.

Surge pond in pond 017 drainage

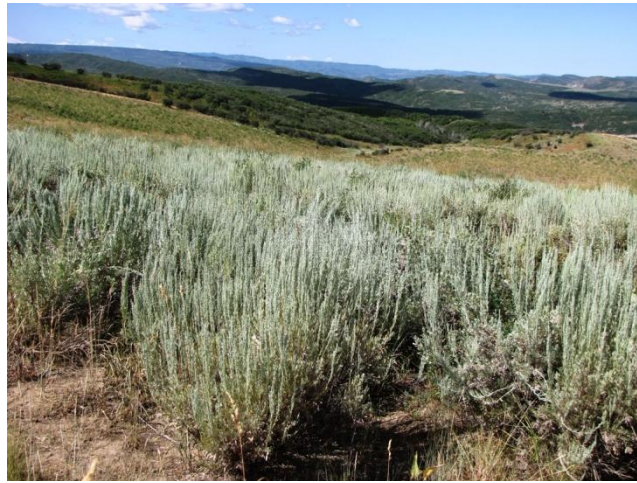
Overall the reclaimed areas of the mine site looked good with no significant erosion or instability problems identified. Vegetation in the former A and B Pits has become fairly well established.

Good vegetation reestablishment in reclaimed area

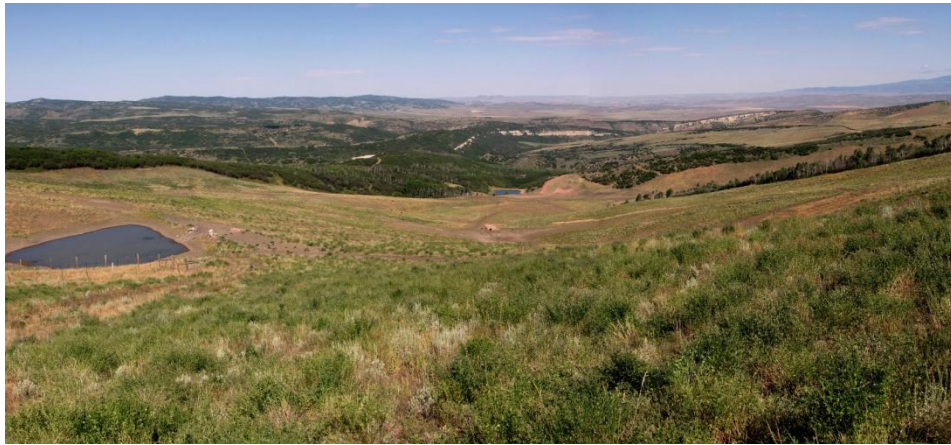
Panorama of reclaimed A & B Pits

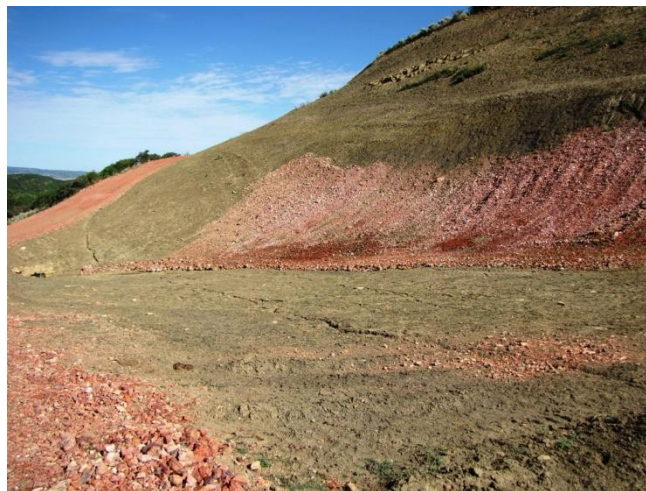
The slide area located in the vicinity of the Pond 016 access road was inspected. A couple small cracks are apparent in vicinity of the original slide location. They appear to be minimal at this time. SCC will continue to visually monitor the slide damaged area for any additional movement or instability.

Slide damaged area above Pond 016
