**COLORADO DIVISION OF RECLAMATION, MINING AND SAFETY  
COAL PROGRAM INSPECTION REPORT**

<b>Permit Number:</b> C-1992-081 <b>Mine Name:</b> Hayden Gulch Loadout <b>Operator:</b> Hayden Gulch Terminal, LLC <b>Operator Address:</b> Mr. Roy Karo 37796 Routt County Road 53 P.O. Box 670 Hayden, CO 81639	<b>County:</b> Routt <b>Operation Type:</b> Loadout <b>Permit Status:</b> Permanent Cessation <b>Ownership:</b> Private
	<b>Operator Representative Present:</b>  Roy Karo
<b>Operator Representative Signature:</b> (Field Issuance Only)

<b>Inspection Start Date:</b> July 30, 2013 <b>Inspection Start Time:</b> 13:30 <b>Inspection End Date:</b> July 30, 2013 <b>Inspection End Time:</b> 14:10	<b>Inspection Type:</b> Coal Partial Inspection <b>Inspection Reason:</b> Normal I&E Program <b>Weather:</b> Clear
<b>Joint Inspection Agency:</b>  None	<b>Joint Inspection Contacts:</b>
<b>Post Inspection Agency:</b>  None	<b>Post Inspection Contacts:</b>
<b>Inspector(s):</b>  Michael P. Boulay	<b>Inspector's Signature:</b>  <i>Michael P. Boulay</i> <b>Signature Date:</b>  August 7, 2013

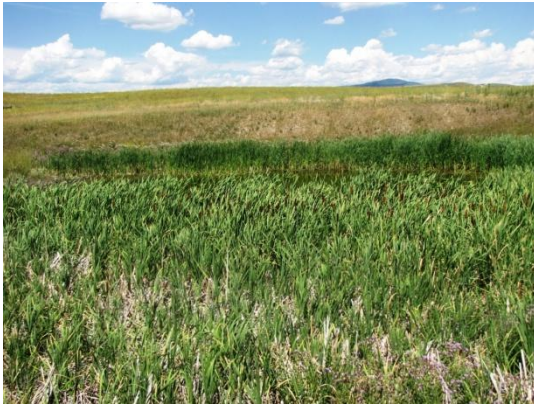
Two sediment ponds remain at the site and provide sediment control for runoff from the Loadout area. The Truck Loop Pond is NPDES Outfall 01A and the Rail Loop Pond is NPDES Outfall 02A. The Truck Loop Pond was retaining water but was not discharging. The Rail Loop Pond was dry. Pond inlets and discharge structures appeared to be functional at both ponds and pond embankments were stable and well vegetated.

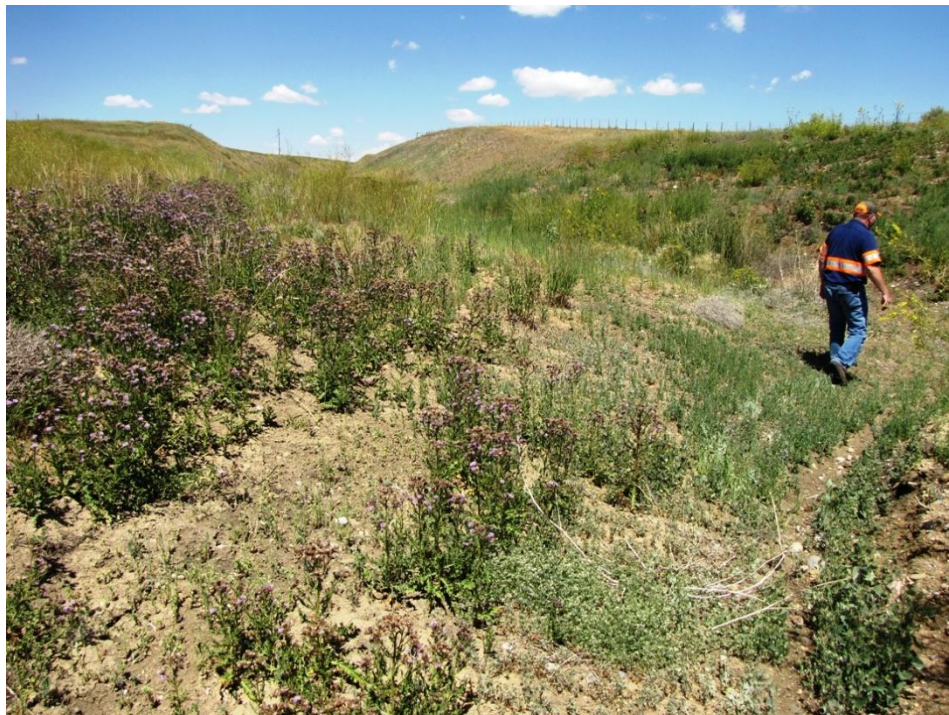
Overall the site is stable with no significant erosion occurring. A substantial patch of Canada thistle was noted near the central portion of the site adjacent to Ditch 8. Canada thistle is a Colorado List B Noxious Weed. Please continue to control the growth of noxious weeds in accordance with the approved weed management plan.

Canada thistle alongside of Ditch 8
