**COLORADO DIVISION OF RECLAMATION, MINING AND SAFETY  
COAL PROGRAM INSPECTION REPORT**

| <b>Permit Number:</b> C-1996-084<br><b>Mine Name:</b> Lorencito Canyon Mine<br><b>Operator:</b> New Elk Coal Company, LLC<br><b>Operator Address:</b><br>Mr Ron Thompson<br>12250 Highway 12<br>Weston, CO 81091 | <b>County:</b> Las Animas<br><b>Operation Type:</b> Surface<br><b>Permit Status:</b> Permanent Cessation<br><b>Ownership:</b> Private |

| <b>Inspection Start Date:</b> July 23, 2013<br><b>Inspection Start Time:</b> 12:48<br><b>Inspection End Date:</b> July 24, 2013<br><b>Inspection End Time:</b> 16:30 | <b>Inspection Type:</b> Coal Complete Inspection<br><b>Inspection Reason:</b> Normal I&E Program<br><b>Weather:</b> Clear |

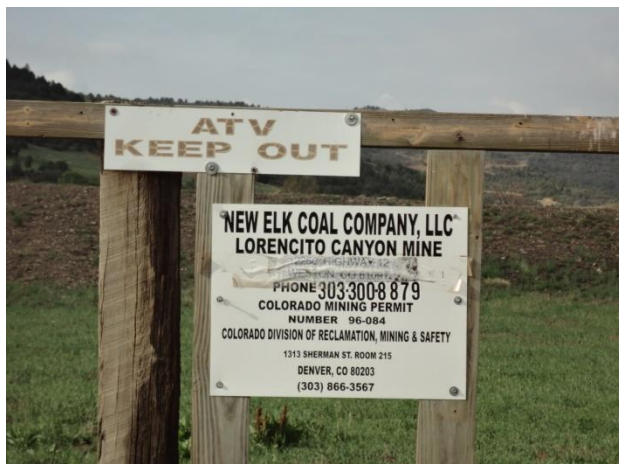
Mine ID signs have been temporarily altered to bring them into compliance. **New signs, or permanent alterations, are needed.**

Photo 1: Mine ID sign

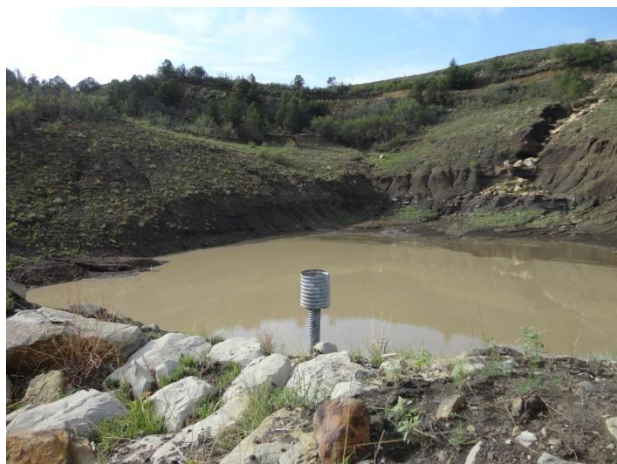
Pond 9B was discharging. The discharge was quite “murky”, but had not yet been sampled. Both spillways were in good order, although the weir box on the primary spillway was partially full. Some work had been done to clear the sediment from around the primary spillway riser, but the recent heavy rain had largely undone the work. At the time of the inspection the water level was above the height of the weep-holes. **When conditions allow, the sediment around the riser should be cleared.** Immediately surrounding the pond were 3 gullies. The first two were actively eroding topsoil, but the third, which was much larger, had cut to bedrock along the lower section. **The first two should be repaired. Repair may not be appropriate in the third, but it should certainly be monitored with great care since it could undermine the road if it were to continue to erode.**

Photo 2: Pond 9B

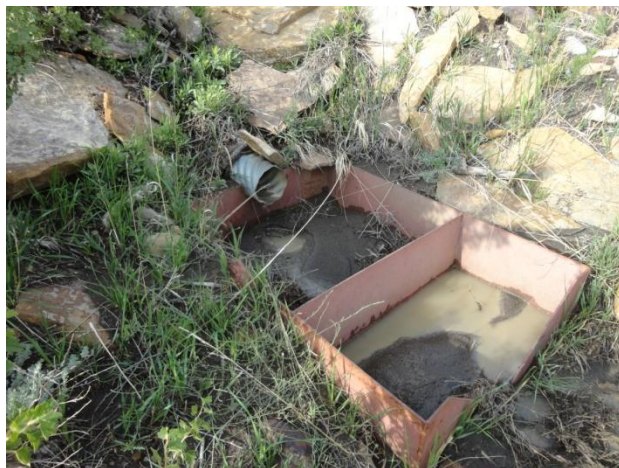
Photo 3: Pond 9B weir box

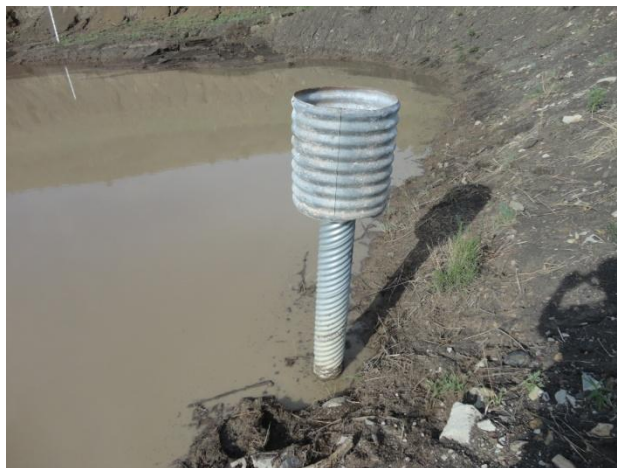
Photo 4: Pond 9B primary spillway riser

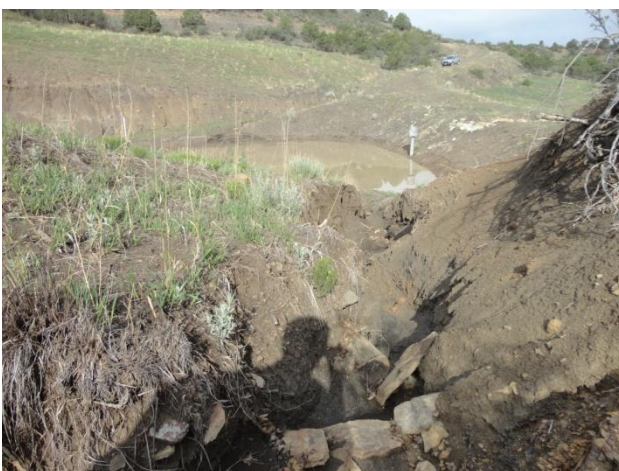
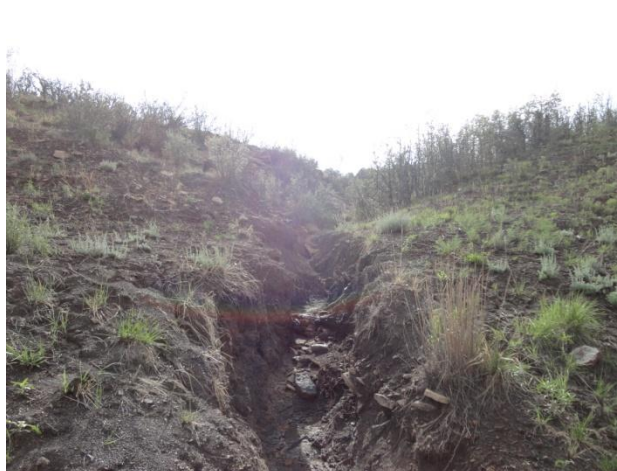
Photo 5: Pond 9B, first gully (1)

Photo 6: Pond 9B, first gully (2)

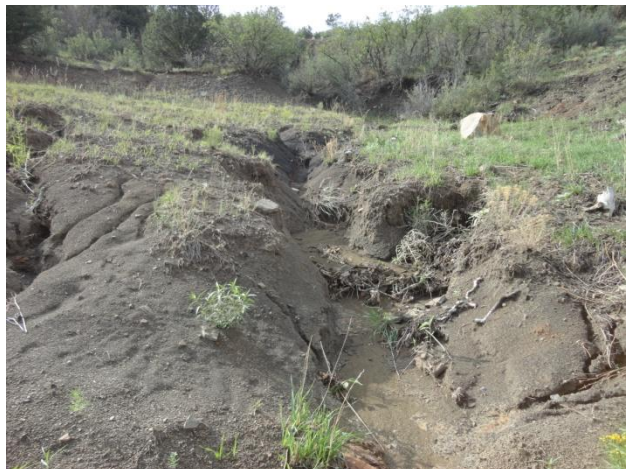
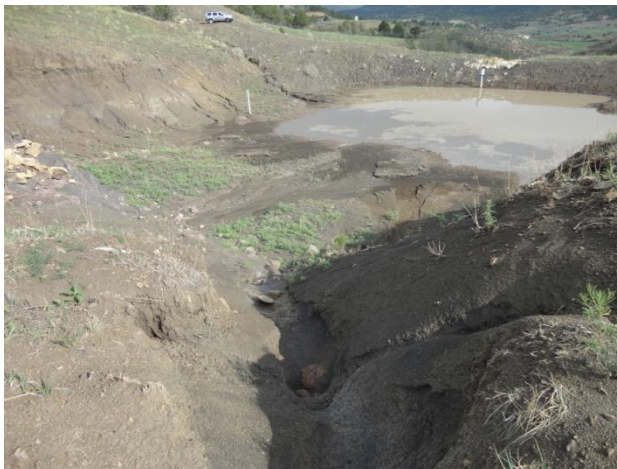
Photo 7: Pond 9B, second gully (1)

Photo 8: Pond 9B, second gully (2)

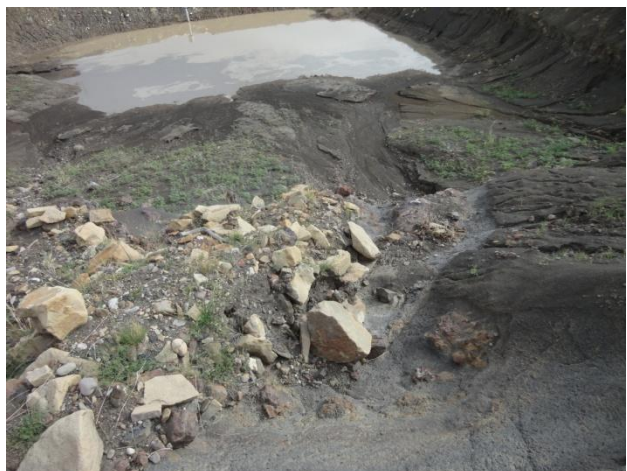
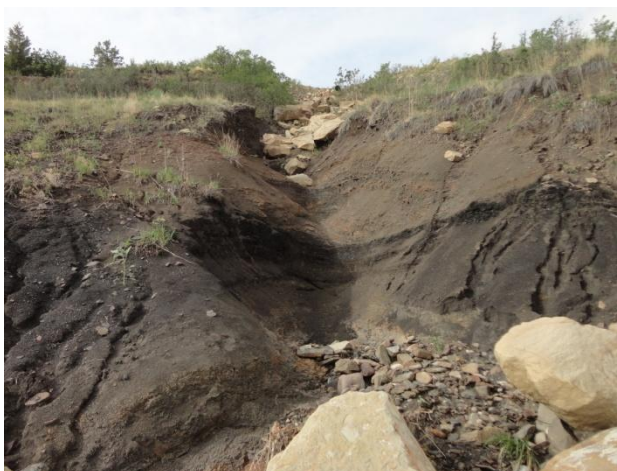
Photo 9: Pond 9B, third gully (1)

Photo 10: Pond 9B, third gully (2)

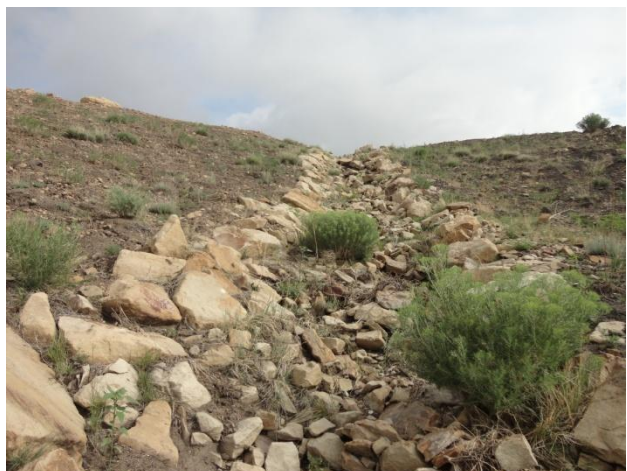
Photo 11: Excellent east down-drain on fill 9

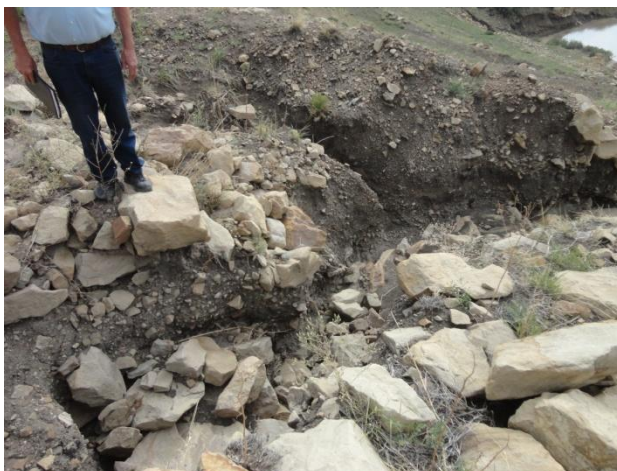
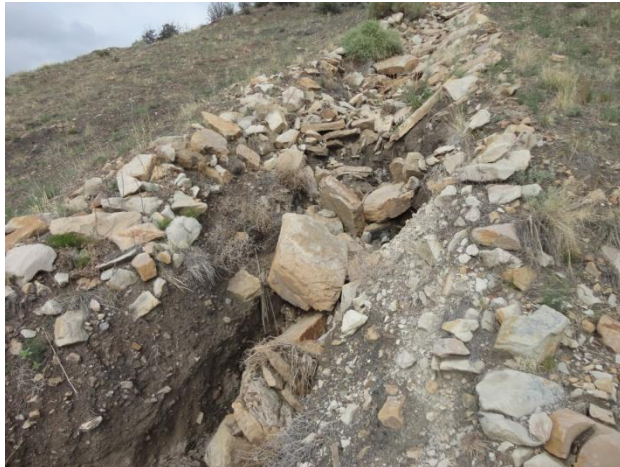
On Fill 9 there was no significant erosion on any of the faces or benches. The armored down-drain on the east side was in excellent shape, with plants growing between the rip-rap. The down-drain on the west side of the fill had some erosion, particularly at the end of the contour ditch, but also lower down. **The erosion should be repaired**; Mr Thompson suggested that this could be done by the end of September. The channel was obviously re-routed many years ago; **NECC should verify that the structure on the ground matches the design in the permit**.

Photo 12: West down-drain on fill 9 needing repair (1)

Photo 13: West down-drain on fill 9 needing repair (2)

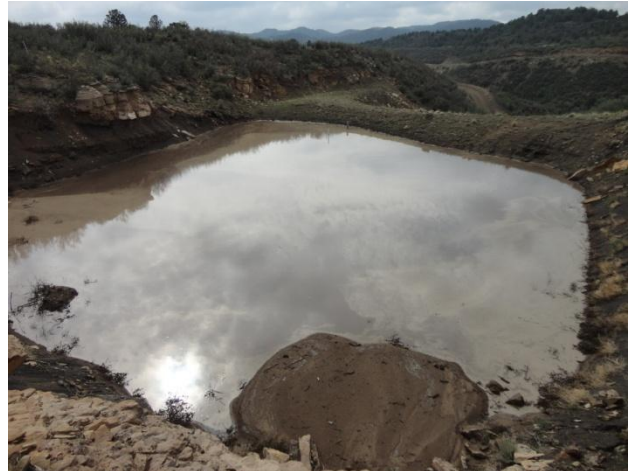
Pond 9A was discharging. It had not been sampled, but again the discharge appeared cloudy. No problems were observed with the spillways or embankments.

Photo 14: Pond 9A

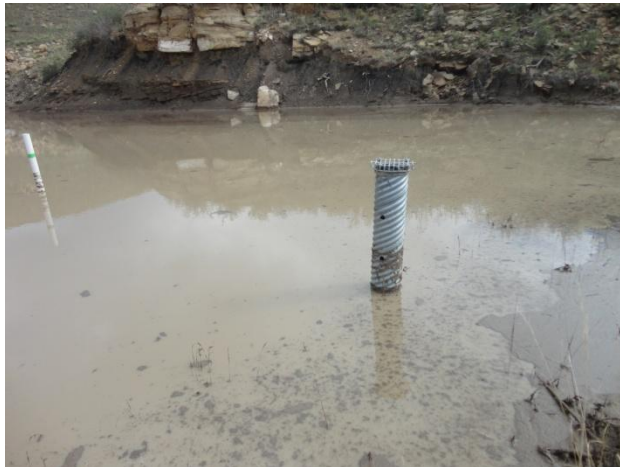
Photo 15: Pond 9A riser

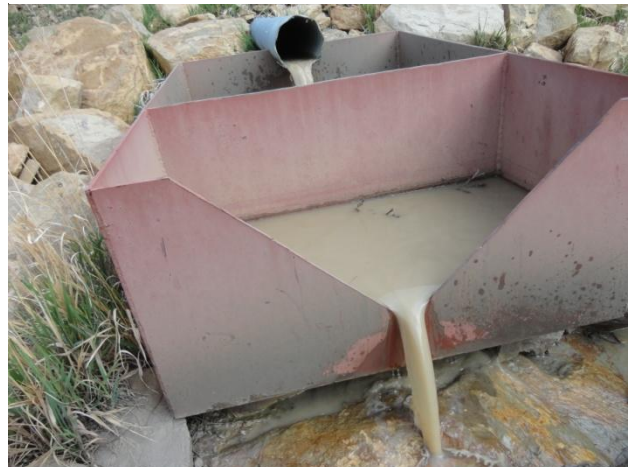
Photo 16: Pond 9A discharge

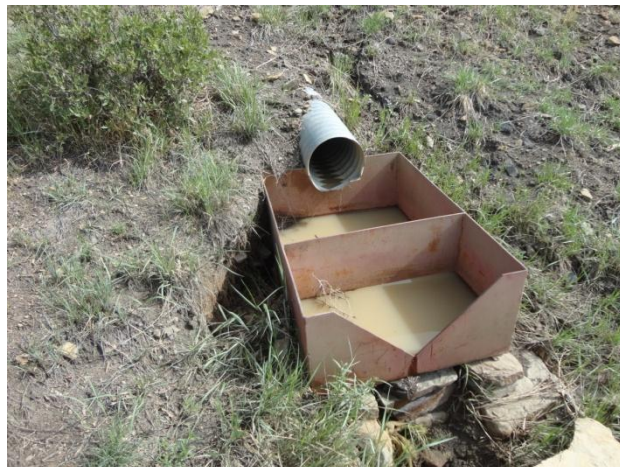
Photo 17: Pond 7 discharge

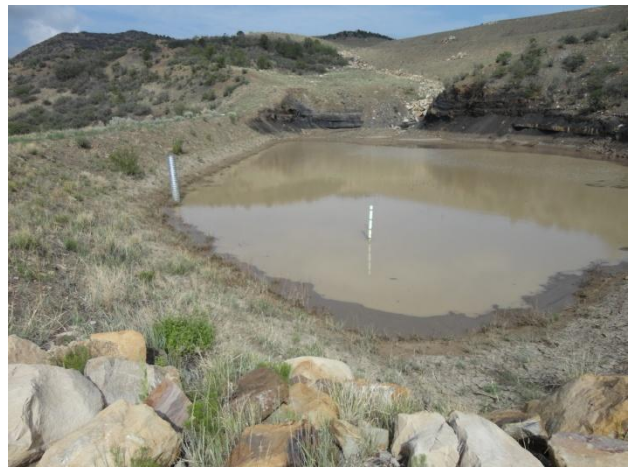
Photo 18: Pond 7

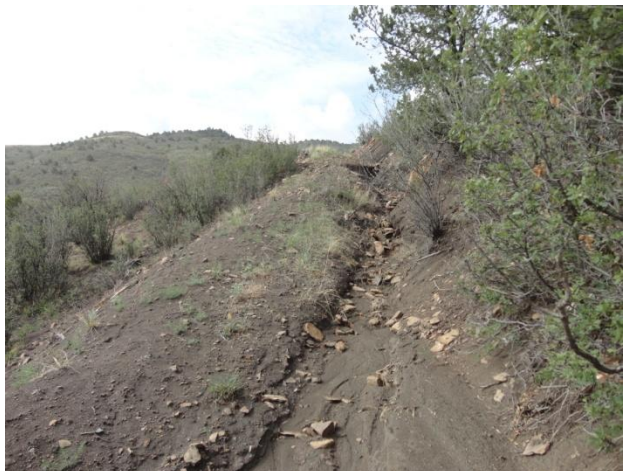
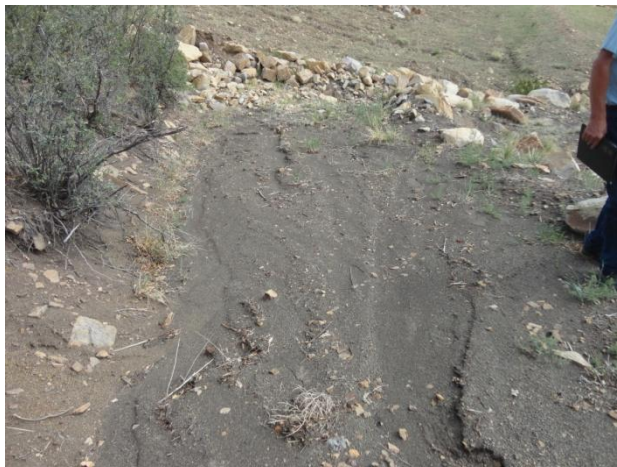
Fill 7 was in good shape, with no significant erosion. A little water had ponded in a couple of the contour ditches, but had not overflowed. It would be advisable for NECC to remove some of the sediment from these ditches to ensure that no water is allowed to cascade down the face of the fill.

Photo 19: Contour ditch west of fill 7 to be cleaned (1)

Photo 20: Contour ditch west of fill 7 to be cleaned (2)

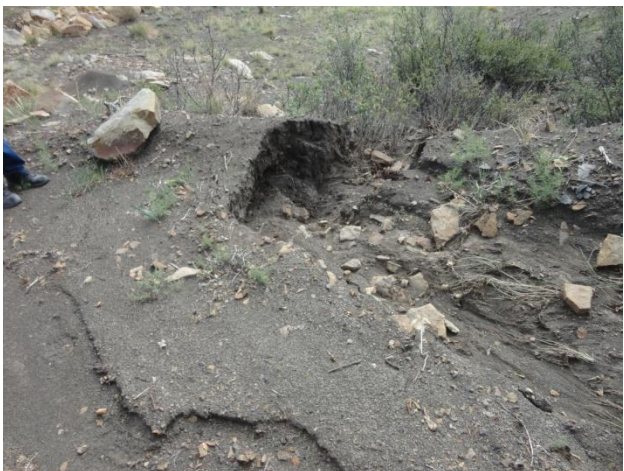
Photo 21: Erosion caused by breach of ditch shown in 19 & 20

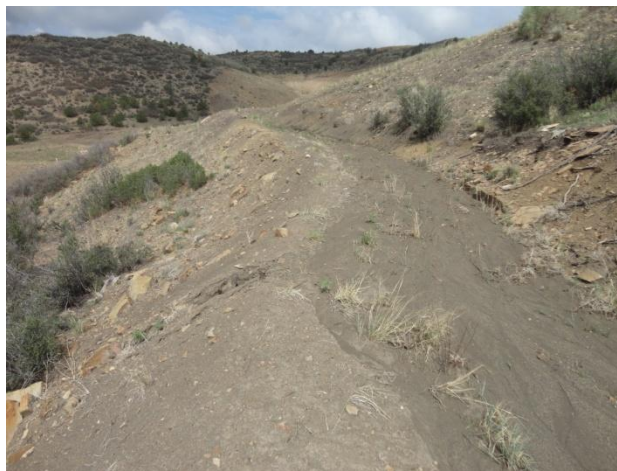
Pond 7 was barely discharging. No problems were observed with the spillways or embankments. Above the pond, west of the fill, the side ditch had filled with sediment and had breached in several places. Further erosion had been caused down the slope from the breaches. **The erosion and the ditch should be repaired.**

Photo 22: Breach of ditch between ponds 7 and 6

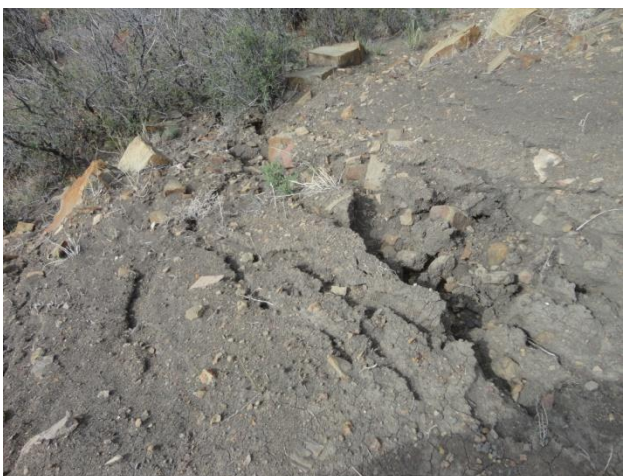
Photo 23: Erosion caused by breach shown in 22

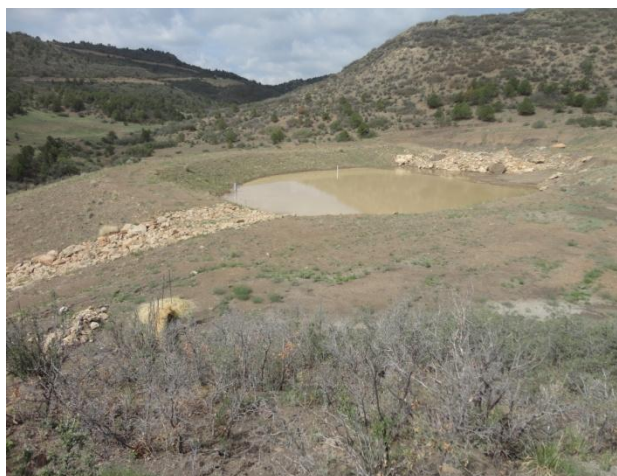
Photo 24: Pond 6

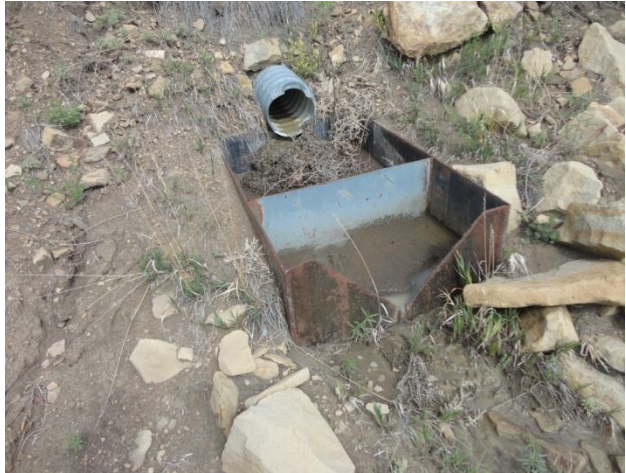
Photo 25: Pond 6 discharge

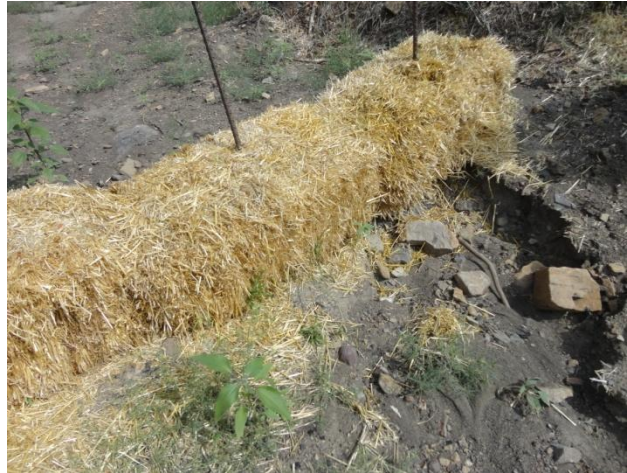
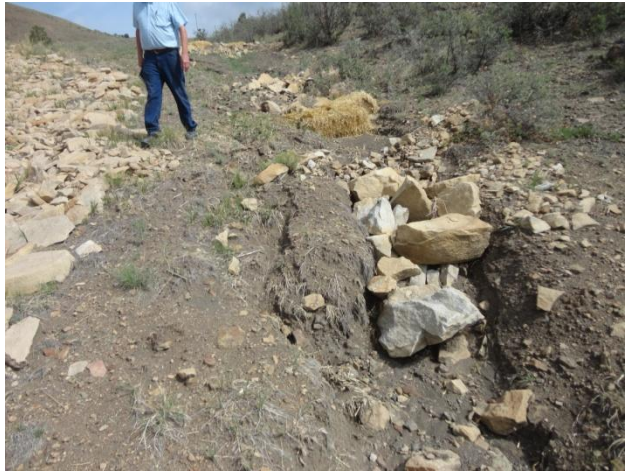
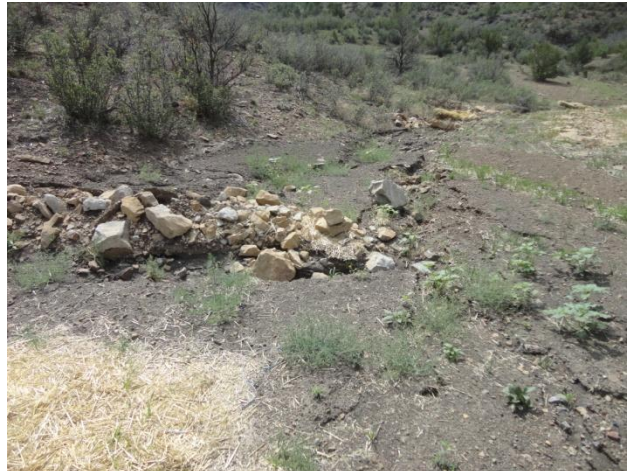
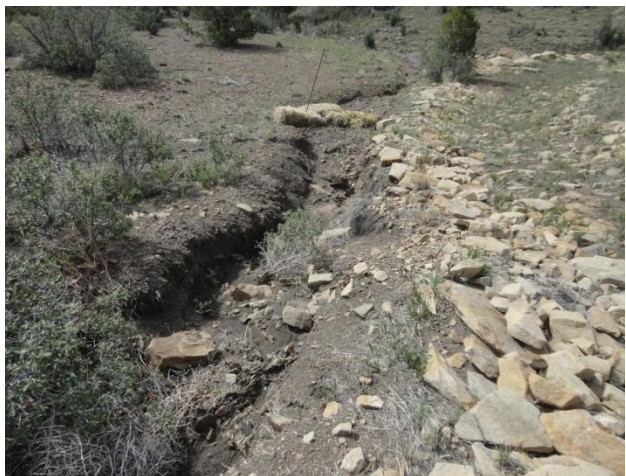
Pond 6 was discharging. The spillways and embankment were in good order. Flow control measures outside had been effective, but had been damaged by the recent heavy rain. **The flow control measures should be repaired.** Above pond 6 the recently placed rock-check dams and straw bales had caught a lot of sediment and were full up. **The sediment should be removed and the structures repaired.** Further up, the steep slope is a problem that needs a long term solution to allow the establishment of vegetation. A contour ditch could be difficult to fit it, but would be worth investigating; straw wattles may be easier to implement - in either case, **considerable repair and maintenance is needed if the slope is ever to meet the criteria for bond release.**

Photo 26: Erosion next to pond 6 emergency spillway (1)

Photo 27: Erosion next to pond 6 emergency spillway (2)

Photo 28: Erosion next to pond 6 emergency spillway (3)

Photo 29: Erosion next to pond 6 emergency spillway (4)

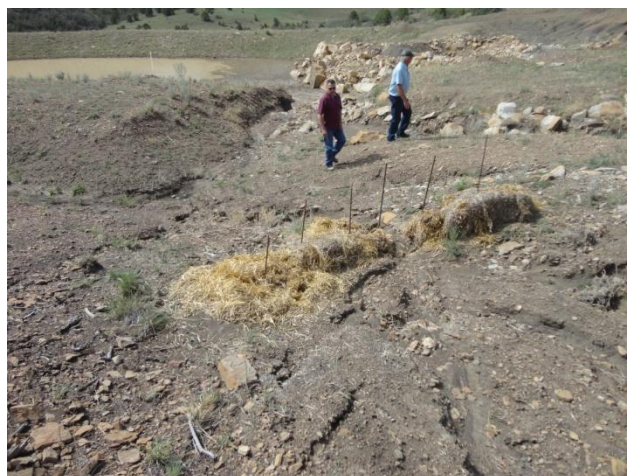
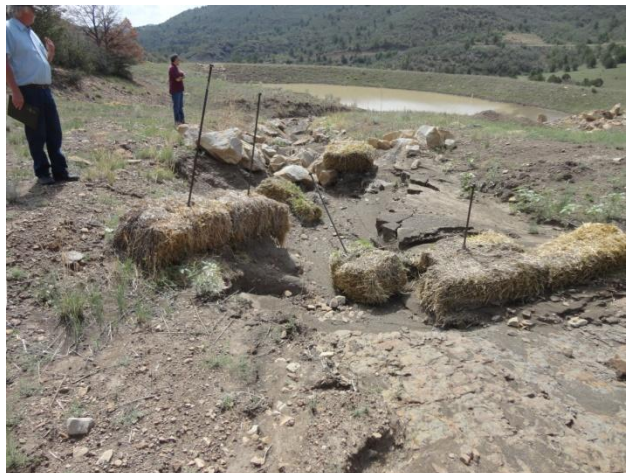
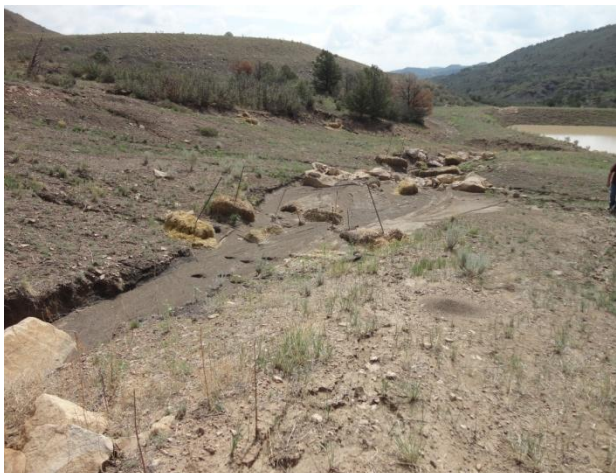
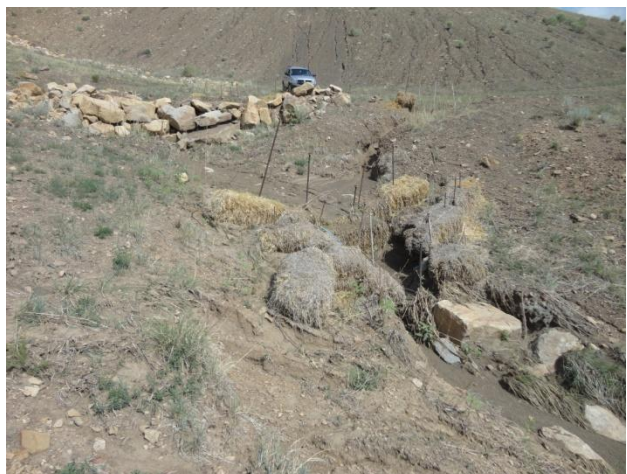
Photo 30: Accumulated sediment above pond 6 (1)

Photo 31: Accumulated sediment above pond 6 (2)

Photo 32: Accumulated sediment above pond 6 (3)

Photo 33: Accumulated sediment above pond 6 (4)

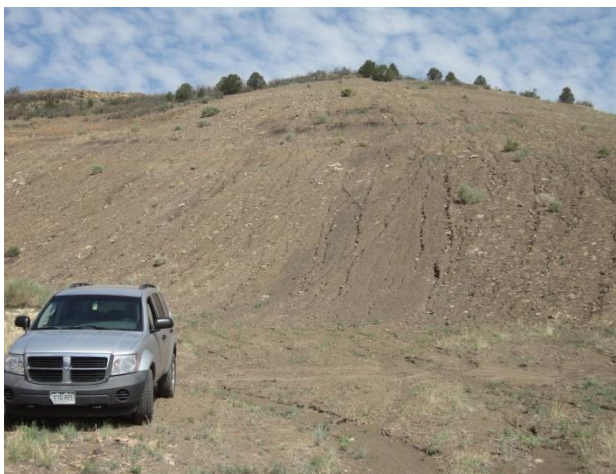
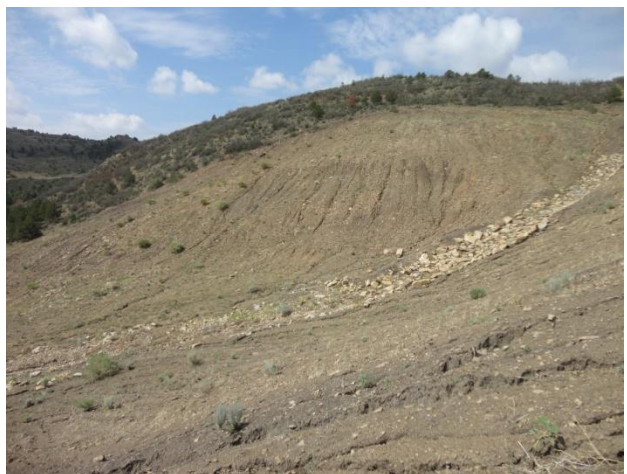
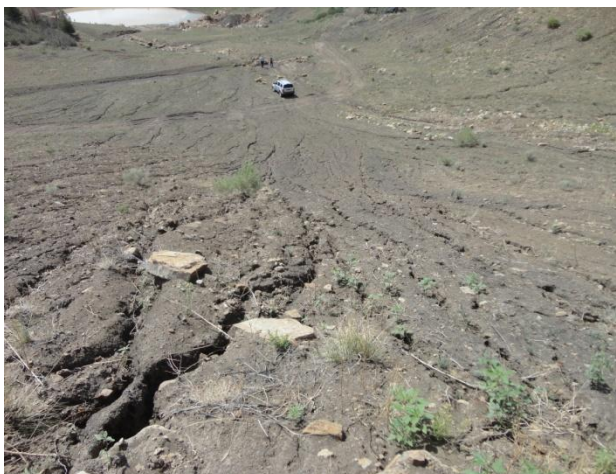
Photo 34: Steep slope above pond 6, showing erosion (1)

Photo 35: Steep slope above pond 6, showing erosion (2)

Photo 36: Steep slope above pond 6, showing erosion (3)

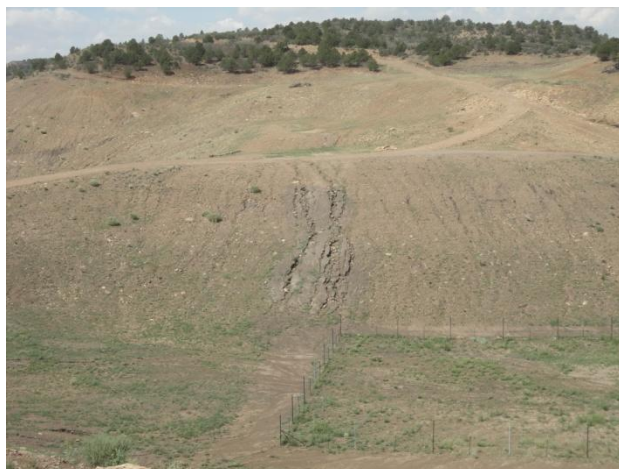
The east facing slope to the west of the shrub plot had some significant gullies. Earlier hydro-mulched repairs have eroded away after only 1 year. The problem appears to be caused by run-off from the road above. **The gullies should be repaired again and some sort of flow control should be used to prevent the same problem recurring.**

Photo 37: Steep slope above shrub plot, showing erosion

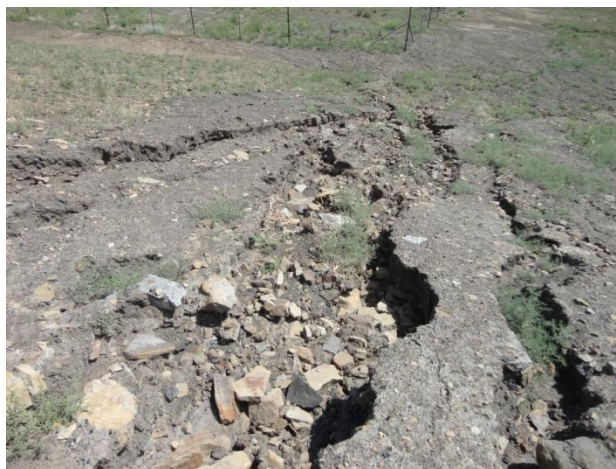
Photo 38: Close up of erosion in 37

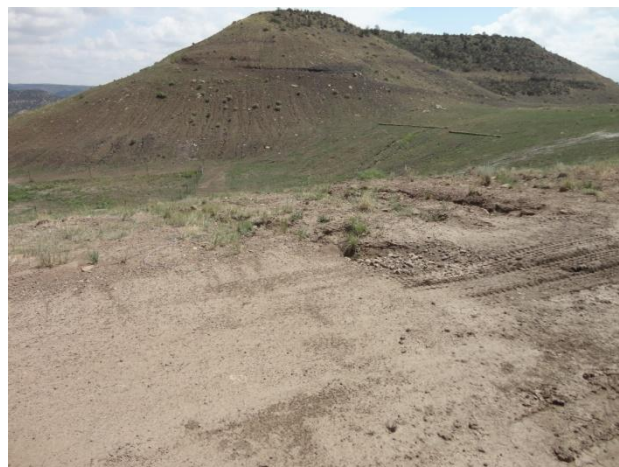
Photo 39: Road run-off causing erosion in 38

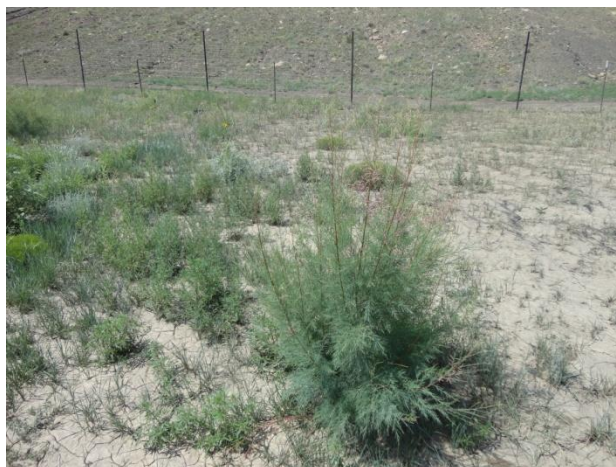
The shrub transplants in the fenced plot had survived with mixed success. Utah serviceberry, *Amelanchier utahensis*, and Mountain sumac, *Rhus glabra*, were observed. Some Tamarisk was also observed in the shrub plot area, in flower. **Tamarisk is a List B noxious weed and should be controlled.**

Photo 40: Tamarisk in shrub plot

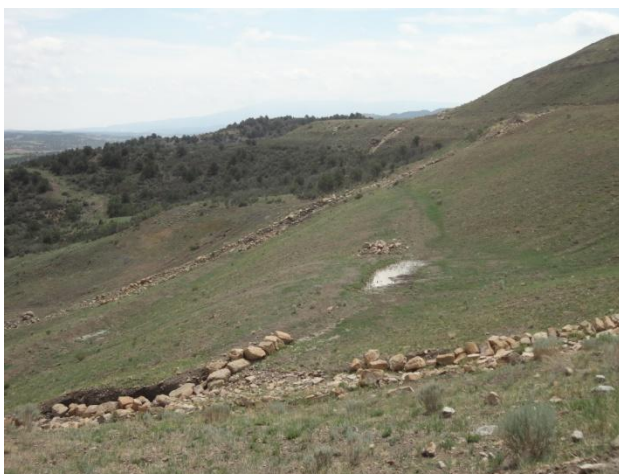
On fill 8, the rills that had been identified in the report of April 29, 2013, on the lower faces were inspected. There had been no additional damage, despite the several intense rainstorms. This suggests that the area is no longer actively eroding. Repairs are not required at the moment, however the area should continue to be monitored. Water had ponded in two places on the benches, but had not breached. The erosion outside of the

Photo 41: Fill 8

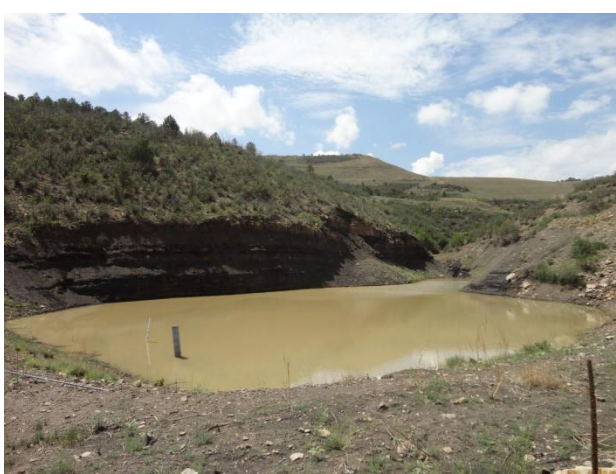
Pond 8 was discharging. No problems were observed with the spillways or embankments.

Photo 42: Pond 8

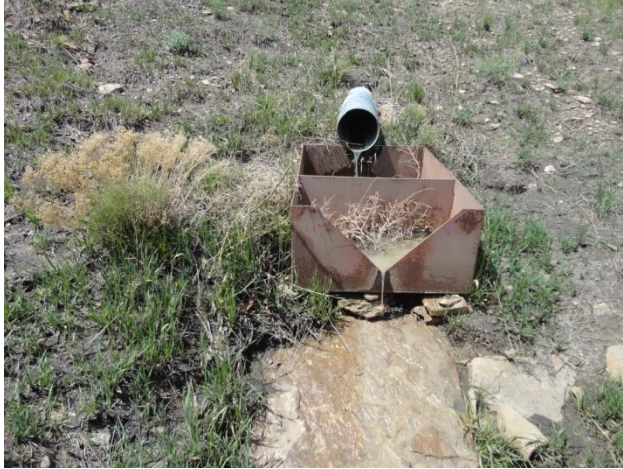
Photo 43: Pond 8 discharge

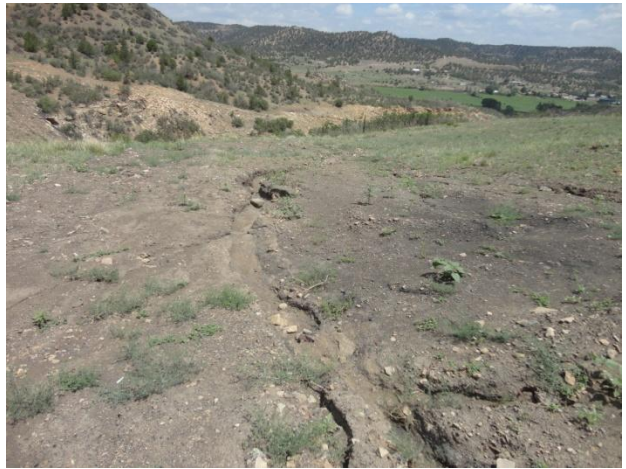
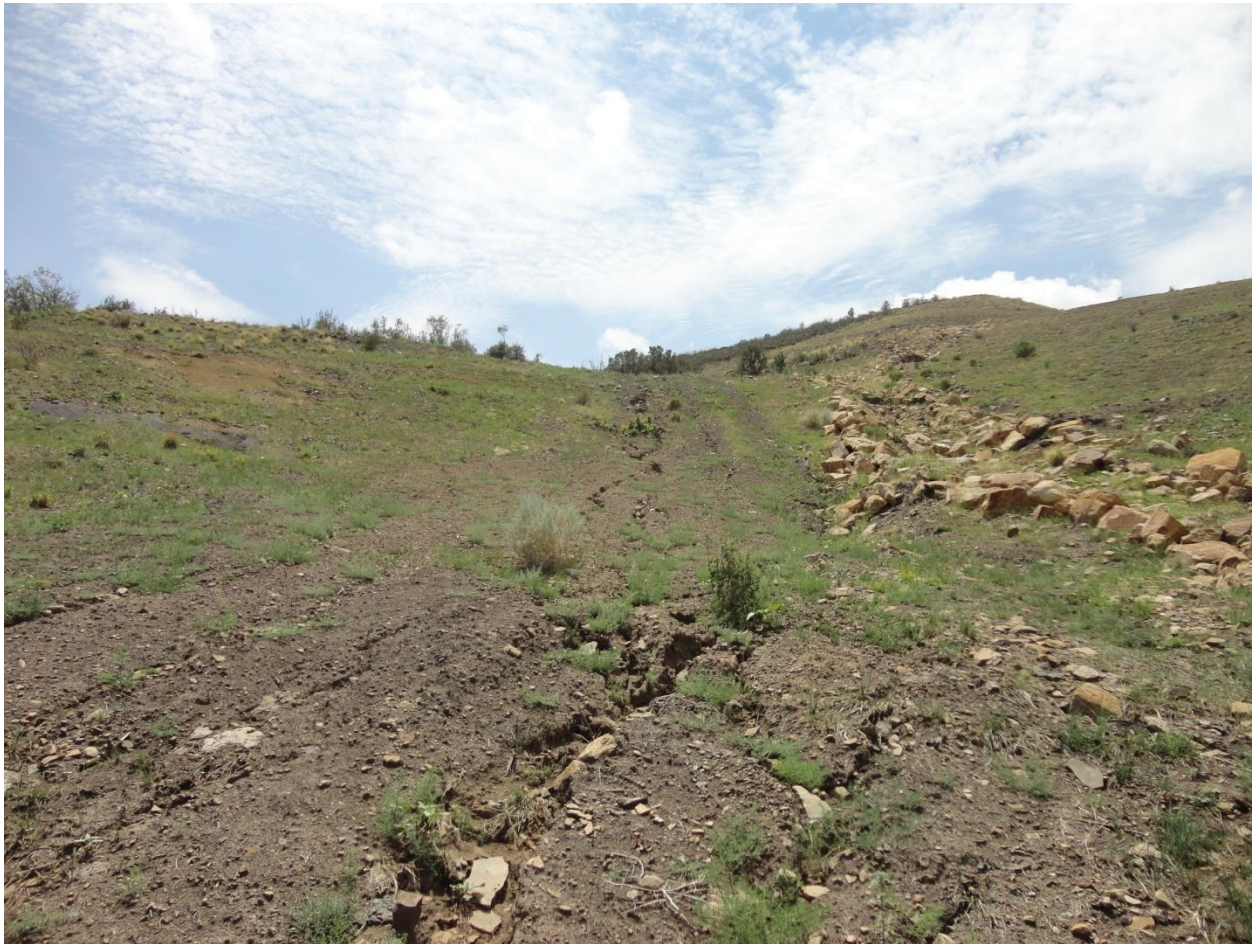
Photo 44: Erosion outside of fill 8 (1)

Photo 45: Erosion outside of fill 8 (2)

down-drain east of fill 8 that was noted in the report of April 29, 2013, had grown larger and vegetation had been washed out of the soil. **This area should be repaired and some flow control structures should be used to protect the repairs.**

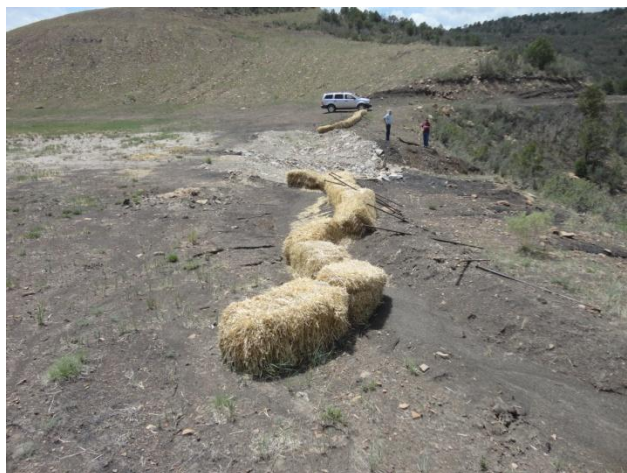
Pond 5 was just discharging. At the flat area (potential SAE) at the head of the pond 5 drainage the armoring and flow control measures had worked very well during the recent heavy rain. **The bales just need to be “touched up” a little.**

Photo 46: Flow control above pond 5

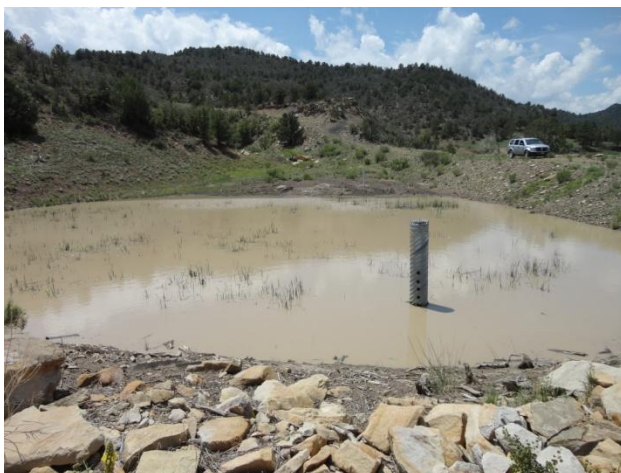
Photo 47: Pond 5

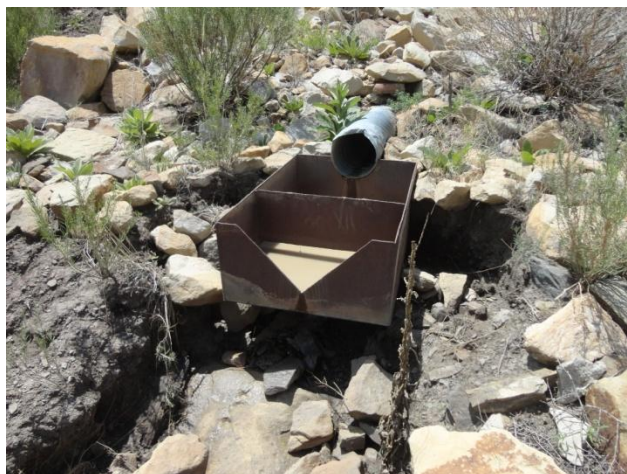
Photo 48: Pond 5 discharge

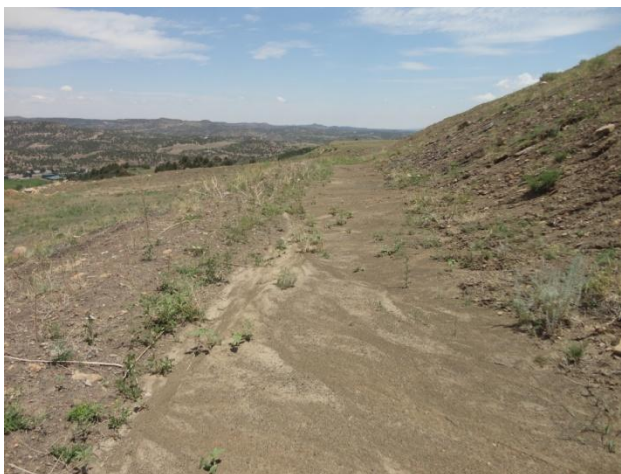
Photo 49: Sediment in contour ditch north east of "nob"

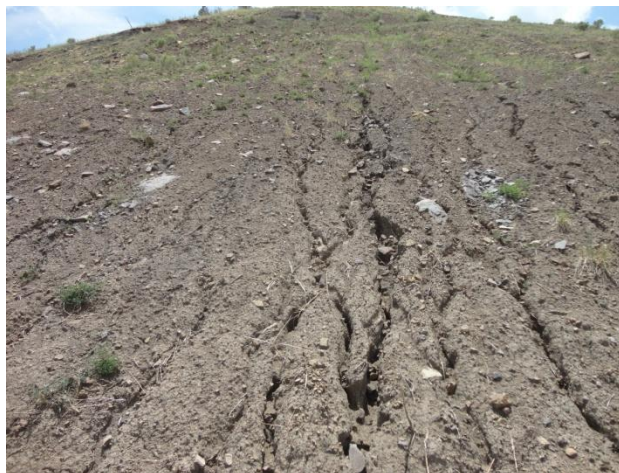
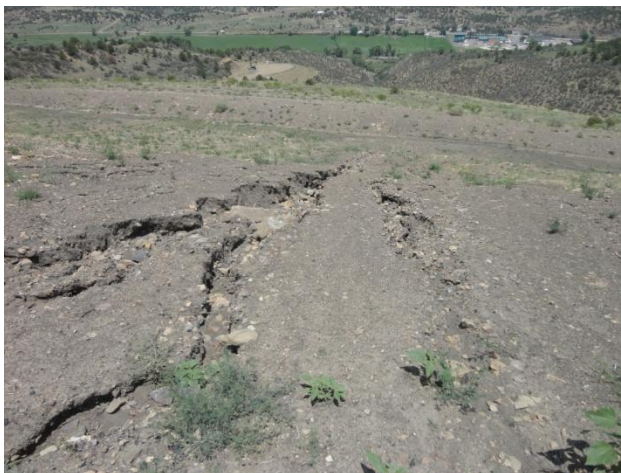
On the north east side of the “nob” the contour ditch was full of sediment. **The ditch should be cleaned out.** The lower 1/3 of the slope above showed extensive erosion, including previously repaired gullies that had re-opened. **The erosion should be repaired and some flow control device should be used to reduce the slope length and reduce flow velocity.**

Photo 50: Erosion north east of "nob" (1)

Photo 51: Erosion north east of "nob" (2)

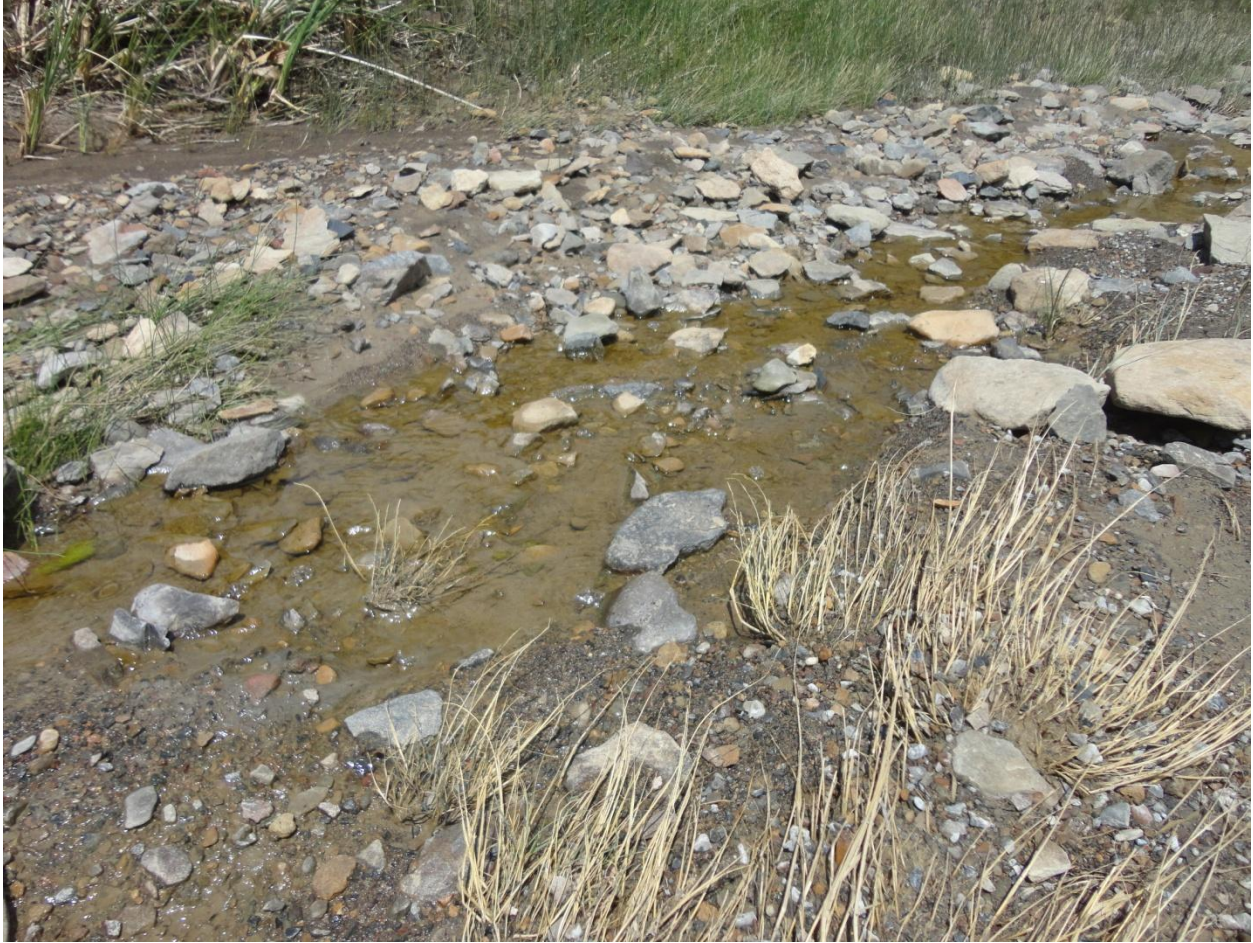
Methane was bubbling from the ground, in the water in the natural drainage adjacent to that leading to pond 5 (outside the area disturbed by the mine). About 1/4 of a mile reach of the stream was completely barren of vegetation where the methane had caused a die-off. Anecdotally, the vegetation die-off was coincident in time with the fracking activity of XTO and Pioneer.

Photo 52: Bubbling methane in natural drainage

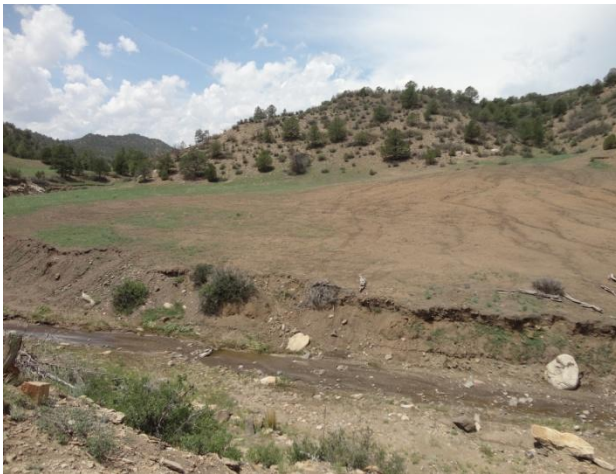
Photo 53: Vegetation die-off caused by methane
