COLORADO DIVISION OF RECLAMATION, MINING AND SAFETY COAL PROGRAM INSPECTION REPORT

Permit Number: C-1981-022 Mine Name: Elk Creek Mine Operator: Oxbow Mining, LLC Operator Address: Mr. Jim Kiger P.O. Box 535 3737 Highway 133 Somerset, CO 81434	County: Delta, Gunnison Operation Type: Underground Permit Status: Active Ownership: Federal
	Operator Representative Present: None
Operator Representative Signature: (Field Issuance Only)

Inspection Start Date: July 23, 2013 Inspection Start Time: 11:25 Inspection End Date: July 23, 2013 Inspection End Time: 11:30	Inspection Type: Aerial Inspection Inspection Reason: Normal I&E Program Weather: Clear
Joint Inspection Agency: None	Joint Inspection Contacts:
Post Inspection Agency: None	Post Inspection Contacts:
Inspector(s): Brock F. Bowles Harry B. Ranney	Inspector's Signature:

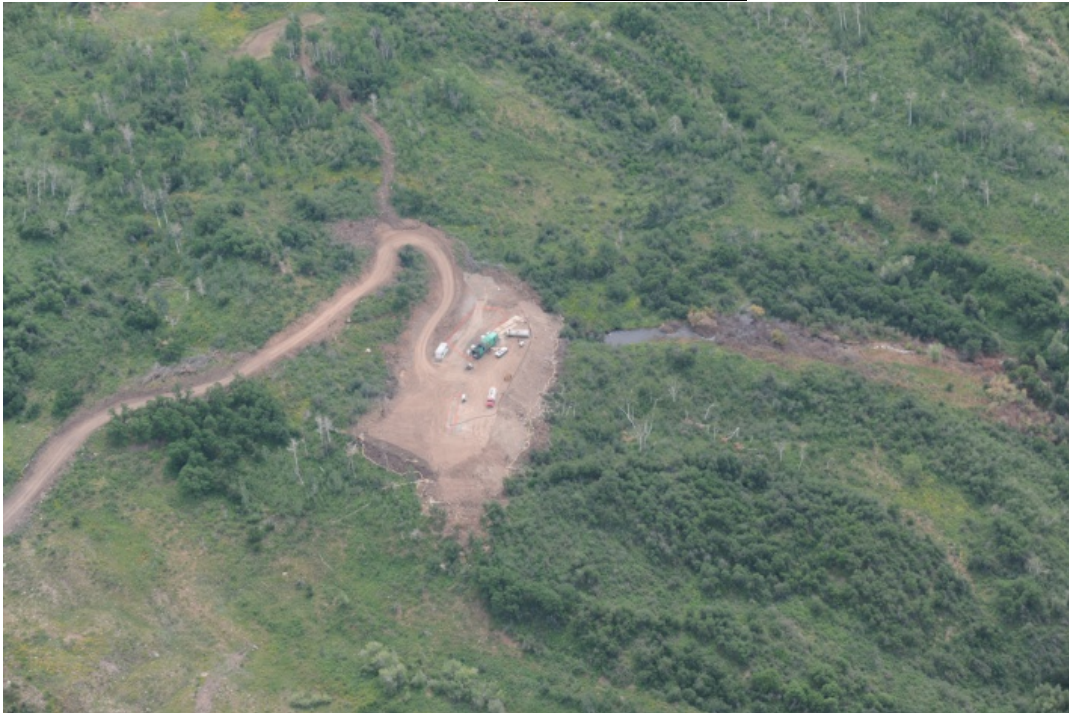
Photo 1 – De-Water Pad, Wells

Sediment control structures are in place around the de-water well pad (photo 1). Sediment ponds B and D contain water.

It appears that much of the vegetation downhill of the 015B discharge point is brown and potentially dead (photo 1).

It appears that topsoil stockpiles are in place for the de-water pad (photo 1).

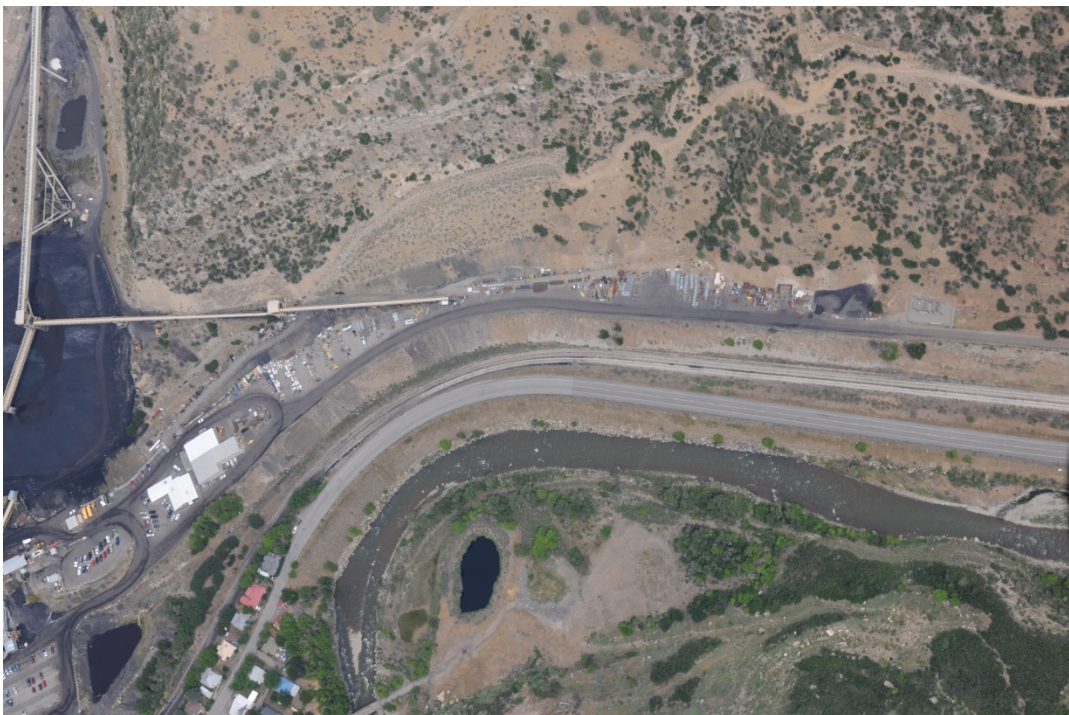
Photo 2 – East Yard Area

Some coal waste material has been placed in the East Yard Pond (photo 2).
