COLORADO DIVISION OF RECLAMATION, MINING AND SAFETY COAL PROGRAM INSPECTION REPORT

Permit Number: C-1981-028 Mine Name: Keenesburg Strip Mine Operator: Coors Energy Company Operator Address: Mr. Benjamin Moline P.O. Box 4030 Suite 400 Golden, CO 80401	County: Weld Operation Type: Surface Permit Status: Active Ownership: Private
	Operator Representative Present: None
Operator Representative Signature: (Field Issuance Only)

Inspection Start Date: July 23, 2013 Inspection Start Time: 09:00 Inspection End Date: July 23, 2013 Inspection End Time: 09:05	Inspection Type: Aerial Inspection Inspection Reason: Normal I&E Program Weather: Clear
Joint Inspection Agency: None	Joint Inspection Contacts:
Post Inspection Agency: None	Post Inspection Contacts:
Inspector(s): Brock F. Bowles Harry B. Ranney	Inspector's Signature:

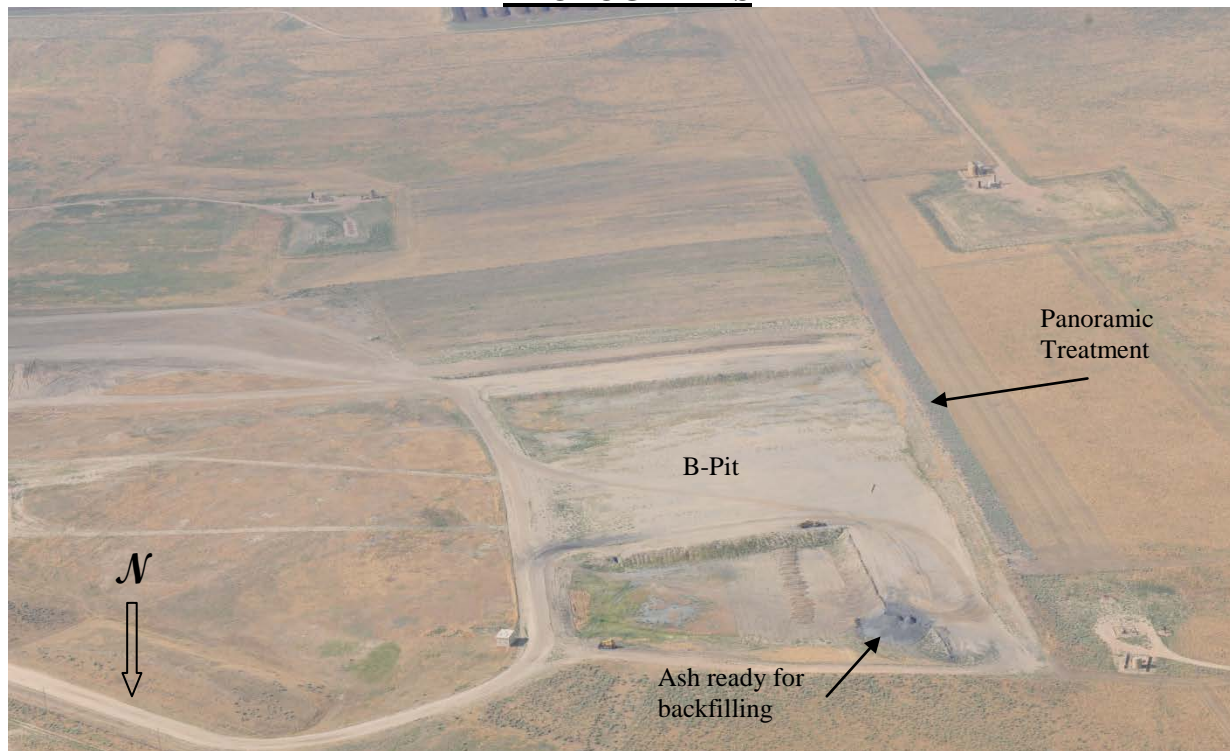
Coal ash was stacked in B-Pit ready for backfilling (photo 1). It appears that the south side of the long term spoil pile has been cleaned up and graded to a level surface (photo 2).

It is very apparent in this photo the extent of the cheatgrass beyond the mine permit boundary and how effective the Panoramic treatment was on the west side of B-Pit (photo 1).

Photo 1 – View of B-Pit From the North

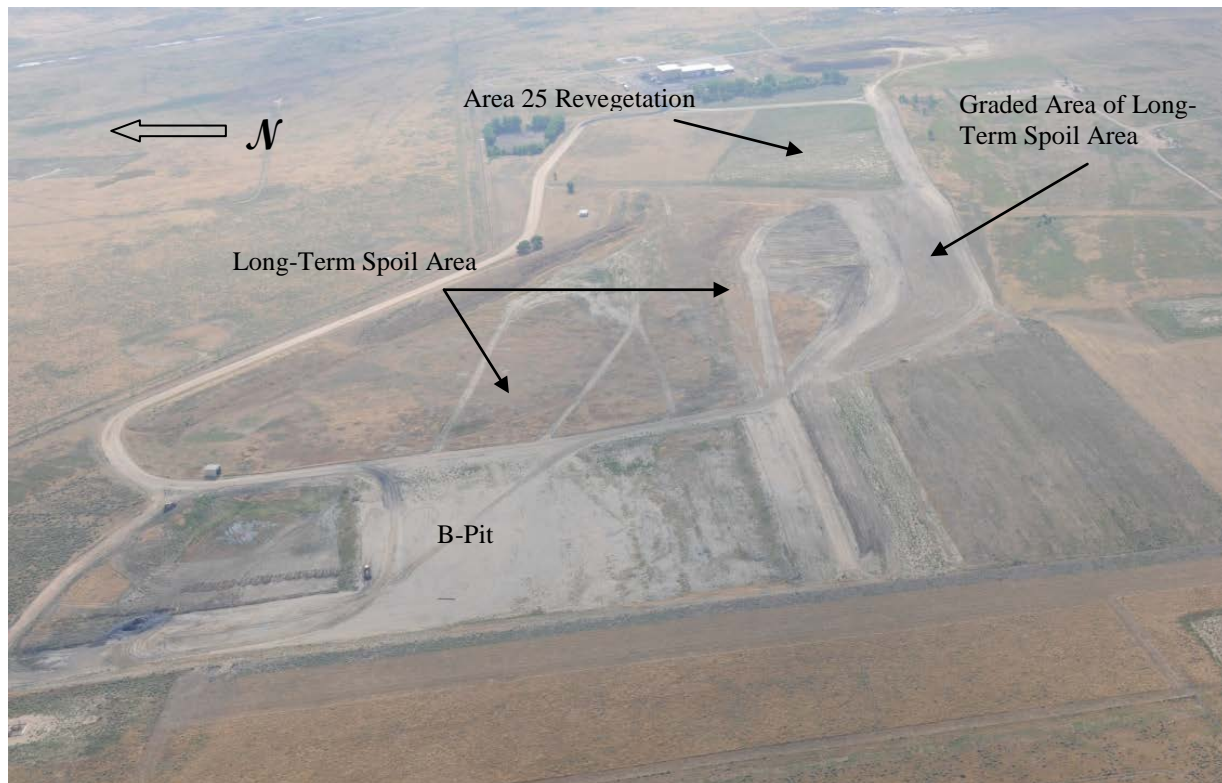
The section of Area 25 that was revegetated last fall looks like it has a good vegetative cover. The area is very green compared to other sections of the mine (photo 2).

Photo 2 – View of B-Pit from the West
