COLORADO DIVISION OF RECLAMATION, MINING AND SAFETY
MINERALS PROGRAM INSPECTION REPORT
PHONE: (303) 866-3567

MINE NAME: San Juan Silver Project	MINE/PROSPECTING ID#: P-2008-037	MINERAL: Silver & gold	COUNTY: Mineral
INSPECTION TYPE: Mineral Prospect Inspection	INSPECTOR(S): Bob Oswald	INSP. DATE: July 11, 2013	INSP. TIME: 11:00
OPERATOR: Rio Grande Silver, Inc.	OPERATOR REPRESENTATIVE: Randy McClure, Cassady Harraden	TYPE OF OPERATION: MP - Mineral Prospecting

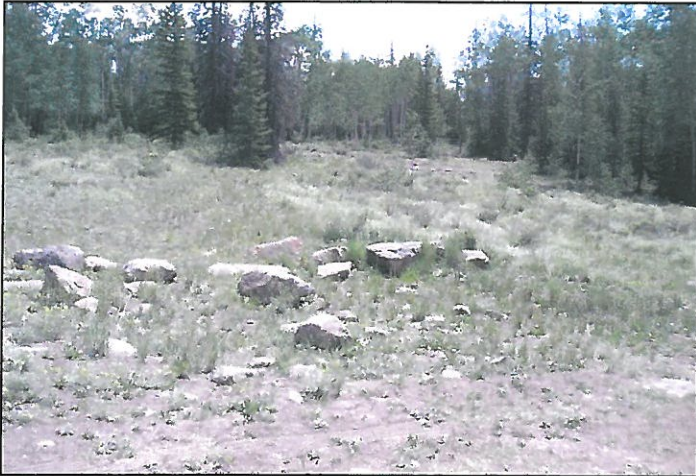
The purposes of this inspection were to monitor the ongoing activity occurring under this NOI, as well as to confirm that there was no re-disturbance of the reclamation of drill site BD-4 and the access road. The Division approved Modification MD-1 for re-disturbance of drill pad BD-4 and its access road, and the operator was instructed to provide a bond increase for the new disturbance. Prior to posting the increase, the operator requested a withdrawal of Modification MD-1, stating that there would be no new disturbance of the drill pad BD-4 and its access road. It was observed during this inspection that drill pad BD-4 and its access road were not redisturbed and were (still) fully reclaimed.

Access road and drill site BD-4, in forest clearing.

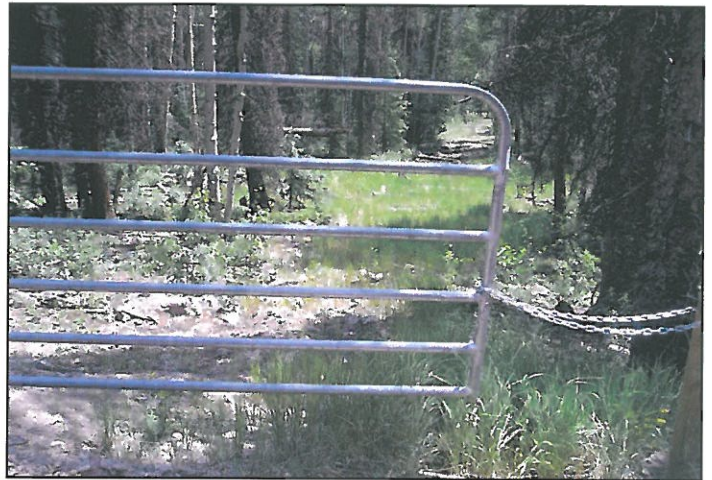
Further north along the forest road is drill site BD-5. This site was prepared for drilling by clearing brush and downed logs, and blading a short access trail to it. The operator's drilling plans changed, and no drilling occurred there. The surface was reclaimed by grading back to natural contours, resspreading topsoil, and seeding it. The surface appeared fully reclaimed at the time of this inspection. There is still a locked gate at the turnoff from the forest road, which could be removed if the operator wished to. It was discussed that a log could perhaps be placed across the entrance to prevent vehicular entry, since the site could suffer undue damage from recreational use.

Drill site BD-5, behind entrance gate.
