COLORADO DIVISION OF RECLAMATION, MINING AND SAFETY COAL PROGRAM INSPECTION REPORT

Permit Number: C-1981-022 Mine Name: Elk Creek Mine Operator: Oxbow Mining, LLC Operator Address: Mr. Jim Kiger P.O. Box 535 3737 Highway 133 Somerset, CO 81434	County: Delta, Gunnison Operation Type: Underground Permit Status: Active Ownership: Federal
	Operator Representative Present: Jim Kiger
Operator Representative Signature: (Field Issuance Only)

Inspection Start Date: August 6, 2013 Inspection Start Time: 08:30 Inspection End Date: August 6, 2013 Inspection End Time: 15:00		Inspection Type: Coal Complete Inspection Inspection Reason: Normal I&E Program Weather: Clear	
Joint Inspection Agency: None		Joint Inspection Contacts:	
Post Inspection Agency: None		Post Inspection Contacts:	
Inspector(s): Brock F. Bowles	Inspector's Signature:

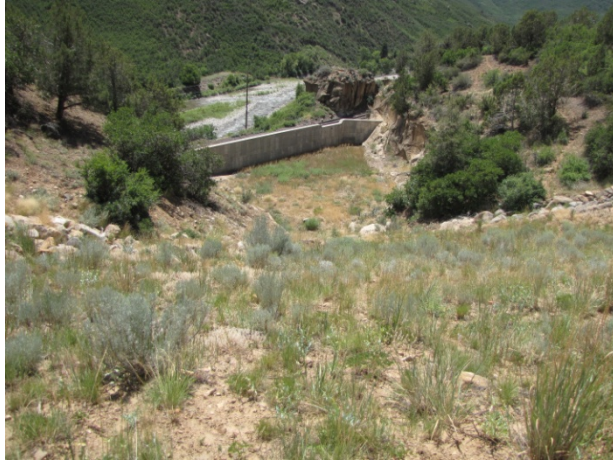
Photo 1 – Pond E

Ponds A, B and D all contained water but none were discharging. Ponds C and E (photo 1) were dry. According to Mr. Kiger, all the ponds were cleaned two weeks ago, before the heavy rains. The pond cleanings are currently staged in the East Yard Pond for drying. The East Yard Pond is full and the pond cleanings need to be moved to the refuse pile as soon as possible. The ditch along the West Valley Haul road was free and clear of obstructions, the sumps were recently cleaned and straw bales were in good condition.

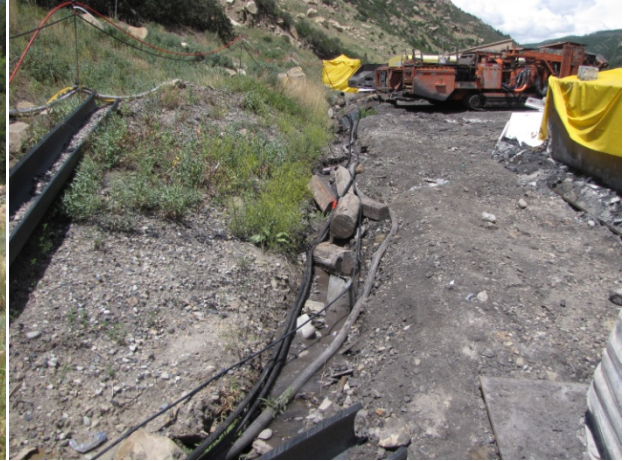
Ditch D3 (below the portals, west side of haul road) has an excessive amount of debris in it (photo 2). This debris needs to be removed. The west ditch of the II West Refuse pile is not well defined in the area of the first bench (photo 3). Water has the potential to run down the face of the spoil pile. The ditch channel needs to be re-established to direct water flow to the lower segment of the rock-lined ditch which is already in place.

Photo 2 – Ditch D3 Needs to be Cleaned

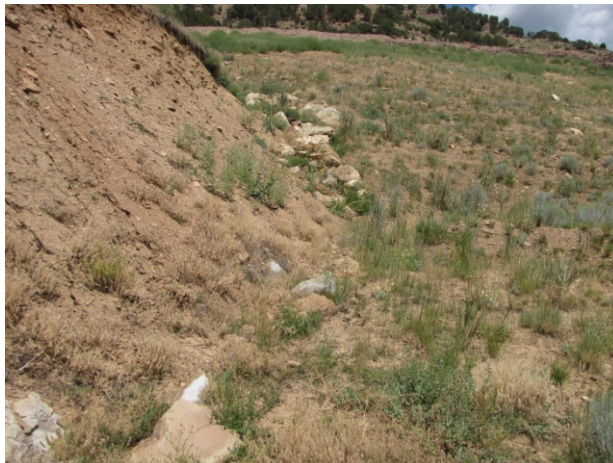
Photo 3 – West Ditch of II West Refuse Pile

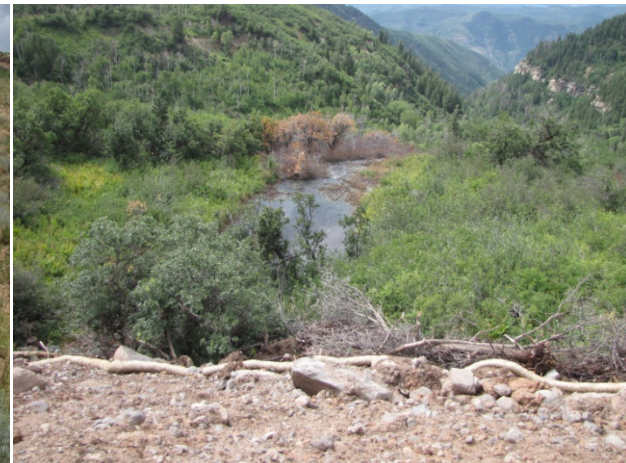
The water level in the north mine workings is down to normal levels. Only one de-water well pump (approved MR-104 and -105) is needed at the present time to maintain the mine water level. Water is being pumped through outfall 015B at a rate of 120 gpm. It is expected that once access to the mine workings is achieved, the underground mine pumps will resume pumping water to the B-seam and the surface pumps (outfall 015B) will no longer be needed. The vegetation around the temporary external outfall 015B is dead (photo 4). The rocks and straw waddles at the outfall 015B discharge are stained red (photo 5). The latest DMR submitted to the Division (6/30/2013) reports the iron 30 day average to be 860 ug/l which is below the 1000 ug/l limit of the permit. The area below outfall 015B will be inspected once the mine water discharge is terminated. At that time, Oxbow, LLC and the Division will determine if any reclamation work is needed to repair the area.

Photo 4 – Dead Oak Trees by Outfall 015B

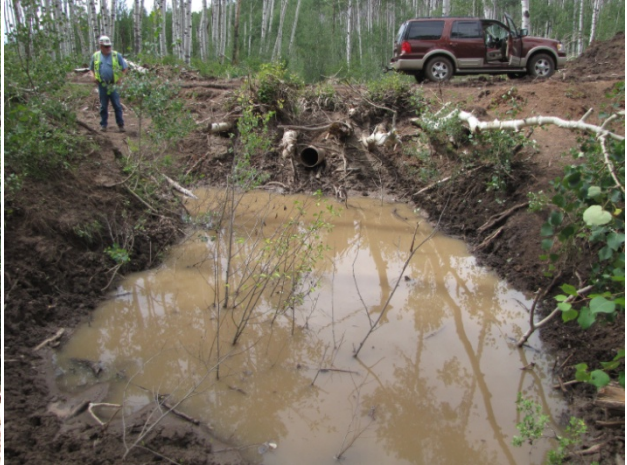
Photo 6 – Elk Creek Crossing for Temp Road

The haul and access roads around the main facilities area are well maintained. The temporary road leading to the de-water holes approved in MR-104 and -105, is in good condition. A pipe is in place for drainage where the road crosses Elk Creek. Trees felled for the road construction were laid in corduroy fashion with soil over the pipe for vehicle access (photo 6). There was no water flow in this part of Elk Creek. The water seen in the picture is residual from the latest rain.
