COLORADO DIVISION OF RECLAMATION, MINING AND SAFETY COAL PROGRAM INSPECTION REPORT

Permit Number: C-1996-083 Mine Name: Bowie No. 2 Mine Operator: Bowie Resources, LLC Operator Address: Mr William A Bear P.O. Box 483 Paonia, CO 81428	County: Delta Operation Type: Underground Permit Status: Active Ownership: Federal and Forest
Operator Representative Present: Bill Bear	
Operator Representative Signature: (Field Issuance Only)

Inspection Start Date: August 21, 2013 Inspection Start Time: 08:30 Inspection End Date: August 22, 2013 Inspection End Time: 08:20	Inspection Type: Coal Complete Inspection Inspection Reason: Normal I&E Program Weather: Clear
Joint Inspection Agency: None	Joint Inspection Contacts:
Post Inspection Agency: None	Post Inspection Contacts:
Inspector(s): Susan L. Burgmaier	Inspector's Signature: <i>Susan Burgmaier</i> Signature Date: 08/23/2013

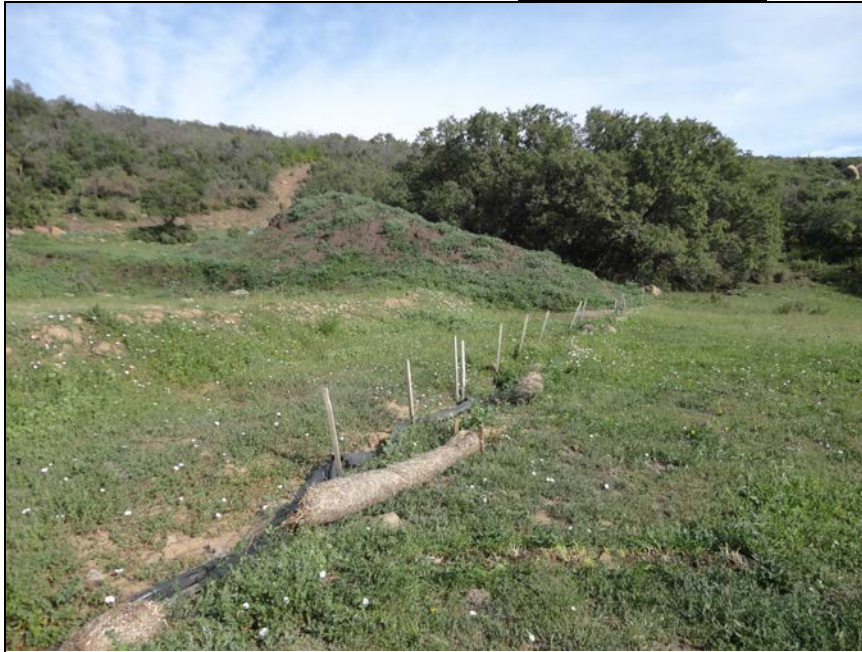
GVB B12C - cattle had destroyed most of the straw wattles.

Photo 1
GVB – B12C drill pad,
straw wattles have been
damaged by cattle

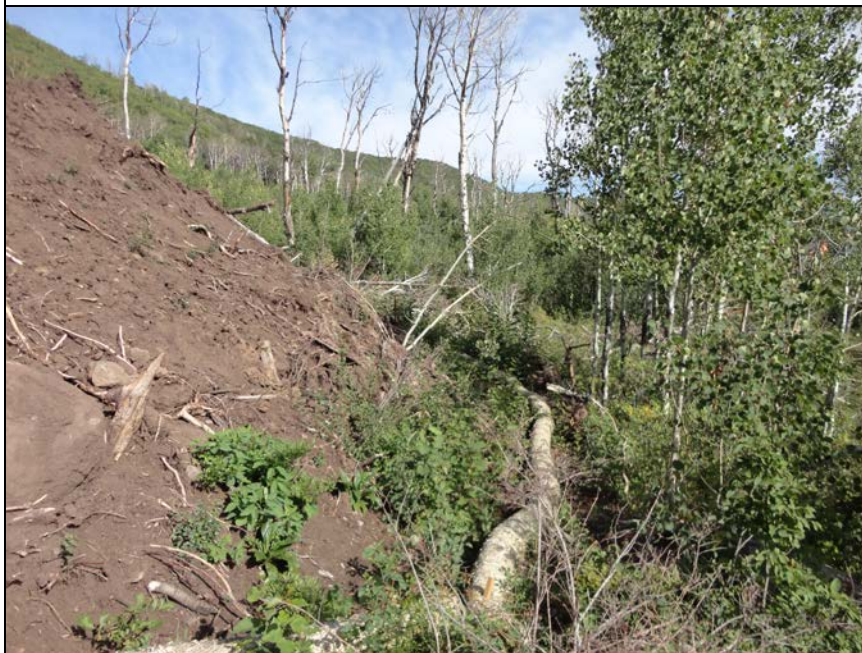
Photo 2
GVB - B14B outslope

Two new drill pads had been constructed (B14B and B14C). Straw wattles and slash piles had been installed for sediment control, and were in good condition.

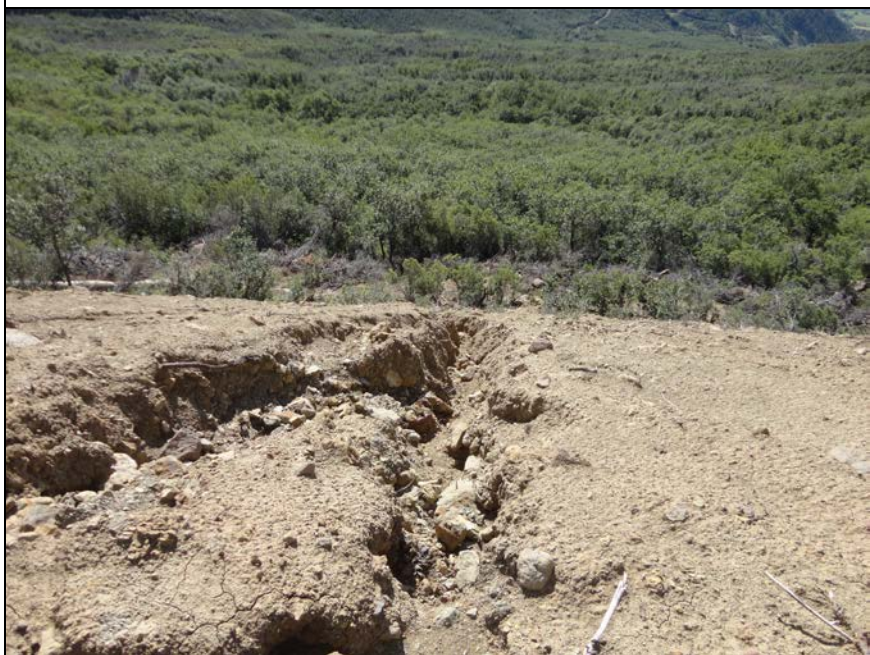
GVB B14A - the berm needed to be built up (possibly subsided).

Photo 4
Outslope of GVB – B14A,
where berm was low

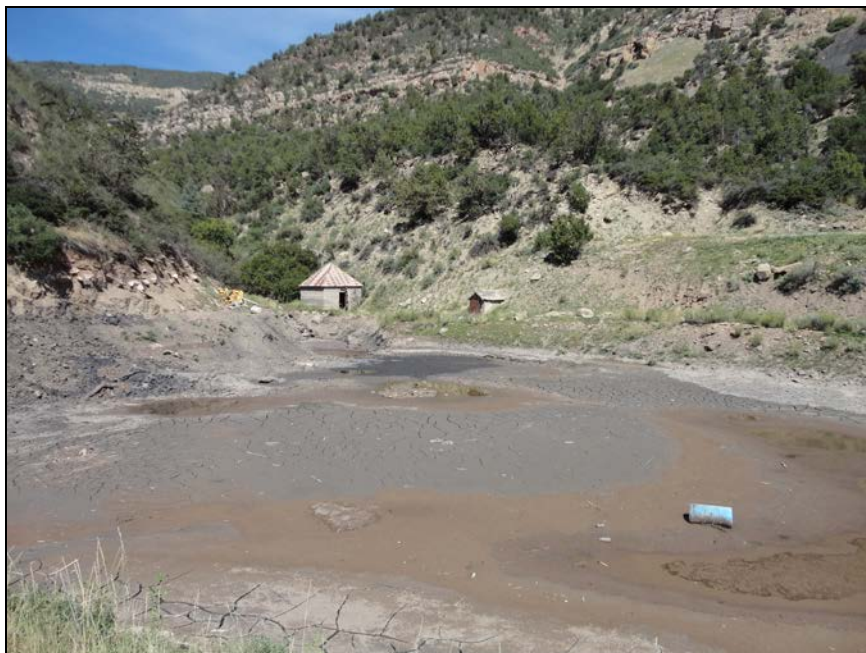
Photo 5
Pond C

Ponds B, C, D, F, and J all held water; none were being discharged. Pond K was dry. It was evident at Ponds B, C, D, F, and J that water had discharged through the emergency spillways as a result of the July 28, 2013 storm. Tamme Bishop, consultant for the operator, had previously reported the discharges from these ponds as observed during her July 29, 2013 site visit report. A considerable amount of cleanup work had occurred in the pond spillways and inlets. Remaining pond maintenance includes the cleaning and reshaping of the inlets of Ponds B, C, and D, and sediment removal in Ponds B, C, D, and F. The inlet of Pond F, Ditch F4, and the Pond B spillway had been entirely reconstructed.

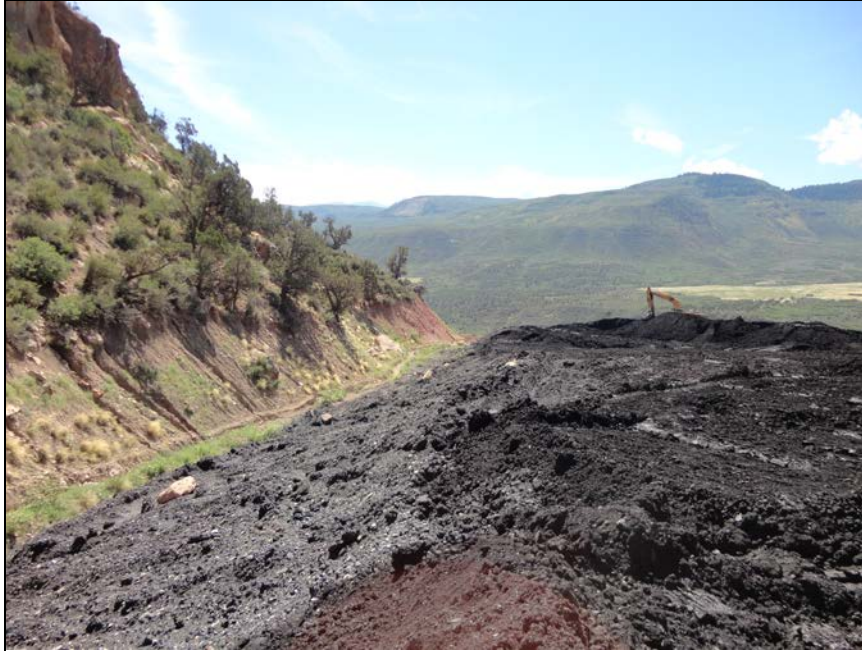
Photo 7
East side of Gob Pile #2

Work continues on Gob Pile #2 in an effort to abate NOV CV2013004. A considerable amount of progress has been made, but the operator indicated that another abatement deadline extension will be requested. The recent rain events have required equipment operators to focus on ditch and pond maintenance, decreasing the amount of operator hours available for spreading and compacting waste material. The lower portion of the expansion area, where end dumping over the winter had resulted in steep slopes and impounded water, had been reworked and was near final grade. The northern portion of the east end of the pile still had end dumped material, but had been worked down to about an acre in size.

Abatement Description: Place and compact all existing end-dumped material on Gob Pile #2 in accordance with the Rules and approved permit application package.

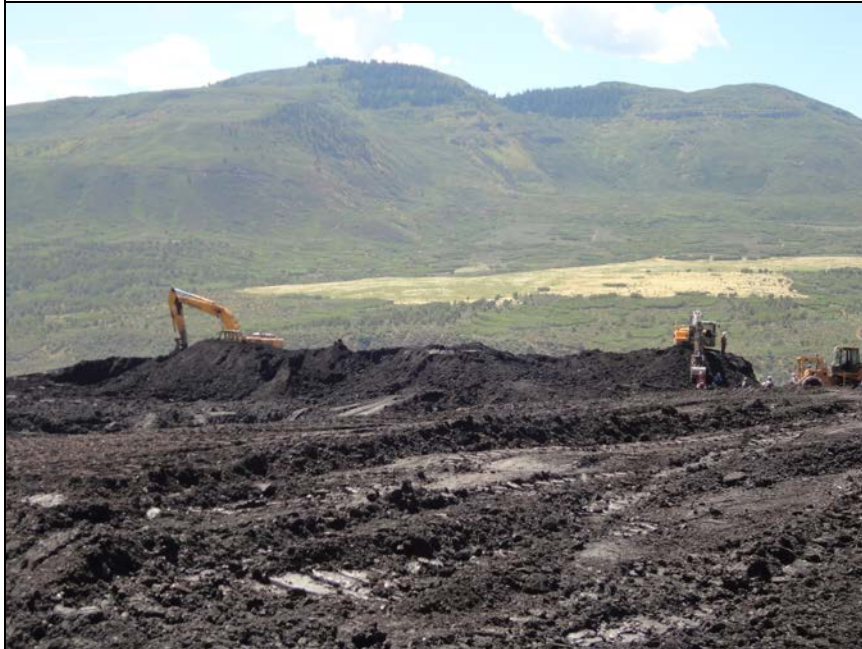
Photo 8
Remaining end-dumped
material on east side of
Gob Pile #2

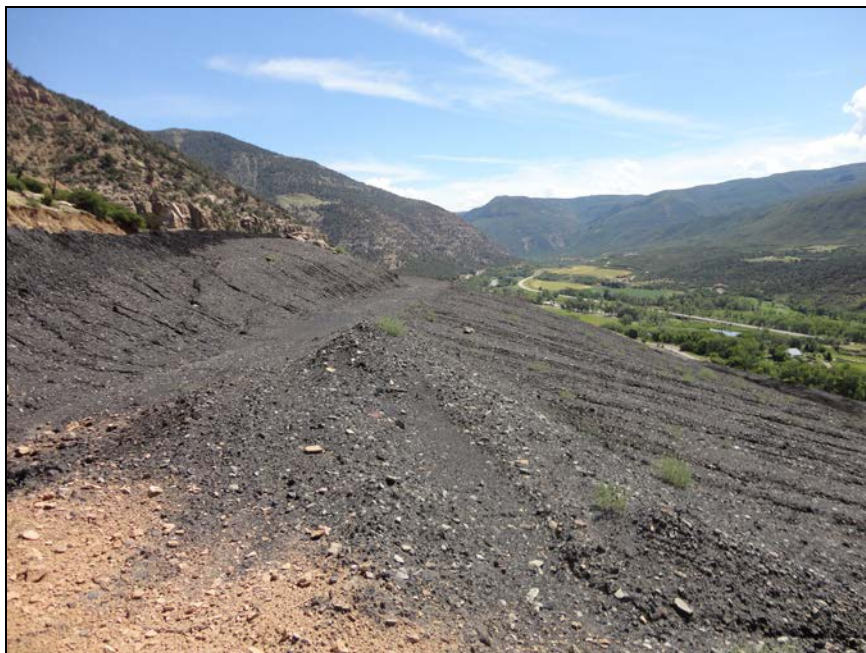
Photo 9
Gob Pile #4 Ditch F-18

No standing water was observed anywhere on the gob piles, and it appeared that the ditches were graded for positive drainage.

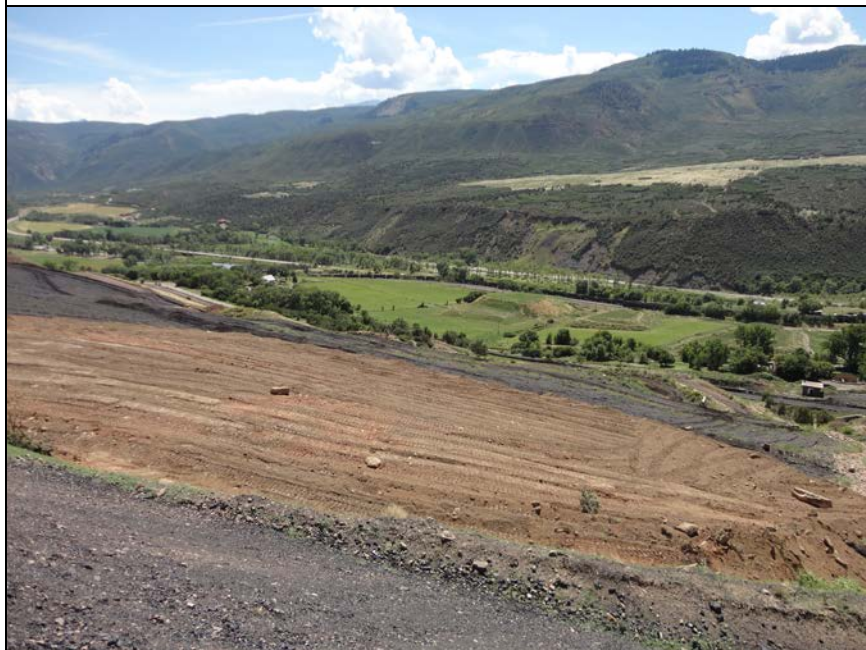
Cover material had been hauled over to Gob Pile #4, but hadn't been spread to final thickness yet. The cover material balance at the site was discussed with the operator and consultant. The latest calculations, assuming the availability of about 200,000 cy of additional material to be excavated at Gob Pile #3, indicate that there is enough material available to cover all three active piles with the required 4' of material. Detailed calculations are being reviewed under Technical Revision No. 77.

Photo 10
Cover material on Gob
Pile #4

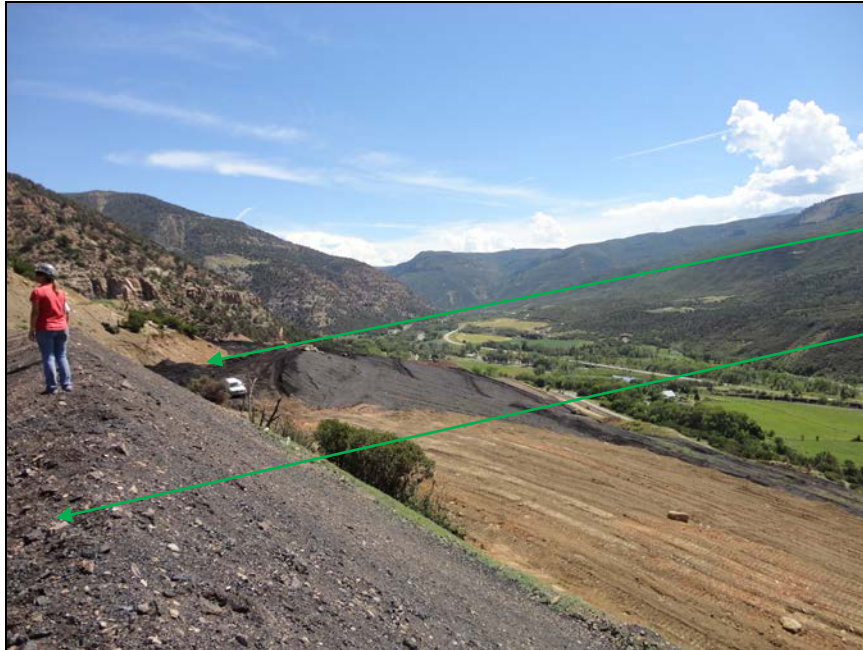
The operator had placed additional gob at the top of Gob Pile #4, to provide positive drainage off of the crest of the pile.

Photo 11
Gob placement to level
top of Gob Pile #4

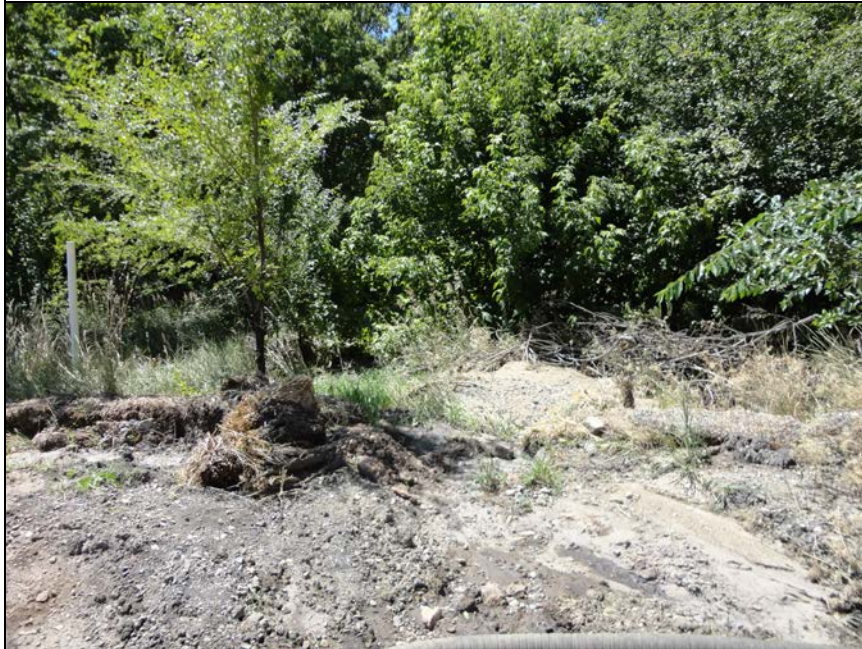
Pump House - straw bales on the south side and wattles on the west side need to be replaced.

Photo 14
Pumphouse SAE, straw
wattles on west end were
washed out by stormwater

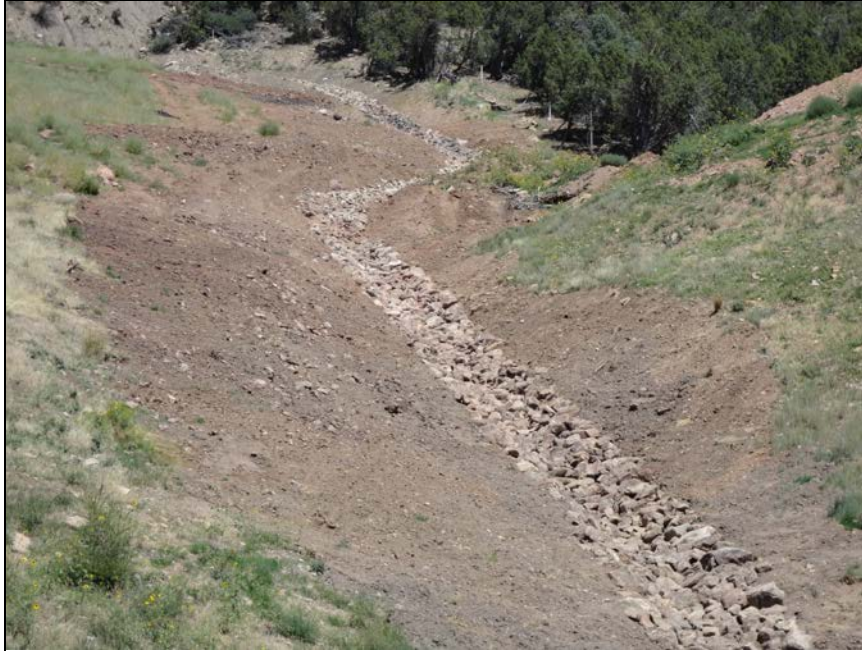
Photo 15
Reconstructed Ditch F4

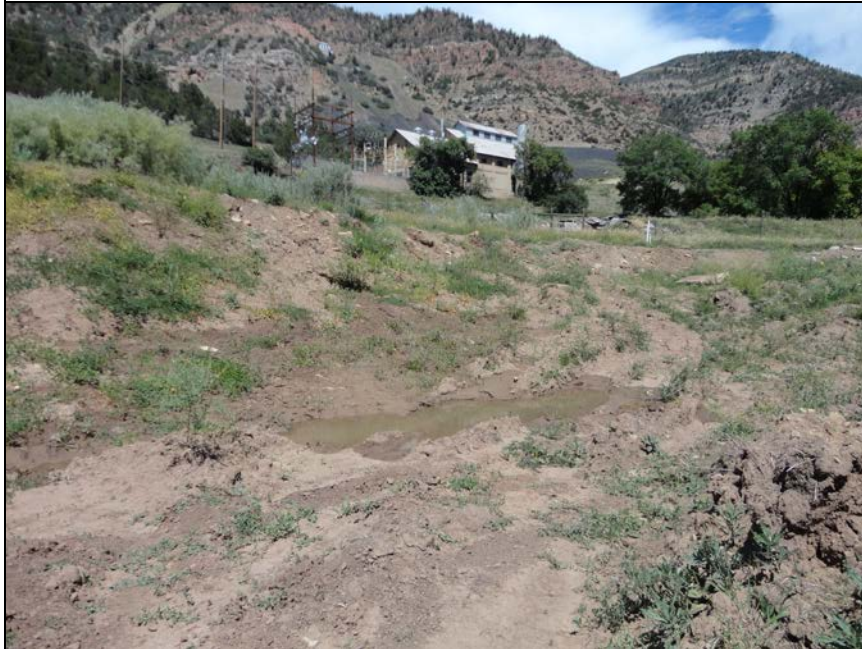
Photo 16
Gob Pile #3 Fire Mountain
Canal Seep

Gob Pile #3 was inactive. Survey stakes had been placed along the diversion ditch, in preparation for final grading and certification of the ditch construction. Additional material will be excavated from the pile area prior to placement of waste in this area; the operator indicated that a technical revision to address the additional excavation and material balance would be forthcoming.
