COLORADO DIVISION OF RECLAMATION, MINING AND SAFETY COAL PROGRAM INSPECTION REPORT

Permit Number: C-1981-038 Mine Name: Bowie No. 1 Mine Operator: Bowie Resources, LLC Operator Address: Mr Basil Bear P.O. Box 1488 Paonia, CO 81428	County: Delta Operation Type: Underground Permit Status: Active Ownership: Federal
	Operator Representative Present: None Present
Operator Representative Signature: (Field Issuance Only)

Inspection Start Date: August 22, 2013 Inspection Start Time: 08:40 Inspection End Date: August 22, 2013 Inspection End Time: 12:30	Inspection Type: Coal Partial Inspection Inspection Reason: Normal I&E Program Weather: Clear
Joint Inspection Agency: None	Joint Inspection Contacts:
Post Inspection Agency: None	Post Inspection Contacts:
Inspector(s): Susan L. Burgmaier	Inspector's Signature: <i>Susan Burgmaier</i> Signature Date: 08/23/2013

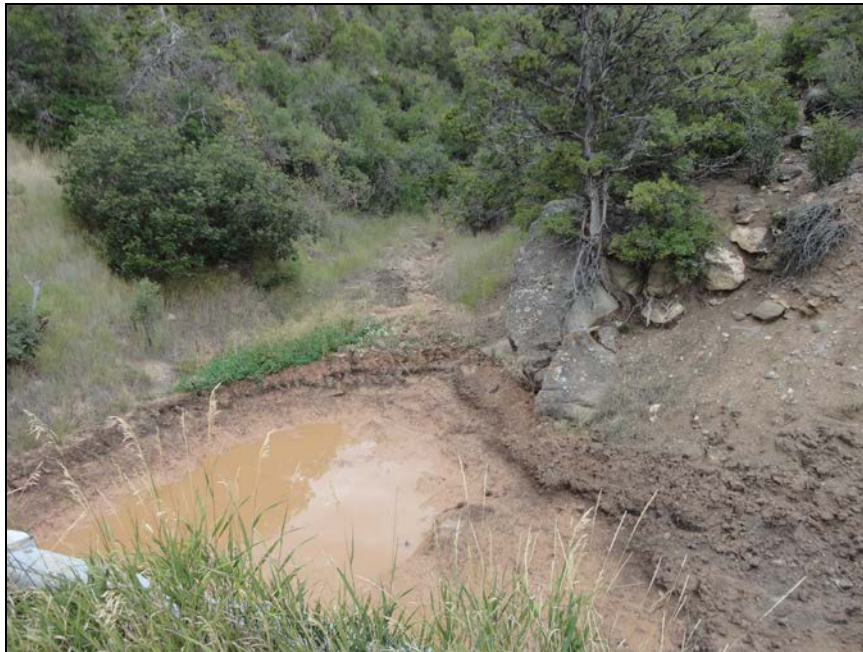
Photo 1
Pond 3

East Mine : Pond 4 was muddy but not holding water. Pond 3 held water below the discharge level but appeared to have recently discharged, as the area below the bin wall was wet. Repairs had been made on the east side of the pond embankment, to direct drainage from the adjacent light use road away from the pond. Pond 2 held water below the discharge level. The inlet to Pond 2 had been eroded from recent heavy rains. Pond 1 was dry. The West Ridge pond held water below the discharge level, and did not appear to have discharged recently.

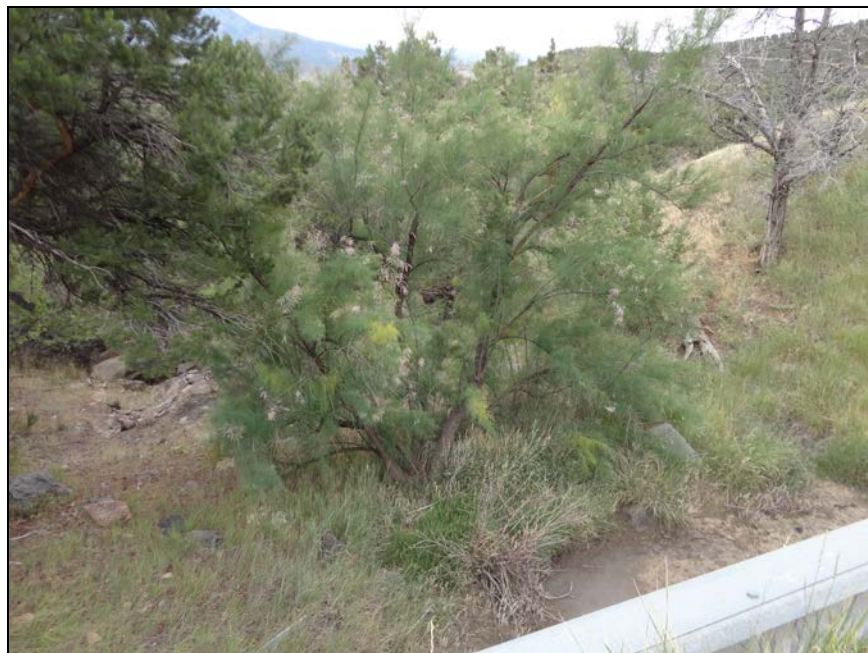
Photo 4
Tamarisk at Pond 2

Weeds had been sprayed throughout the East Mine reclamation, presumably targeting thistle. Recently sprayed dead thistle was observed in several locations. The operator chopped down the tamarisk at Ponds 1 and 3. There is still a large tamarisk bush just below Pond 2 that should also be eradicated.

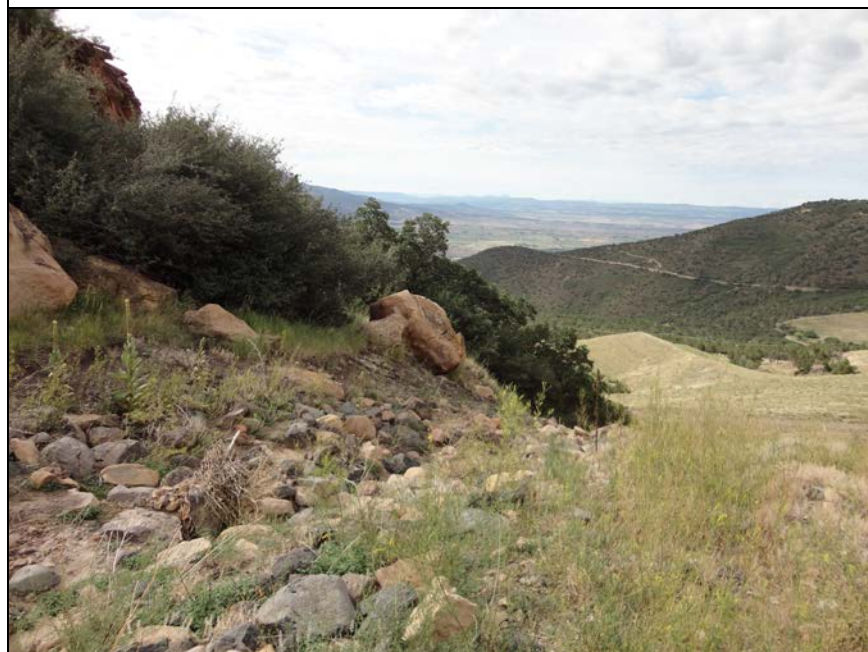
Photo 5
Upper channel above
Ditch 7

Ditch 7, on the east side of the East Mine, was partially blown out with the recent storm activity, but had been fully reconstructed at the time of the inspection. There were small gullies at the base of the reclaimed crushing bench outslope, where braided flow from the Ditch 7 blowout made its way down to Pond 2. The channel above

Ditch 7, from the former fan bench to Ditch 7 was in excellent condition and did not appear to have been damaged by the recent events.

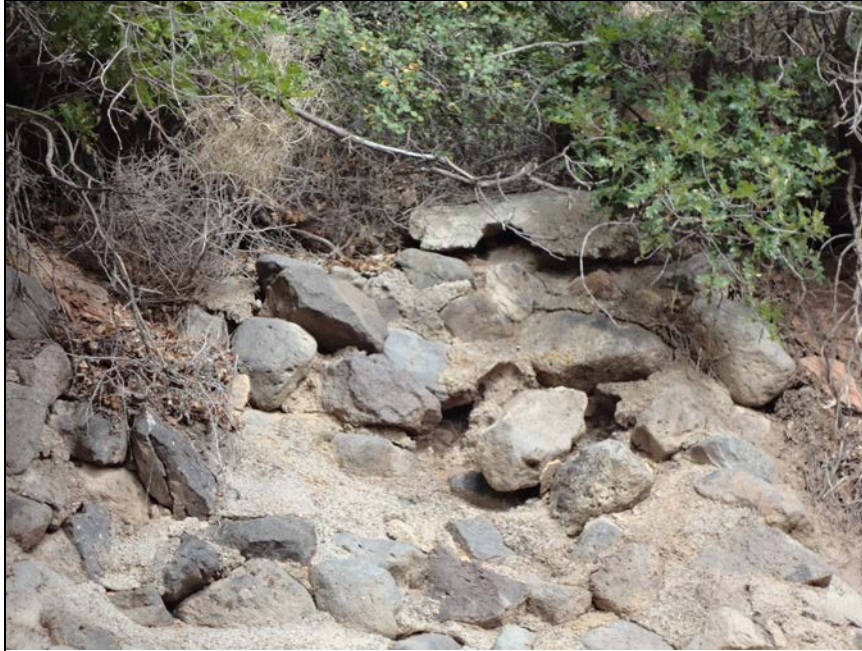
At the third curve up from the entrance, between the former Warehouse Bench and the Transfer Tower 1 location, the rip rap and shotcrete were dislodged.

Photo 6
Shotcrete channel above
warehouse bench

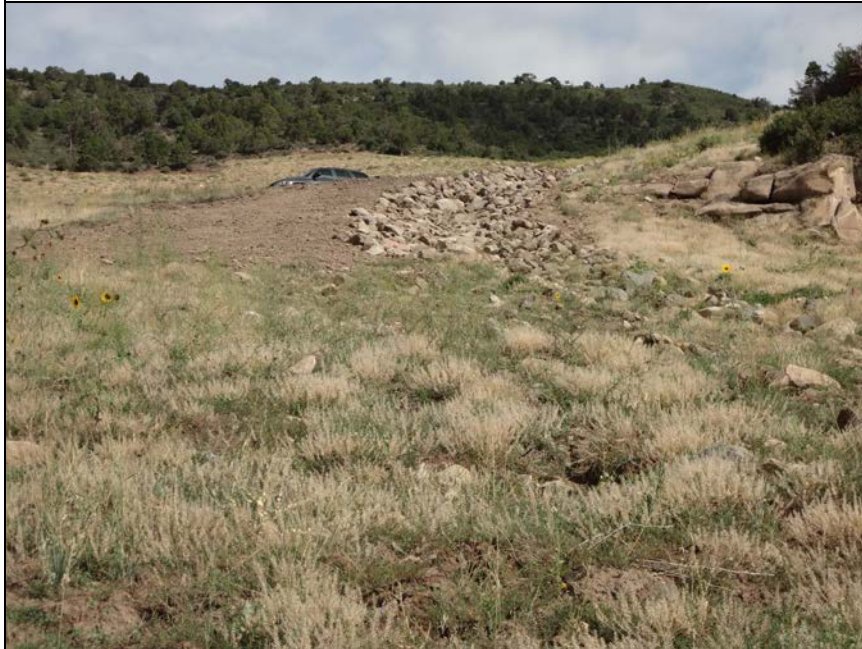
Photo 7
Repaired upper Ditch 7

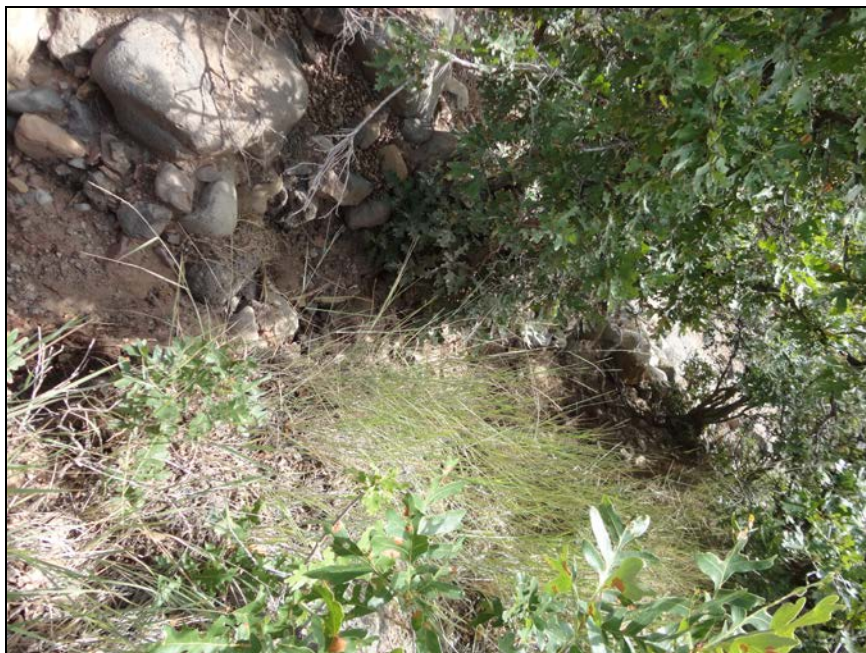
Photo 8
Culvert outfall along East
Mine road

The main entrance road surface at the East Mine was in good condition. Ditches were functional, but slightly downcut in places along the straight north/south stretch just north of the reclaimed refuse disposal area, just before the culvert that crosses the drainage over to the east side of the road. Water has also eroded around and under the shotcrete lining just above the culvert. The outfall of the culvert was downcut considerably, below and slightly to the right of the rip rap. This steep outfall drop might benefit from the installation of step pools or splash blocks. The first section of the outfall does have a large splash block that seems to help with the downcutting, but the next 20-30' beyond are still steep enough to allow for significant erosion.

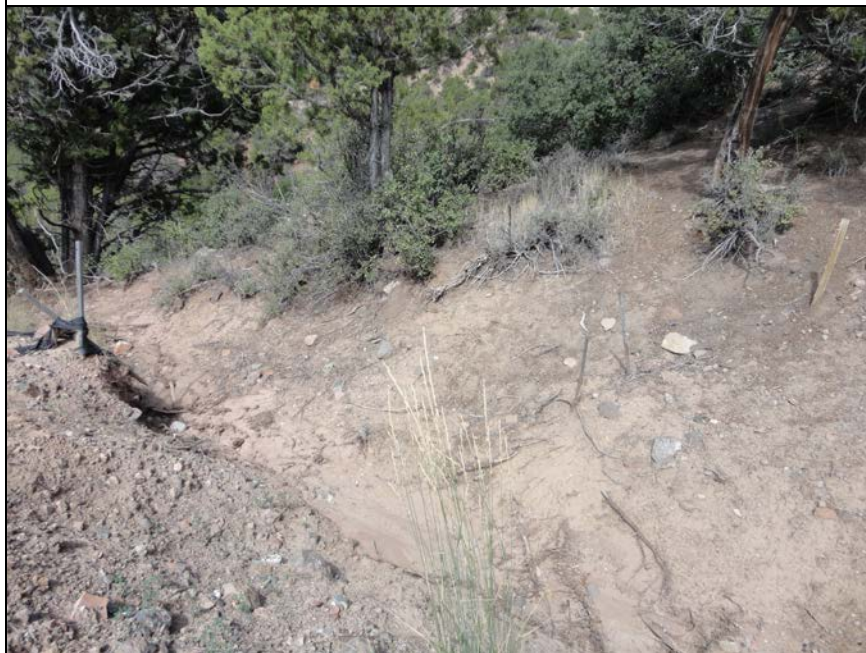
Photo 9
Ditch outlet on East Mine
road

Straw bales had been replaced in several locations along the main East Mine road. There is one location that still needs the bales replaced, on the switchback just west of the refuse disposal area (second curve heading up from entrance). When the bales are replaced, it would also be good to excavate a small pooling area (similar to the installations upgradient) to drop some sediment and reduce velocity before the water flows into the adjacent undisturbed area.

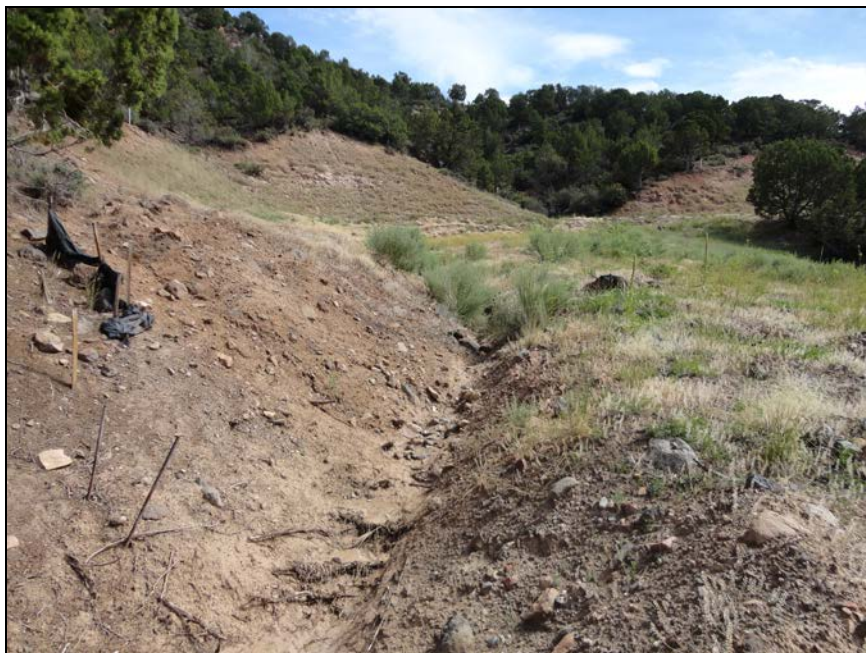
Photo 10
Upgradient portion of
ditch carrying East Mine
road runoff into
undisturbed area

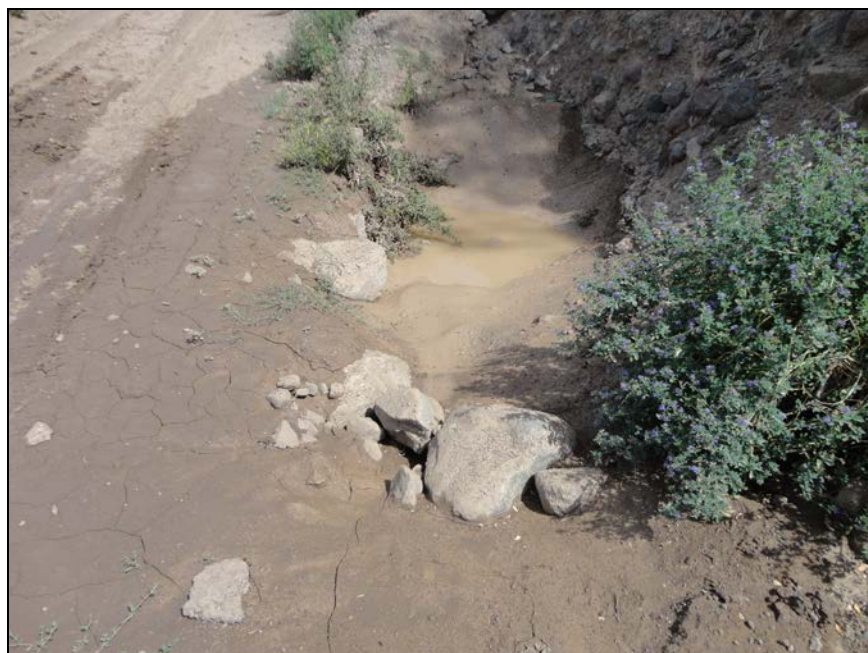
Photo 12
West Mine culvert inlet

At the West Mine, the culvert that brings drainage across the road from the east side to the west is still blocked. Water has crossed over onto the road and caused a large soft spot in the road. The culvert should be cleared this construction season, to be ready for Spring snowmelt.

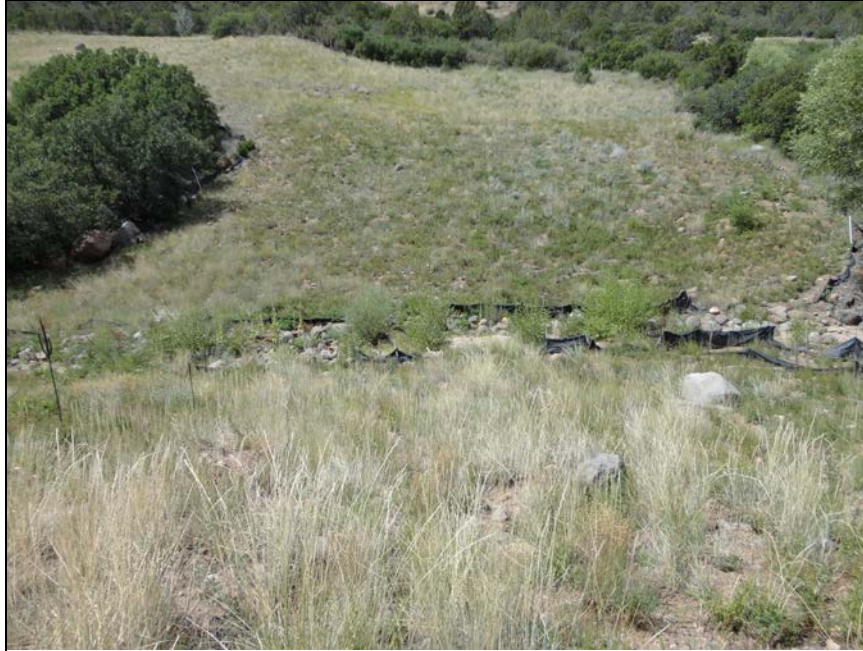
Photo 14
Silt fence on Stevens
Gulch at ROM area

The silt fence along Stevens Gulch, at the ROM area, needs to be replaced. Alternatively, BRL can submit a revision to the permit to allow for alternate sediment control measures (straw wattles, vegetative filter, etc.) along the disturbance, or provide a demonstration that vegetation is adequate to control erosion and sedimentation. Repairs, replacement, or a demonstration need to be completed by October 31, 2013.

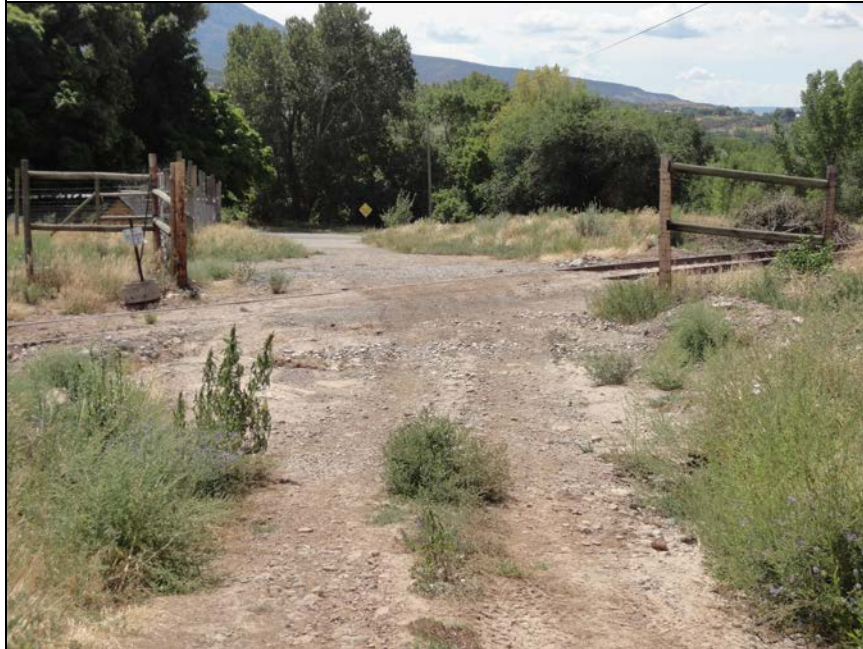
The coal stockpile pond and sewage lagoon at the loadout were dry; the east sediment pond at the loadout had about 6" of water in it. The berm at the south end of the gravel storage area SAE on the west end of the eastern part of the loadout was not in place, and needs to be repaired immediately.

Photo 15
Loadout gravel storage
area SAE – berm should
be parallel to tracks, on
near side

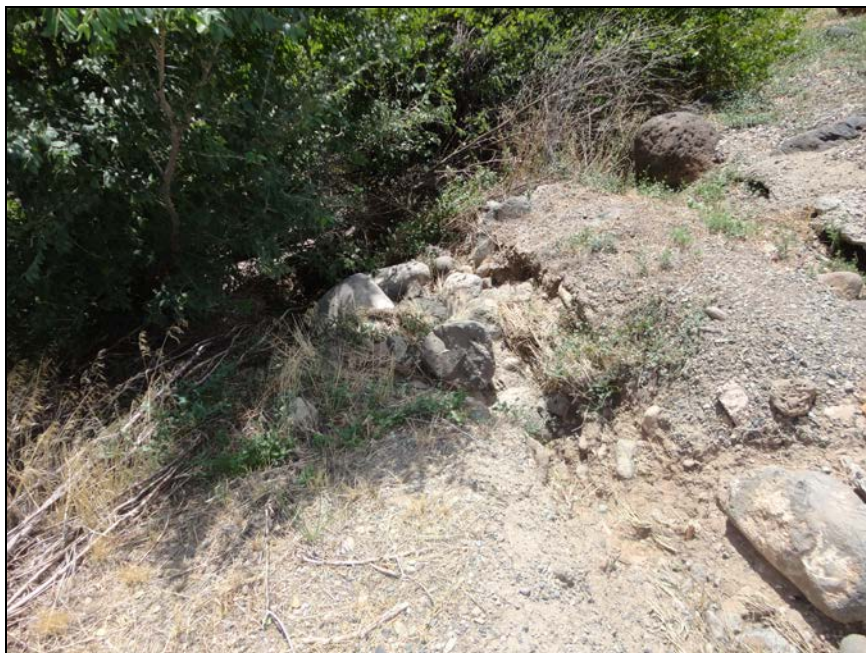
There were a few gullies near the loadout substation that need to be repaired; two coming off of the substation and one just east of the substation. Drainage from these areas does flow to the sediment pond, as shown on Map 7, but the concentrated flow paths to the ditch are not stable.

Photo 16
Gullies on outslope just
east of loadout substation
